EPA 550/9-82-331F

Field
Test
of a
Quieted
Ford CLT 9000
Heavy-Duty
Diesel Truck

October 1981

4. TITLE AND SUBTITLE Field Test of a Quieted Ford CLT 9000 Heavy-Duty Diesel Truck	5. REPORT DATE October 1981	6. PERFORMING ORGANIZATION CODE
	7. AUTHOR(S) E.K. Bender and J.A. Kane	8. PERFORMING ORGANIZATION REPORT NO. BBN Report No. 4700

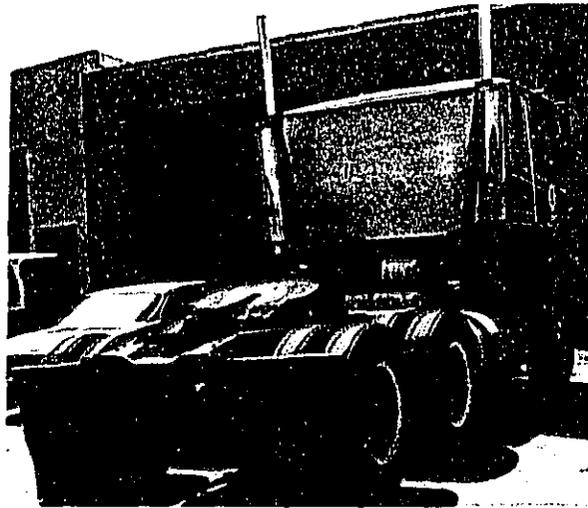
FIG. 11. DUAL EXHAUST SYSTEM.

Figure 11 shows a rear view of the dual exhaust system. As may be seen from this figure, no degradation is apparent. Closer

inspection of the exhaust system components showed them to be in good condition.

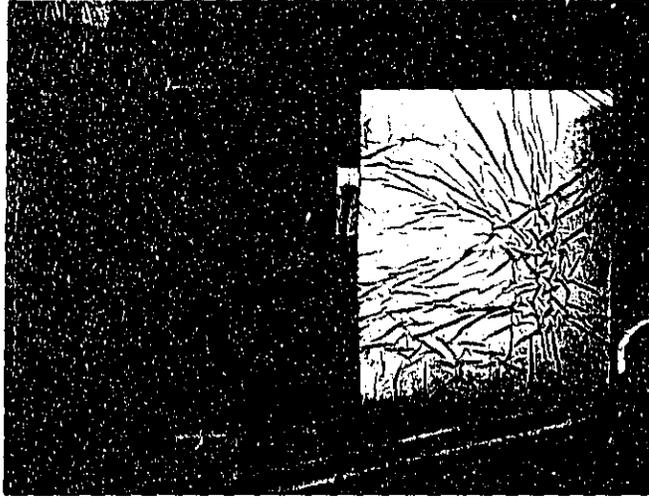
FIG. 12. PARTIAL DETERIORATION OF THE FORD UNDERCAB ABSORPTIVE TREATMENT.

A partial deterioration of the undercab sound-absorptive material, originally installed by the vehicle manufacturer, may be seen in Fig. 12. Two of the foam panels, faced with aluminized polyester, apparently fell off. On a third panel, the protective polyester covering has worn through, but no excessive absorption of oil or grime is seen. Maintenance records do not indicate when this deterioration occurred.

correctable according to the results of this test. The undercab sound-absorptive treatment could be more firmly fastened by using a better adhesive. The damage to the right side shield and right shelf could be avoided by redesigning these components with more clearance space for the tire, turbocharger, and dipstick tube. Wear to the wiping seals is perhaps more unsightly than acoustically detrimental and could be substantially reduced by using flush-mounted fasteners for the perforated metal on the side shields. Loss of the shim in the top transmission cover could be avoided by using brackets that fit better and do not require a shim.

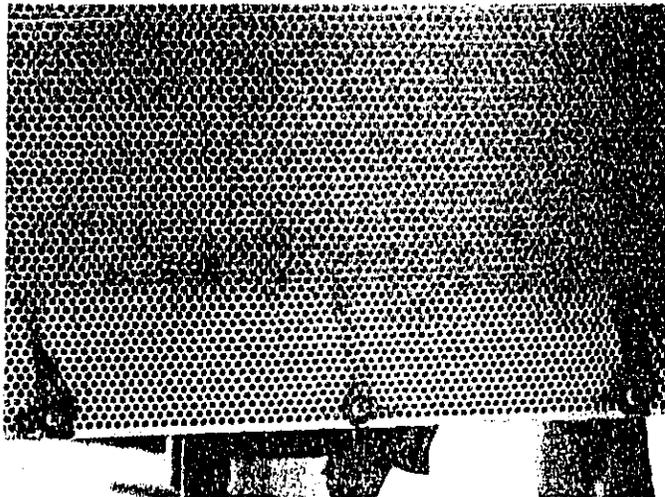
FIG. 15. LEFT SIDE SHIELD POLISHED BY NEOPRENE WIPING SEAL.

A closer view of the left shield shows that a strip about 3 in. wide along the bottom edge of the shield has been polished and left shining by the neoprene wiping seal (Fig. 15). The heads of the sheet metal screws used to fasten the perforated metal are clearly visible in this photograph. Figure 16 shows that these screw heads wore grooves in the left wiping seal. The right wiping seal exhibits even more wear, as illustrated in Fig. 17.

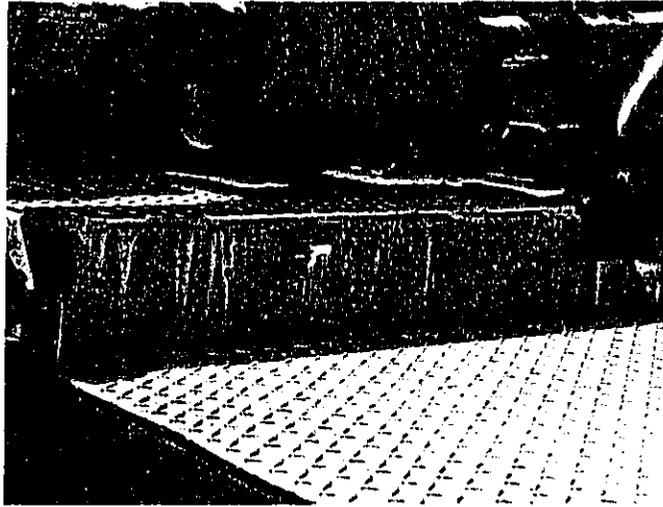
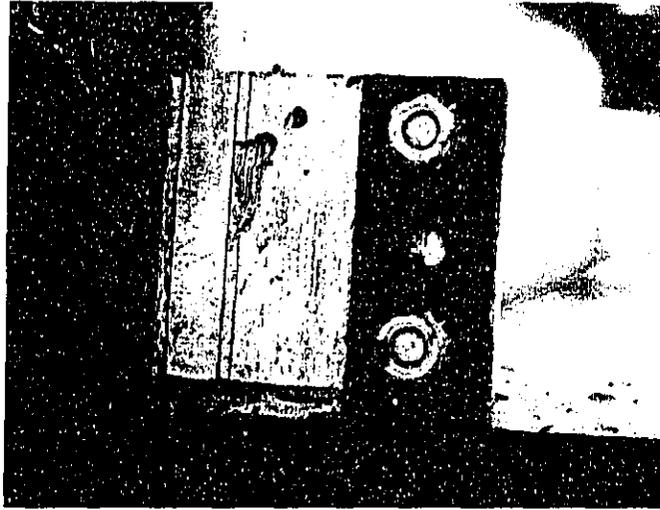
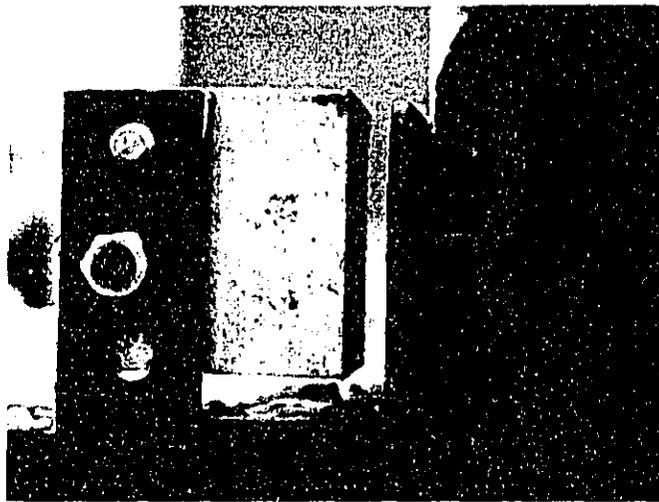
The transmission cover held up well during the test. Figure 19 shows the rear and forward portions of the cover. Two of the upper cover brackets are illustrated in this figure. A close-up of the left bracket (Fig. 20) shows that it is intact. A similar view of the right bracket in Fig. 21 shows a gap where a shim had apparently not been reinstalled after servicing.
