Field  
Test  
of a  
Quieted  
General Motors  
Brigadier  
Heavy-Duty  
Diesel Truck

Environmental Protection Agency

December 1981

Report No. 4796

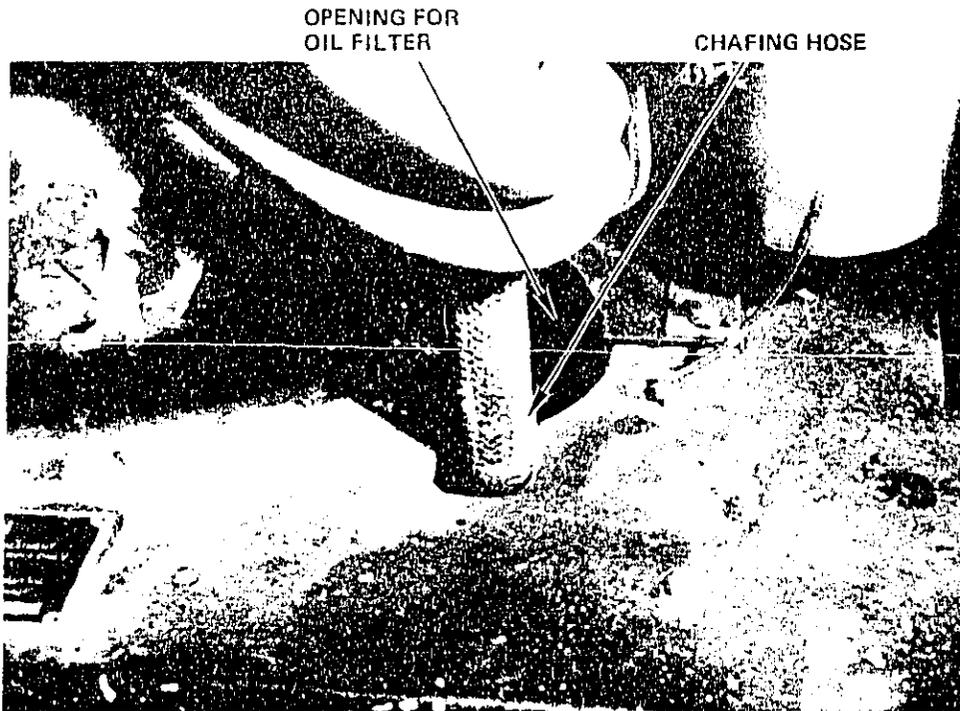
When the enclosure was first installed, an opening was left in the right shelf (see R2 in Fig. 3) to accommodate the stock oil filter. ABF routinely replaces these filters with Luber Finer filters and locates them at the rear of the cab. Figure 12 shows the circular hole left in the shelf when the filter was removed. A significant amount of sound could propagate through this hole. The figure also shows that hose passing through an opening adjacent to the filter hole is being chafed by the shelf.

FIG. 12. RIGHT SIDE SHELF ILLUSTRATING OPENING FOR OIL FILTER AND CHAFING HOSE.

These problems were fixed by covering the oil filter hole with a neoprene sheet riveted to the shelf and supporting the hose with a clamp to prevent further chafing.

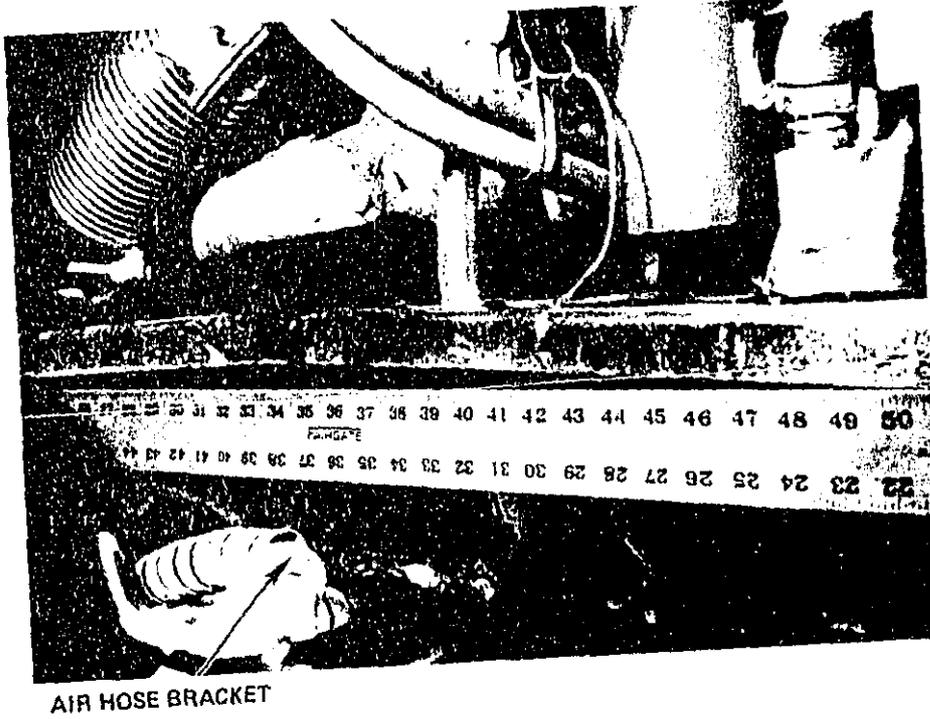
Further inspection of the right shelf discussed above revealed that it was bent from its original plane shape. Fig. 13 shows a side view of the shelf, below which is held a steel scale to illustrate the shelf deformation. The shelf is deformed by approximately 1/2 in.

FIG. 13. BEND IN RIGHT SIDE SHELF (R2).

The cause of the shelf deformation was traced to the air hose bracket shown near the bottom of Fig. 13. For a range of steering angles, the top of the bracket is aligned directly under the lip of the shelf. If the truck traverses a large bump, the bracket could hit the shelf and deform it to the shape illustrated in the figure.

To prevent future contact between the shelf and bracket, the shelf was rebuilt as shown in Fig. 14. The contour was selected to match the contour of the original inner fender.

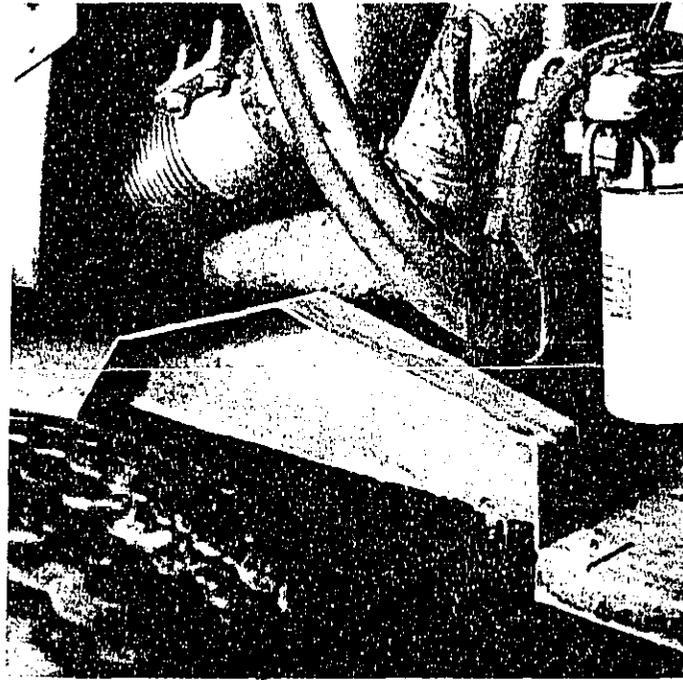
FIG. 14. REBUILT SHELF.

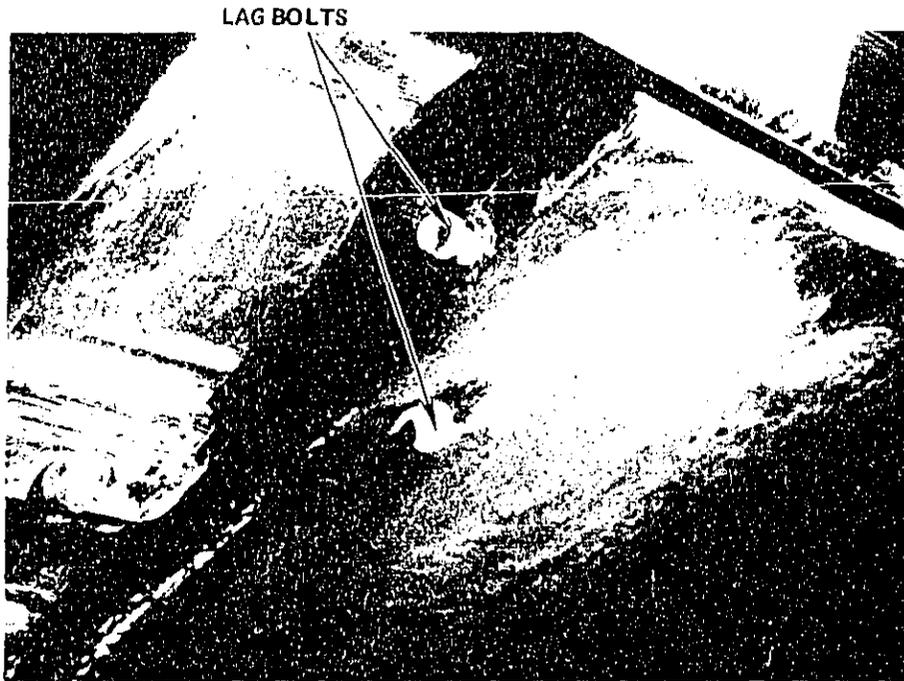
forward bottom panel (B1) in place (see Fig. 21 of Ref. 2). These fasteners had apparently been found unsatisfactory by an ABF mechanic and were replaced with sheet metal lag bolts. An additional bolt was placed through the lip of the panel. Both are illustrated in Fig. 16.

FIG. 16. LAG BOLTS USED TO HOLD PANEL B1 IN PLACE.

Before the truck was placed back in service, these bolts were removed and a heavier quarter-turn fastener was placed at the bottom corners of the bellypan. This fastener was larger and more rugged than those that had been used previously.

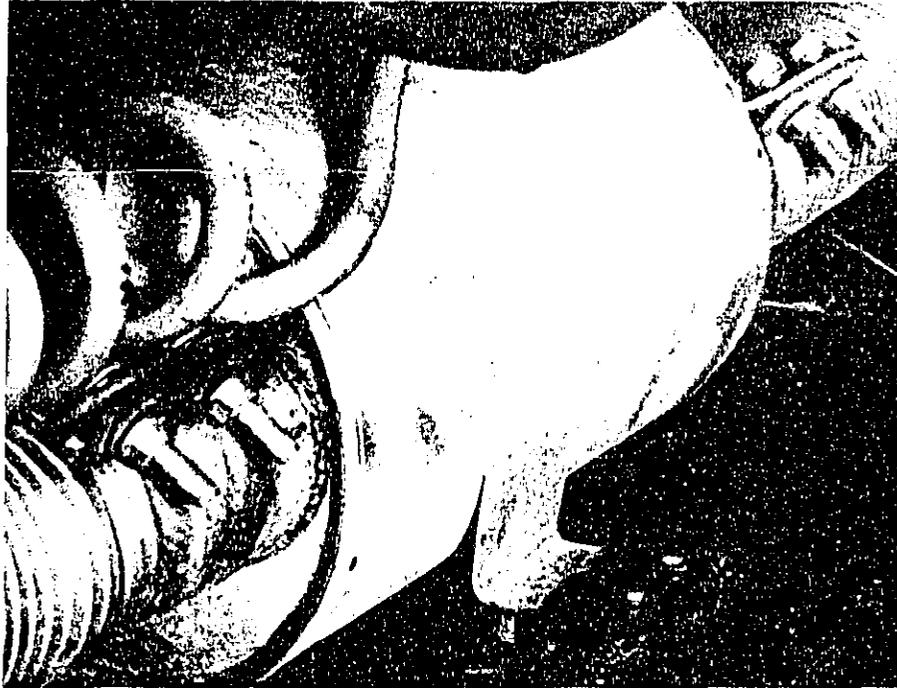
FIG. 18. BRACKET WELDED TO TEE CAN AND BOLTED TO FRAME CROSS MEMBER.

The exhaust system showed no signs of deterioration. The bracket welded to the Tee Can (see Fig. 18) retained its structural integrity and performed its function of supporting and keeping the exhaust line in place.
