APPENDIX B
HIGHWAY CONSTRUCTION NOISE FIELD MEASUREMENTS,
SITE 2: I-205 (OREGON)

October 1981

Office of Noise Abatement & Control
U. S. Environmental Protection Agency
Washington, D. C. 20460

This appendix summarizes field measurements performed at the I-205 (Oregon) construction site during September 1979. This site consisted of 9 miles of 6-lane divided highway being constructed on new alignment. The site topography was generally flat to gently rolling with some hilly canyon terrain. The highway cut through an urban area characterized by single-family dwellings, schools, small stores, etc. Further description of this site is presented in Section 3.5 of the main report.

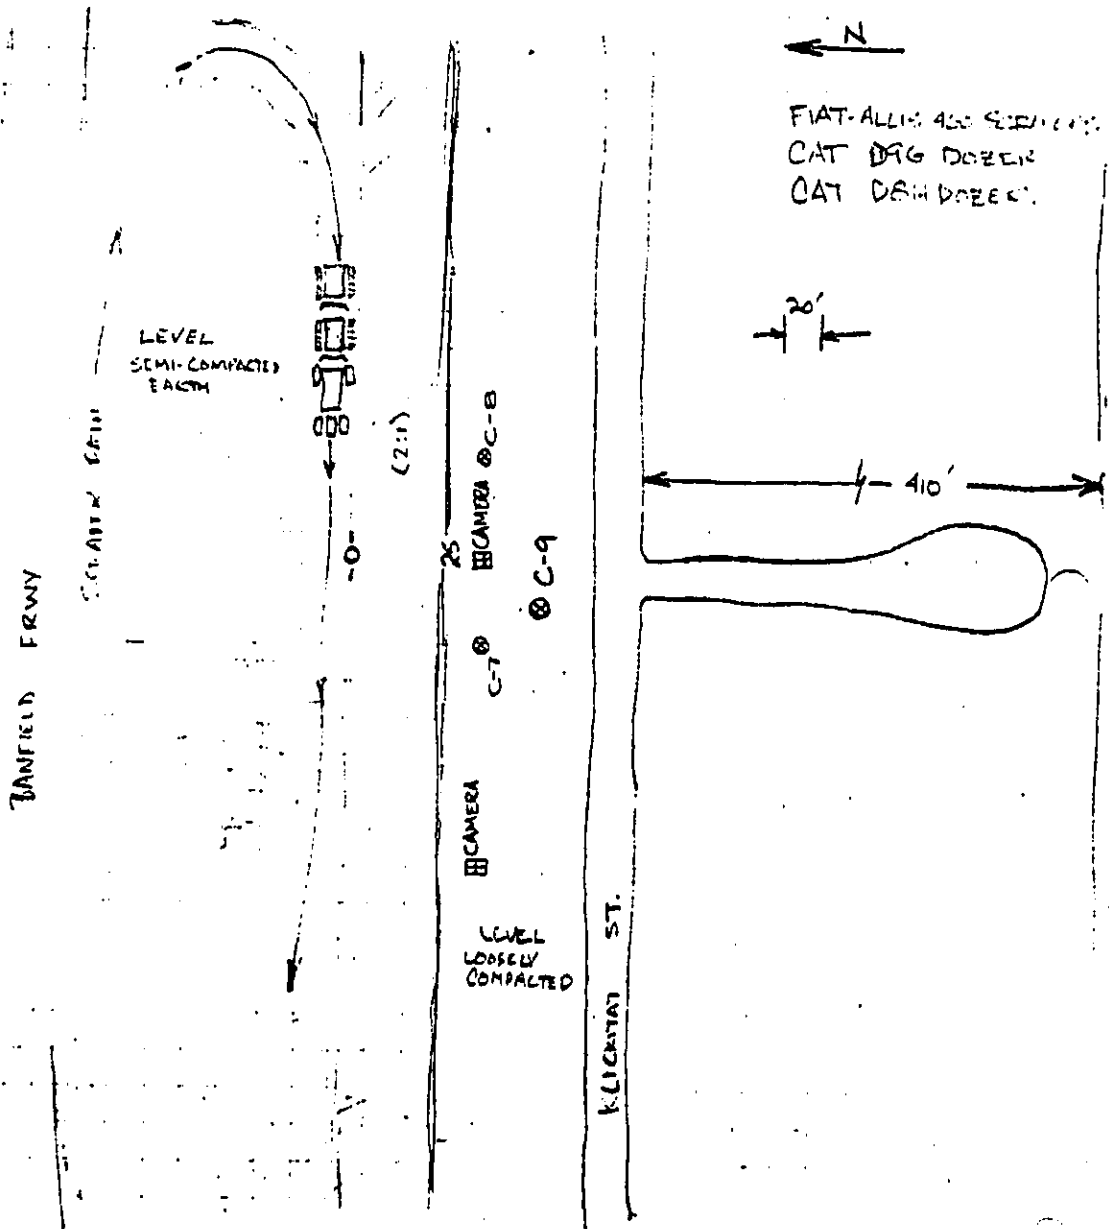
DIAGRAM 9-75

Site Location: Cut Area III; S. of Washington St.

Soil/Terrain Conditions: Terrain is generally flat. Area from microphone to cut operation was flat and grass covered. Area where equipment worked was depressed by about 5 feet.

Cat. D9G Dozer
Cat. DAH Dozer
Cat. 631 Scrape

Dozer worked in tandem pushing scrape

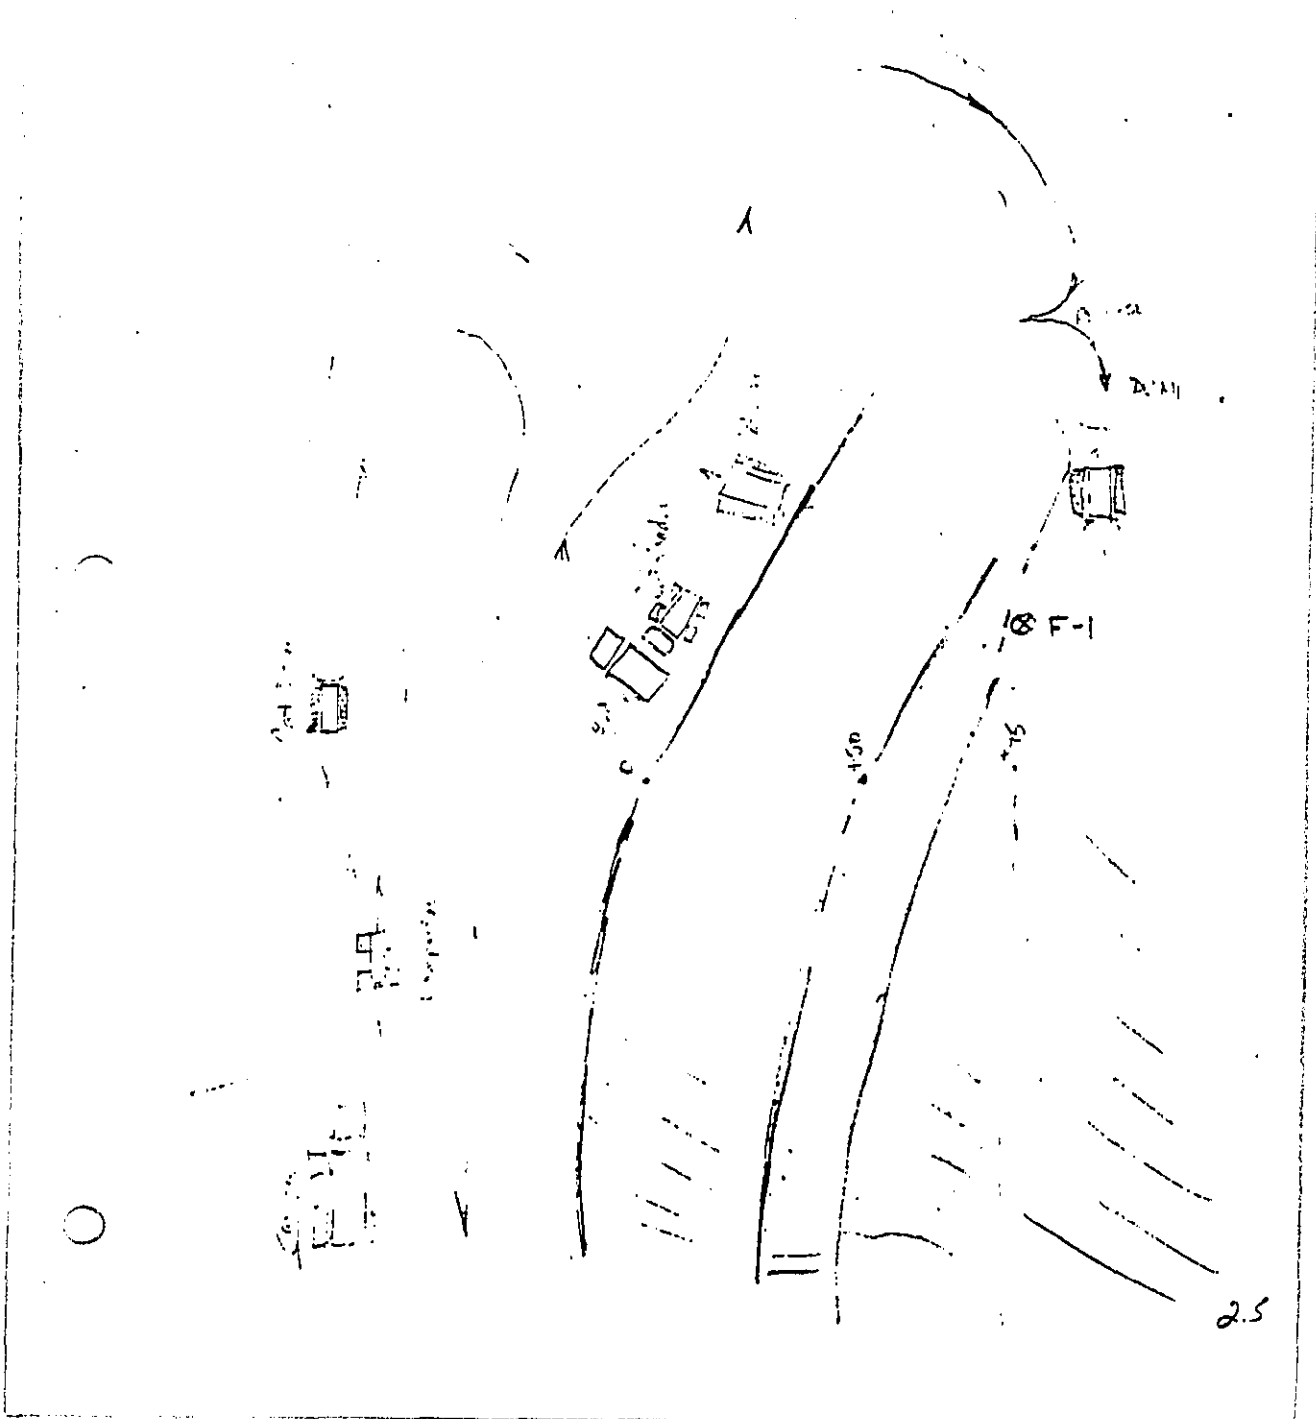
DIAGRAM 9-6A

- 2 CAT 769
- 1 CAT D9H
- 1 CAT D8H
- 1 CAT 983

CAT D8H
(SAME AS
ON RIGHT SIDE)

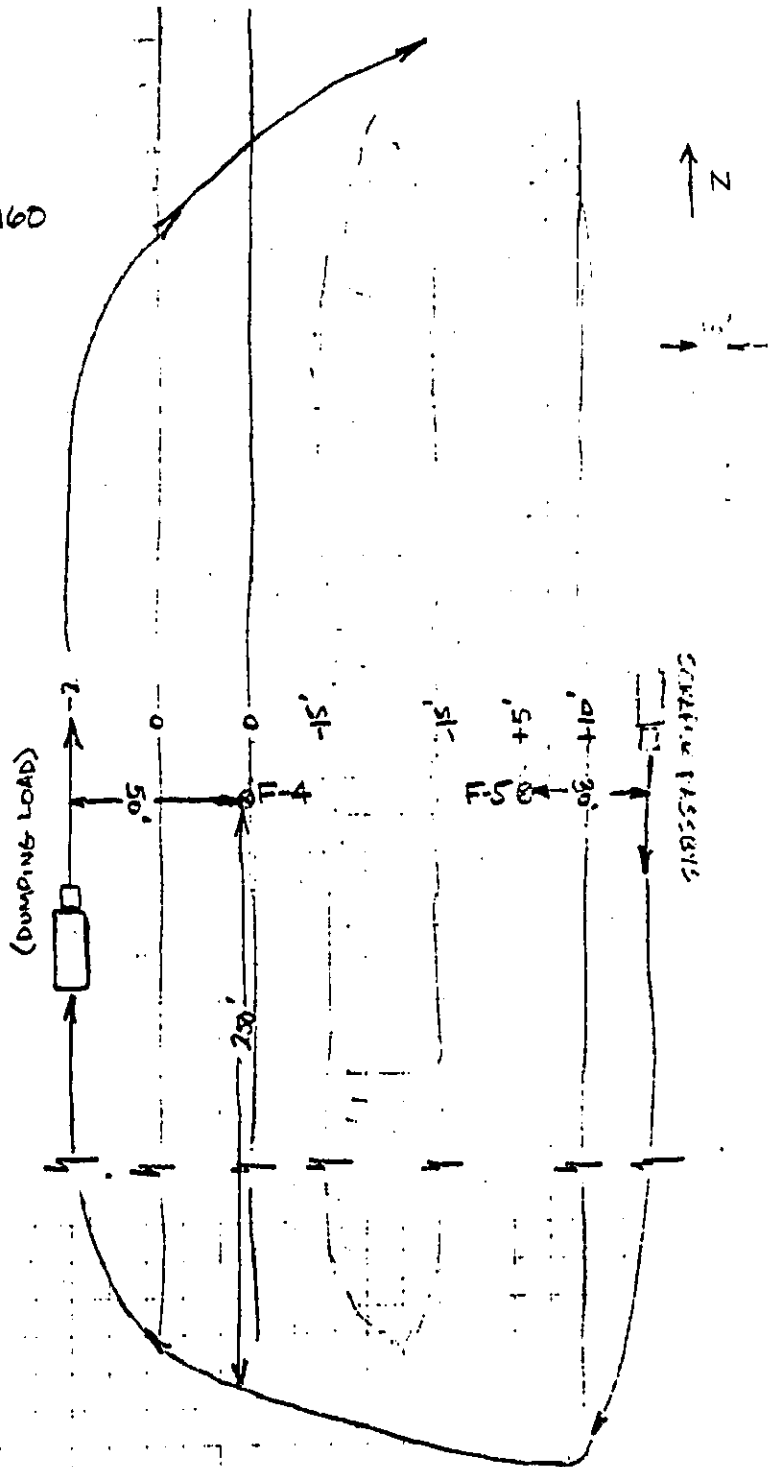
DIAGRAM 9-6C

Site Location: Fill Area III - S. of interchange, between
Fill Areas I & II

Soil/Terrain Conditions: Right-of-way area was flat, compacted
earth. Soil was very wet due to rain the previous
day. Embankment was steep slope covered
with large boulders.

Cat 769 End Dumps with exhaust. Built into
truck bed.

End dumps were unloading rocks
hailed from Fill Area I. Trucks would unload onto
the embankment. Dozer would push loose rock over
the embankment. Activity occurred along a portion of
the right-of-way for which earthwork appeared complete

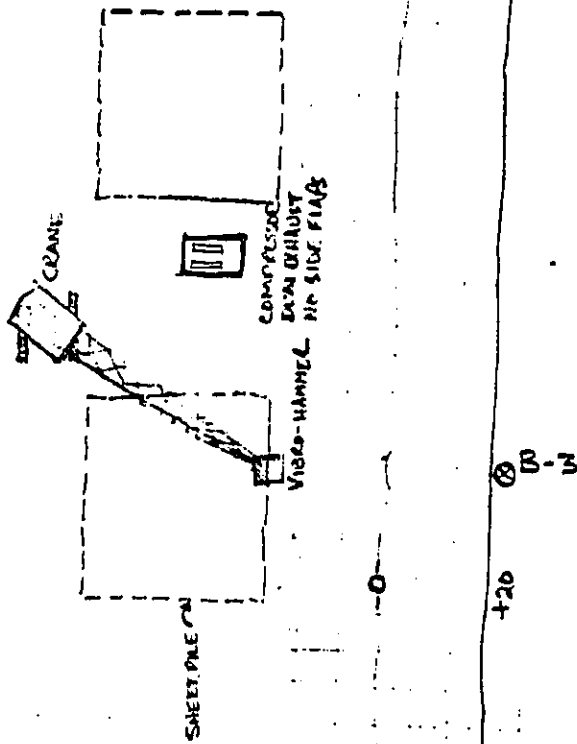
VIBRO-HAMMER

PILL DRIVER
OPERATED INTER-
MITTENTLY 500'
FROM MIC.
POSITION

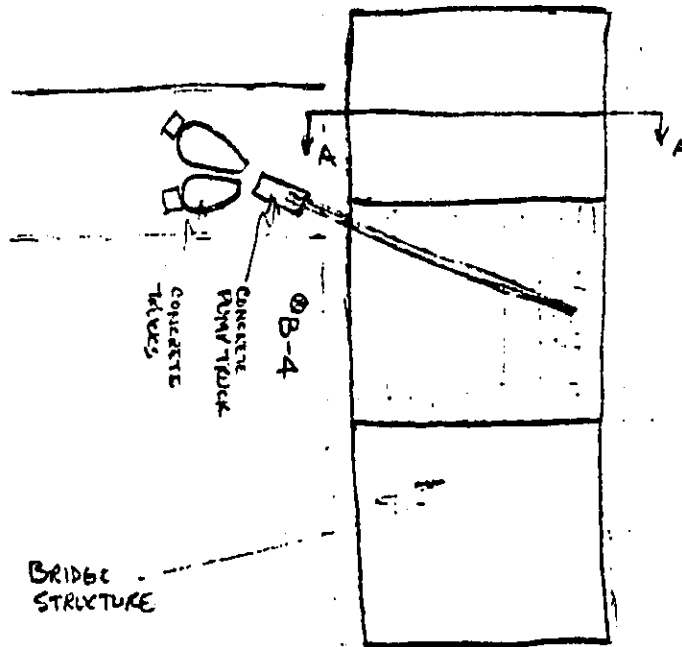
DIAGRAM 9-7B

CONCRETE POUR
ON BRIDGE

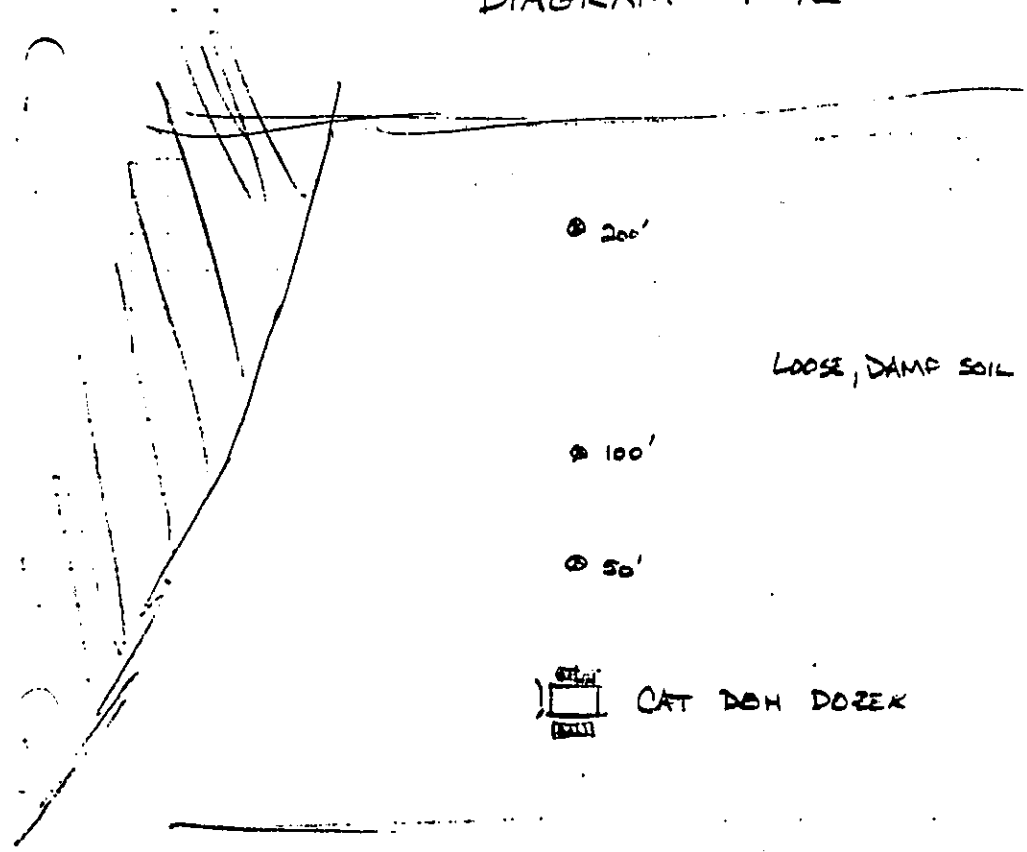
DIAGRAM 9-7E

Site Location: Cut Area I; Propagation Measurements
for Dozer

Soil/Terrain Conditions: Level area. Loosely compacted
soil and small rock. Ground very wet
from rains the previous day.

Cat. DBH Track Dozer

Measurements made at 50' & 100';
then measurements repeated with mic's at 50' and 100'.
Dozer noise levels measured for IMI's.

CAT DOH DOZER

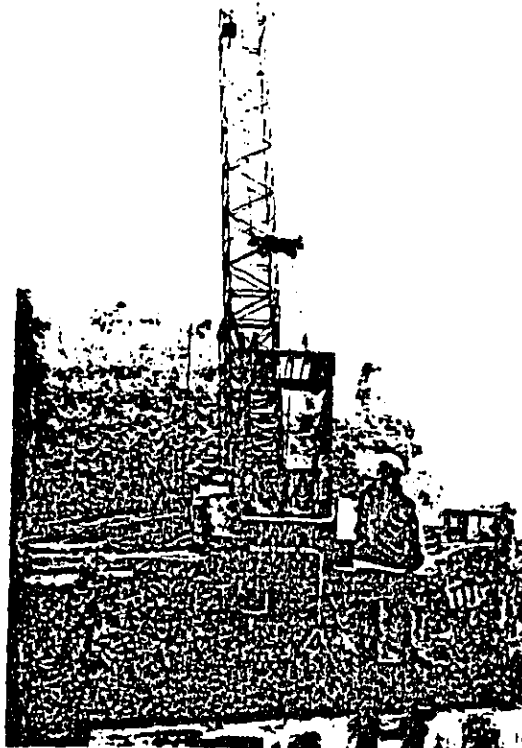
#28

| Frame # | Location | Date | Time | View or Subject |
|---|---|---|---|---|
| 28 | " " " | | | Crane used for concrete pour |

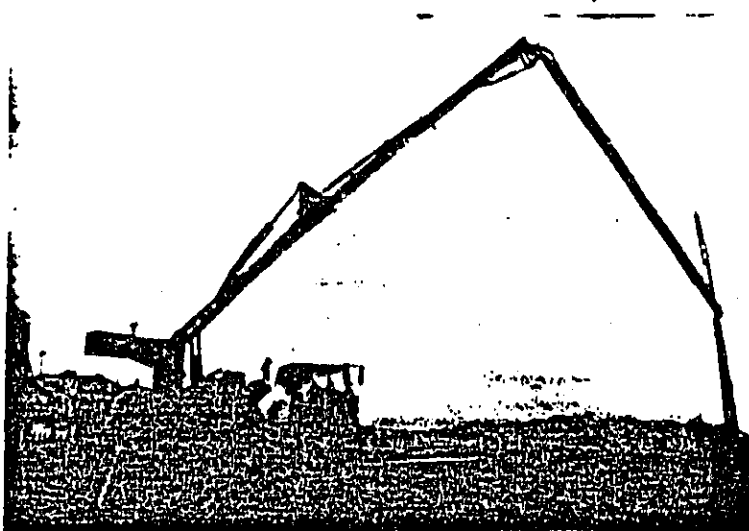
| Frame # | Location | Date | Time | View or Subject |
|---|---|---|---|---|
| 30 | Bridge Site II | | 12:00 | @ B-2, looking S.E. at concrete pump. |

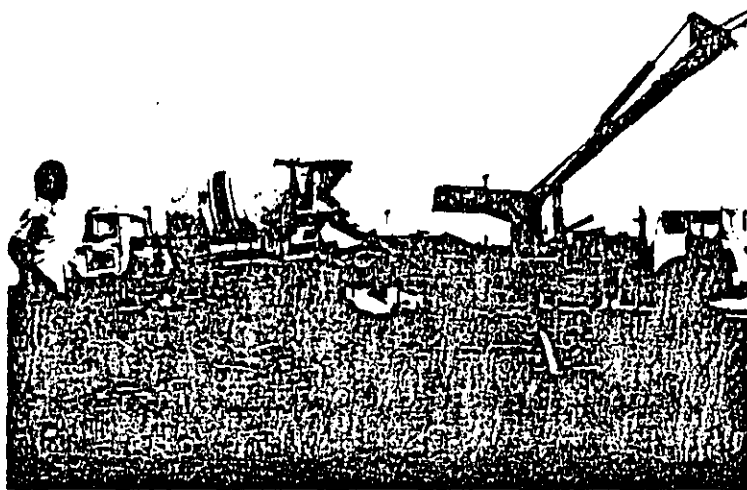
| Frame # | Location | Date | Time | View or Subject |
|---|---|---|---|---|
| 31 | " " " | | | @ B-2, looking east at concrete truck and pump. |

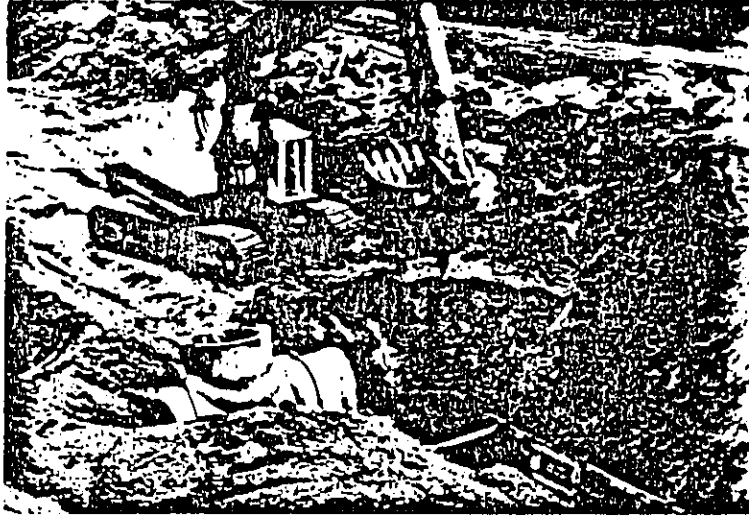
| Frame # | Location | Date | Time | View or Subject |
|---|---|---|---|---|
| 1 | Cut Area I | 9/5 | 1615 | @ C-4; trenching operation |

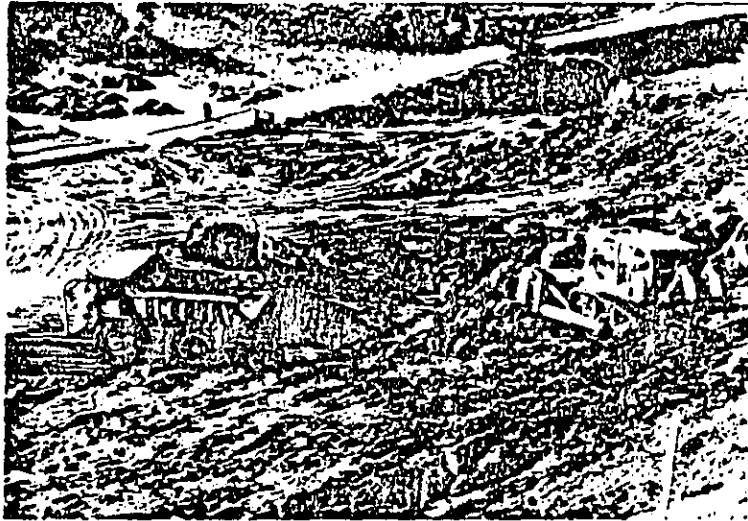
| Frame # | Location | Date | Time | View or Subject |
|---|---|---|---|---|
| 3 | Fill (Cut) Area I | 9/6 | 0900 | @ F-1, looking down on dozer/loader operation, looking east |

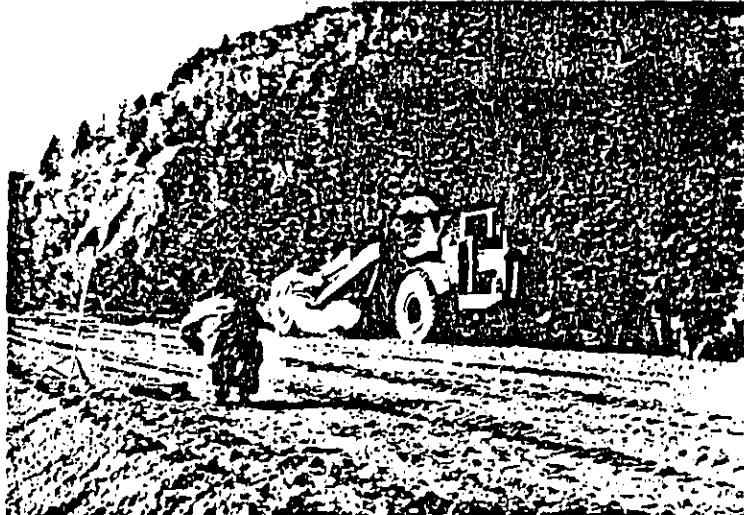
| Frame # | Location | Date | Time | View or Subject |
|---|---|---|---|---|
| 5 | Fill Area II | | 0915 | F-4; scraper unloading near mic. |

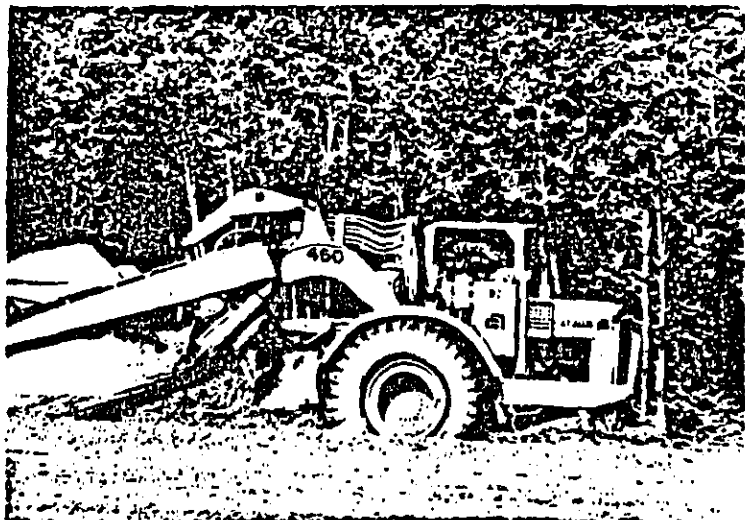
| Frame # | Location | Date | Time | View or Subject |
|---|---|---|---|---|
| 6 | " " " | | | F-4; parking directly west of scraper |

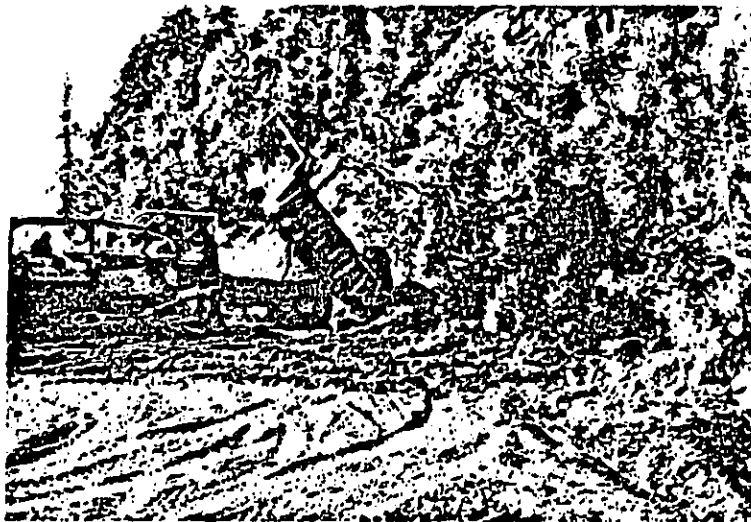
| Frame # | Location | Date | Time | View or Subject |
|---|---|---|---|---|
| 8 | Fill Area III | | | F-6; looking south of it and dump unloading |

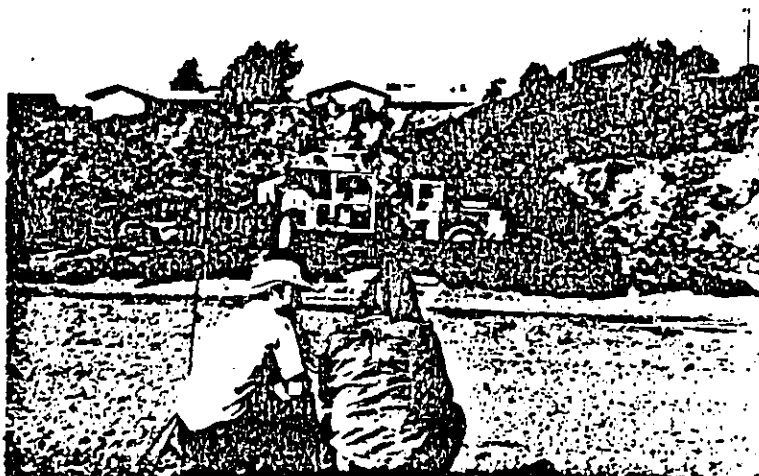
| Frame # | Location | Date | Time | View or Subject |
|---|---|---|---|---|
| 11 | Fill (Cut) Area I | 9/6 | 1040 | @F-3, looking west at loading operation |
