APPENDIX D  
HIGHWAY CONSTRUCTION NOISE FIELD MEASUREMENTS  
SITE 4: I-75 (FLORIDA)

| TECHNICAL REPORT DATA<br><i>(Please read instructions on the reverse before completing)</i> | | |
|---|---|--|
| 4. TITLE AND SUBTITLE<br>Appendix D, Highway Construction Noise Field Measurements, Site 4: I-75 (Florida) | 5. REPORT DATE<br>June 1981 | 6. PERFORMING ORGANIZATION CODE |
| 9. PERFORMING ORGANIZATION NAME AND ADDRESS<br>Wyle Laboratories/Wyle Research<br>2361 Jefferson Davis Highway, #404<br>Arlington, Virginia 22202 | 10. PROGRAM ELEMENT NO. | 11. CONTRACT/GRANT NO.<br>DOT-FH-11-9455 |

This appendix summarizes field measurements performed at the I-75 (Florida) construction site during January 1980. While the total construction encompassed 120 miles of right-of-way, the field noise measurement program focused on the St. Petersburg section, consisting of 25 miles of the I-75 project just south of the City of St. Petersburg. The highway alignment passed through flat, rural landscape, many times encountering large stands of trees. Sparse residential areas existed at various locations, but were some distance from the right-of-way. A more detailed description of the site is presented in

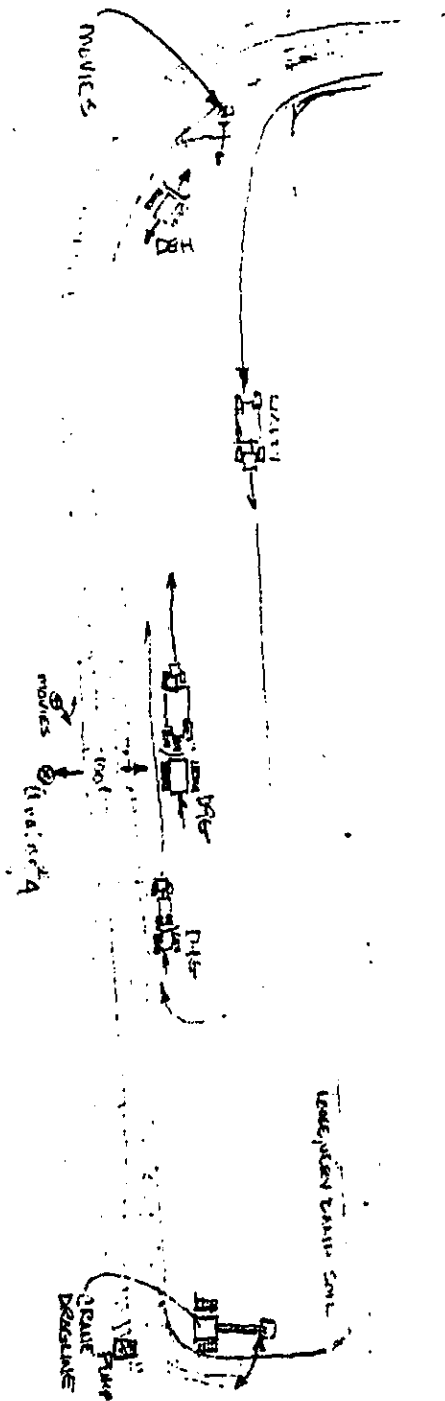
DIAGRAM 1-1SD  
BORROW EXCAVATION

- 2 Cat D9G Dozer
- 1 Cat DBH Dozer
- 2 Cat Scrapers

DIAGRAM 1-1SA, B, C, D REPRESENT  
A CLOSED LOOP SYSTEM; SAME  
SPREADS IN EACH.

SCRAPER LOADING TIMES:  
(TIME WHEN SCRAPER IS BEING  
PUSHED BY DOZER.)

1:05  
1:15  
1:30  
AVG = 1:18

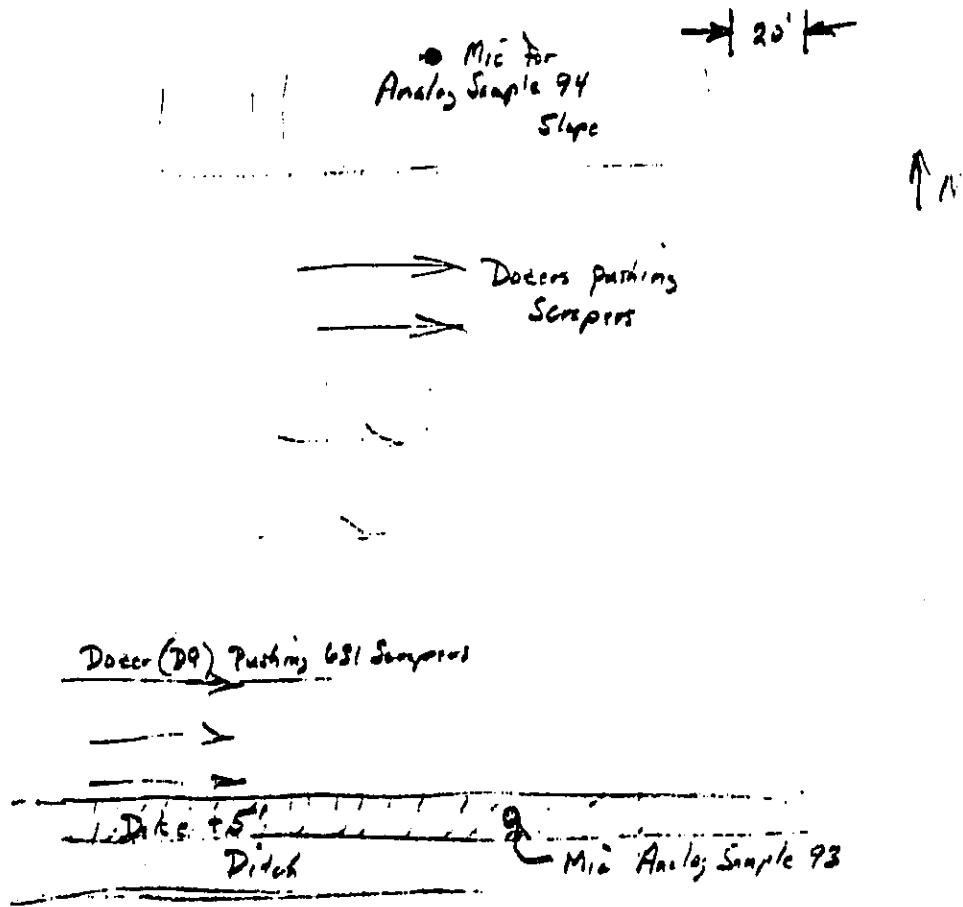
Diagram 1-29 B Borrow Pit

Sample 93 - Possibly of Dozers pushing scrapers at 50 to 130 ft.

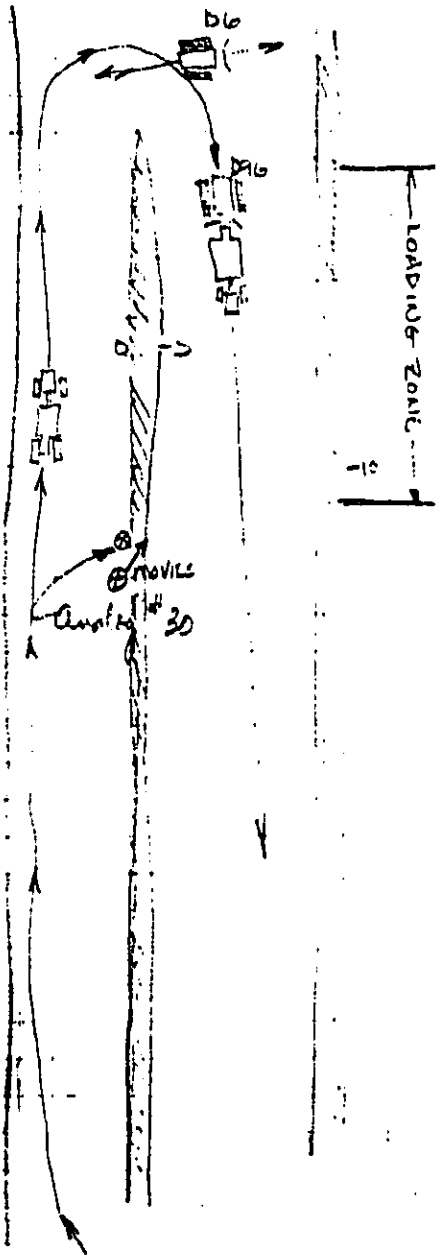
DIAGRAM 1-17F  
Borrow Excavation

- 1 Cat 650
- 1 Cat 600
- 1 Cat 550
- 1 Cat 500

Scraping  
:50  
:55  
1:10

Round Trip Time: 15:00
