Report No. DOT-TSC-OST-72-31

MBTA RAPID TRANSIT SYSTEM (RED LINE)  
WAYSIDE AND IN-CAR  
NOISE AND VIBRATION LEVEL MEASUREMENTS

Edward J. Rickley  
Robert W. Quinn

AUGUST 1972  
FINAL REPORT

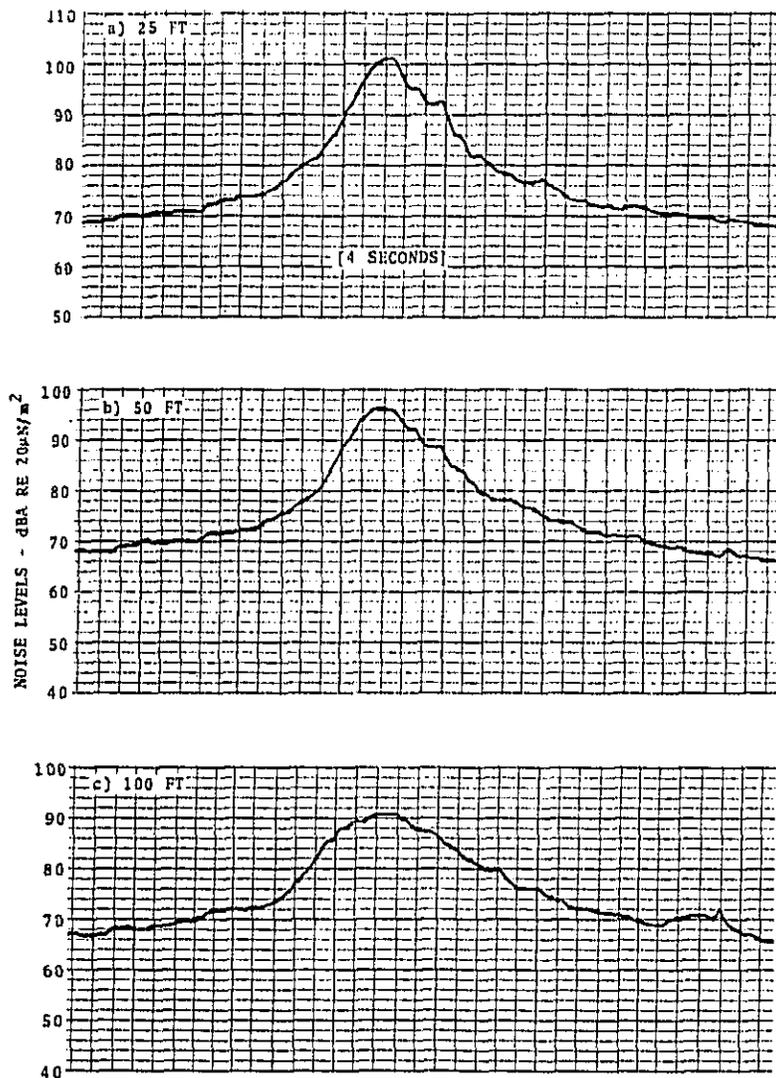
Figure A-2. Coincident Time Histories - Wayside Noise Levels at 25, 50, and 100 ft from centerline at northbound track. MBTA Redline (So Shore Extension) Oct. 28, 1971. Four-Car Train northbound Ser. Nos 1503, 1508, 1641, 1640 at 51.0 mph. See figure A-1.

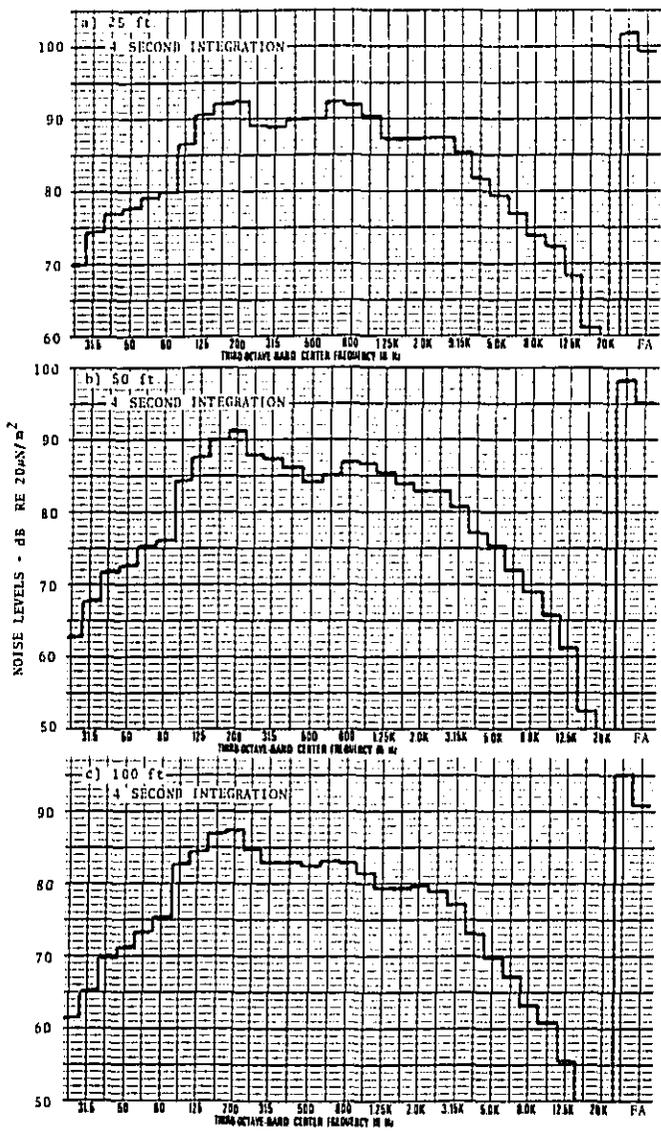
Figure A-3. Wayside Noise Spectra at 25, 50, and 100 ft from center line of northbound track. MBTA Red Line (So Shore Extension) Oct 28, 1971. Four-Car Train northbound Ser. Nos 1503, 1508, 1641, 1640 at 51.0 mph. See figure A-2.

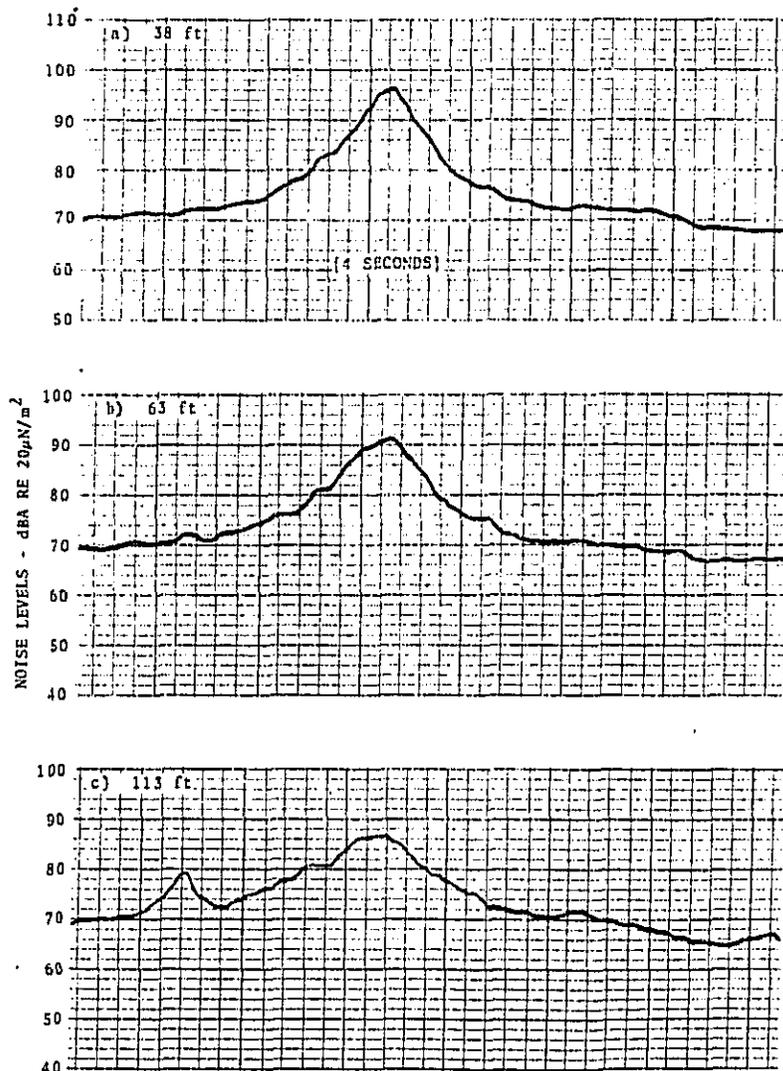
Figure A-4. Coincident Time Histories - Wayside Noise Levels at 38, 63, and 113 ft. from centerline of southbound track. MBTA Red Line (So Shore Extension) Oct 28, 1971. Four-Car Train southbound. Ser. Nos 1503, 1508, 1641, 1640 at 50.4 mph. See figure A-1.

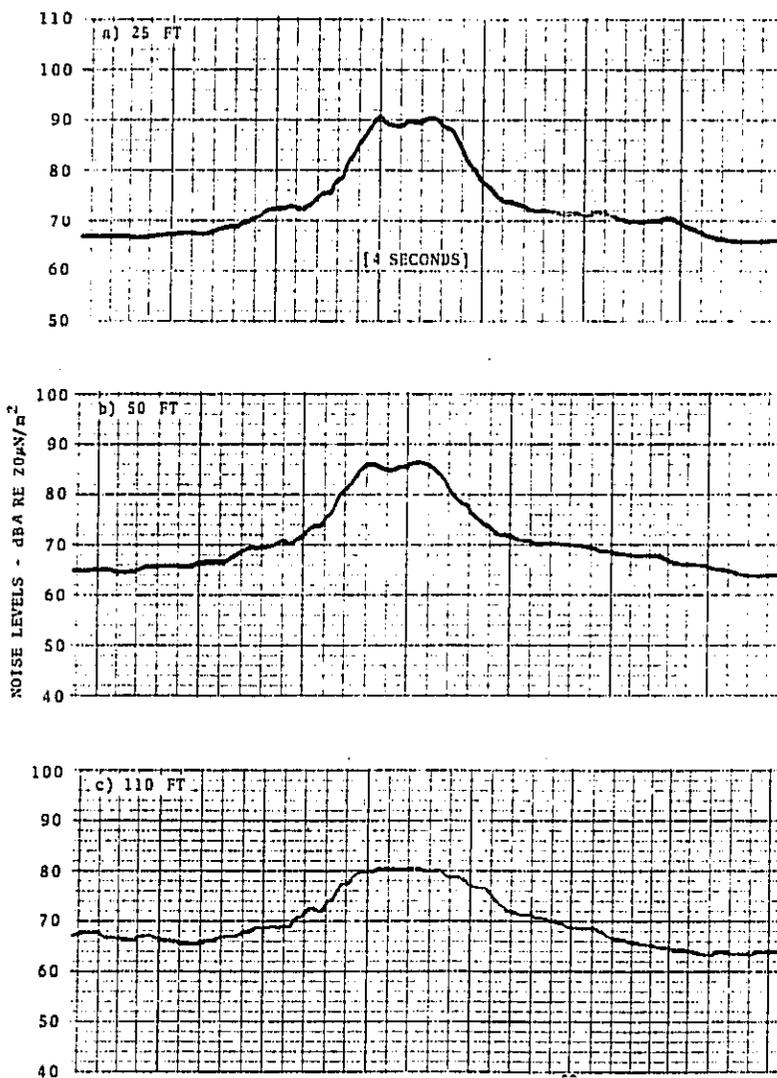
Figure A-6. Coincident Time Histories - Wayside Noise Levels at 25, 50, and 100 ft from centerline of northbound track. MBTA Red Line (So Shore Extension) Oct 28, 1971. Four Car Train northbound Ser. Nos 1639, 1638, 1650, 1651 at 51.0 mph. See figure A-1.

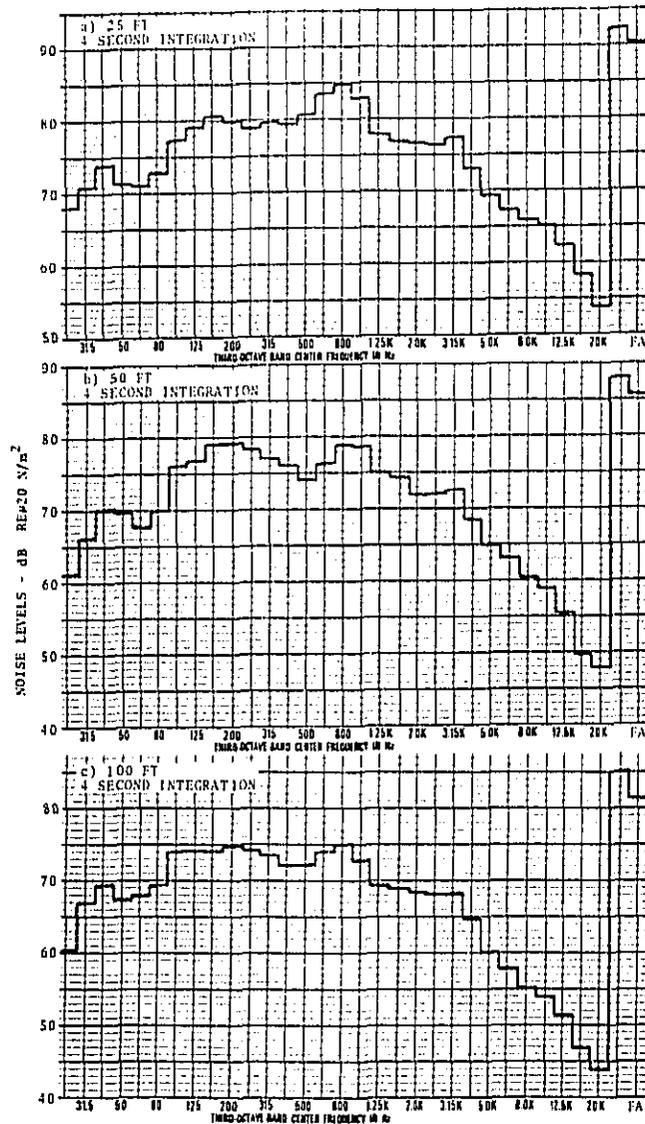
Figure A-7 Wayside Noise Spectra at 25, 50, and 100 ft from centerline of northbound track. MBTA Red Line (So Shore Extension) Oct 28, 1971. Four-Car Train northbound Ser. Nos 1639, 1638, 1650, 1651 at 51.0 mph. See figure A-6.

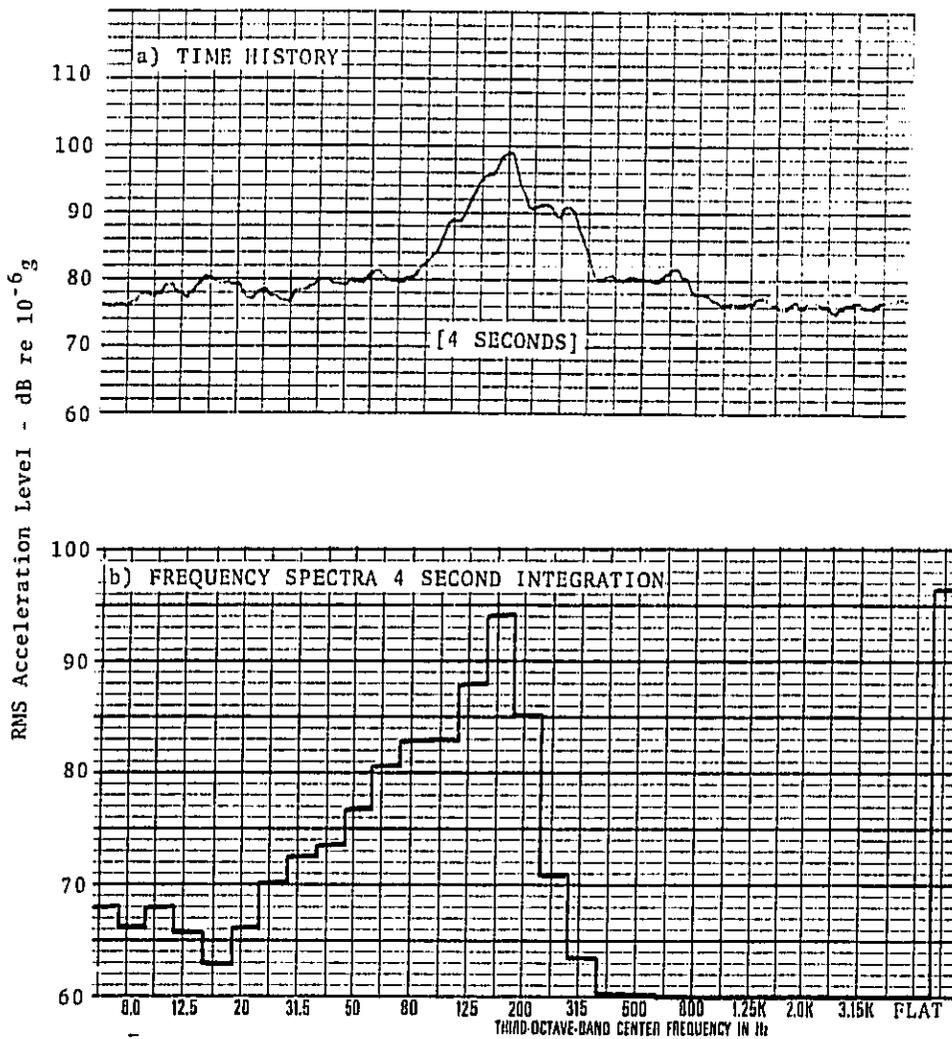
Figure B-2. Ground Vibration - Lateral (y) Axis 25 feet from the centerline of the northbound track. MBTA Red Line (So. Shore Extension) Oct. 28, 1971. Four-Car Train Ser. Nos 1503, 1508, 1641, 1640 at 51.0 mph. See Figure B-1.

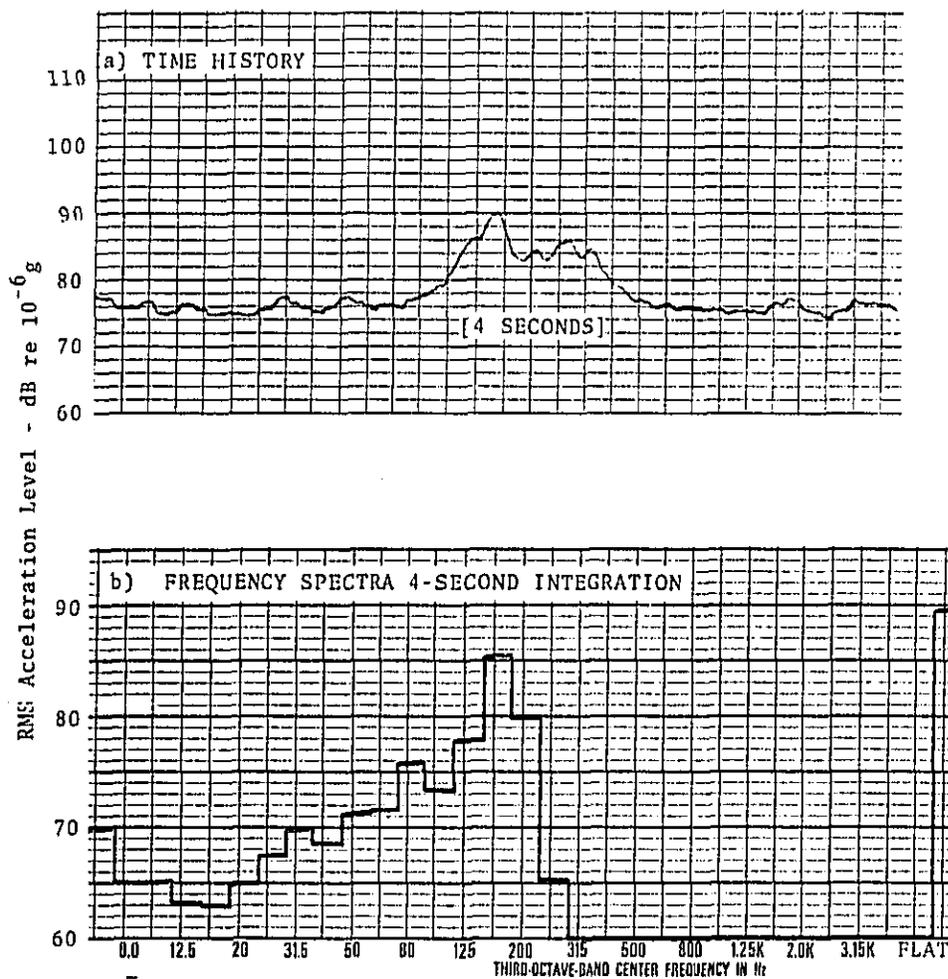
Figure B-4. Ground Vibration - Lateral (y) Axis 25 feet from the center line of the northbound track. MBTA Red Line (So. Shore Extension) Oct. 28, 1971. Four-Car Train Ser. Nos 1639, 1638, 1651, 1650 at 51.0 mph See Figure B-1.

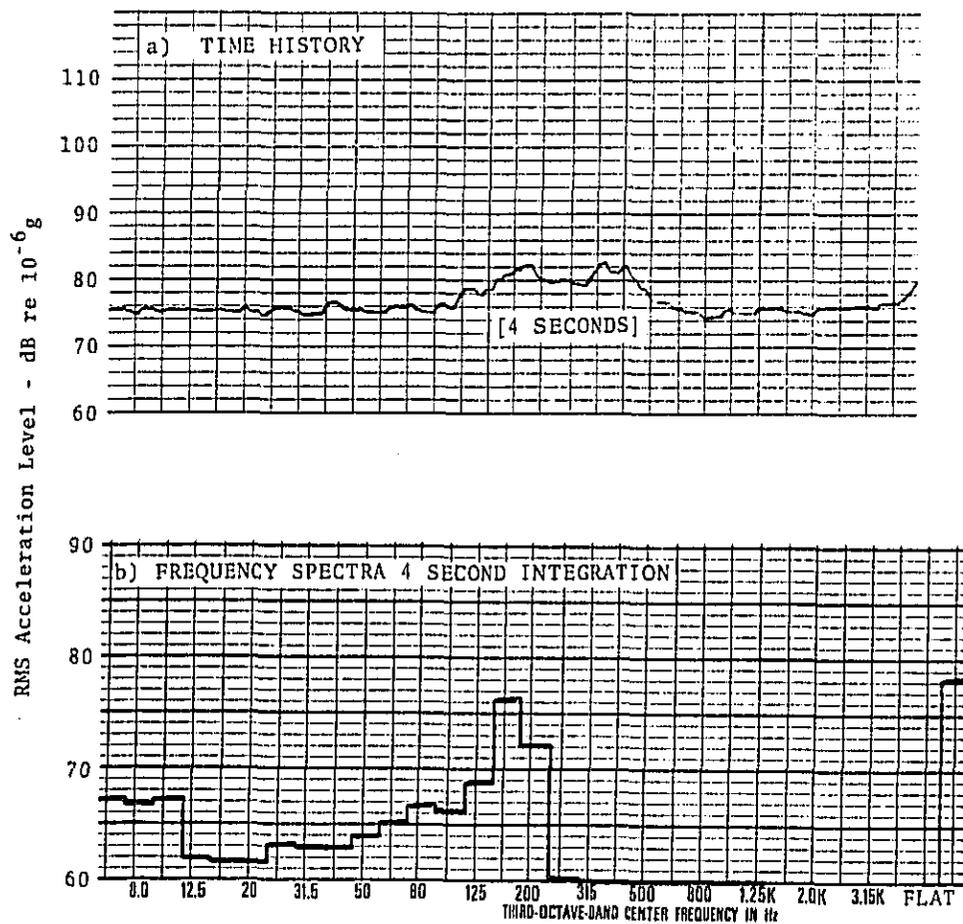
Figure B-5. Ground Vibration - Lateral (y) Axis 38 feet from centerline of southbound track. MBTA Red Line (So. Shore Extension) Oct. 28, 1971. Four-Car Train southbound Ser. Nos 1639, 1638, 1650, 1651 at 51.8 mph. See Figure B-1.

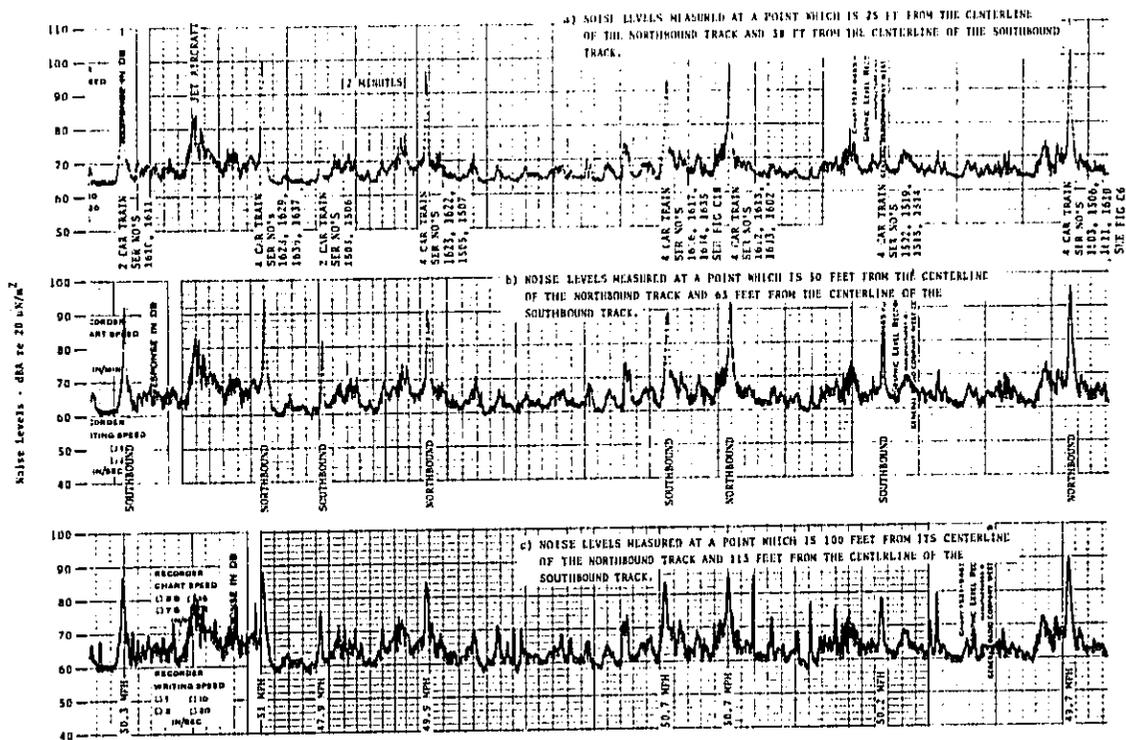
Figure C-1. Coincident Time Histories - Wayside Noise Levels. MBTA Red Line (So. Shore Extension) April 27, 1972. Microphones placed 6.1 ft above level grade and 3 ft above rail tops. See C-1 for microphone locations.

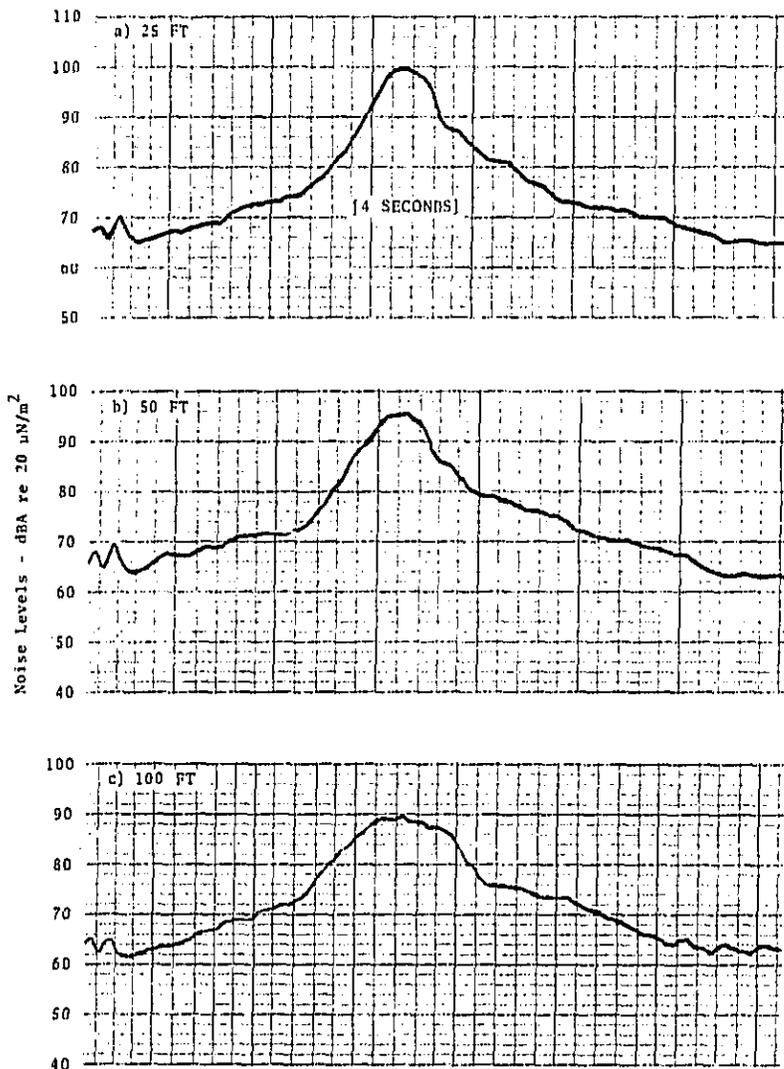
Figure C-2 Coincident Time Histories - Wayside Noise Levels at 25, 50 and 100 ft. from the centerline of the northbound track. MBTA Red Line (So. Shore Extension) April 27, 1972. 2-Car Train northbound Ser. No s 1611, 1610 at 50.6 mph.

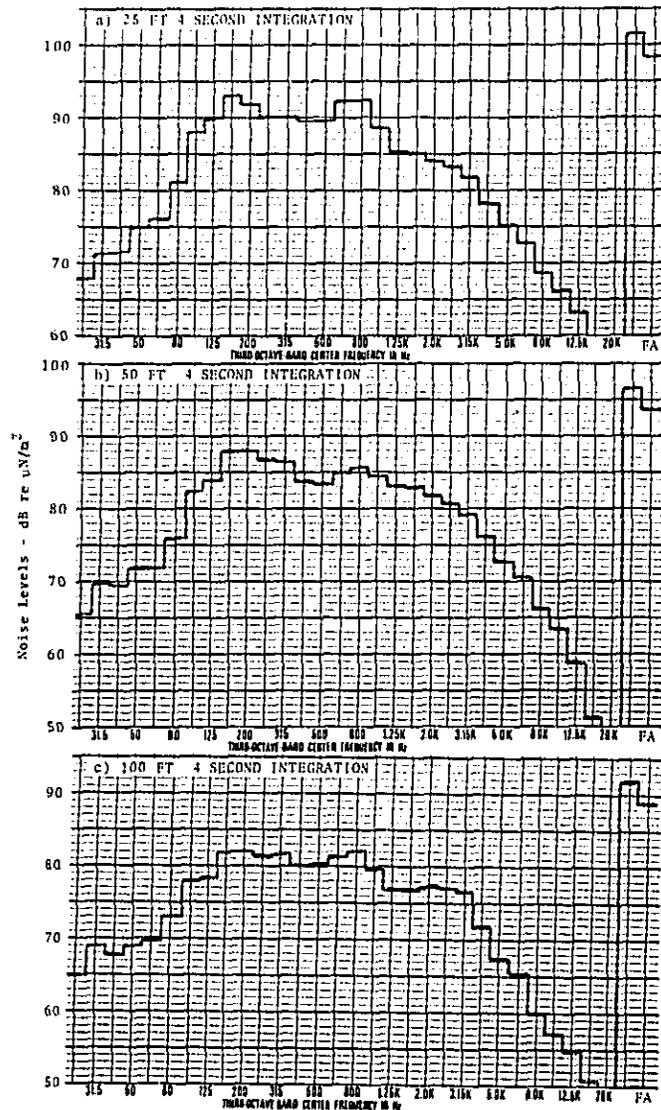
Figure C-3 Wayside Noise Spectra at 25, 50 and 100 ft. from the centerline of the northbound track. MBTA Red Line (So. Shore Extension) April 27, 1972. 2-Car Train northbound Ser. No s 1611, 1610 at 50.0 mph. See Figure G2.

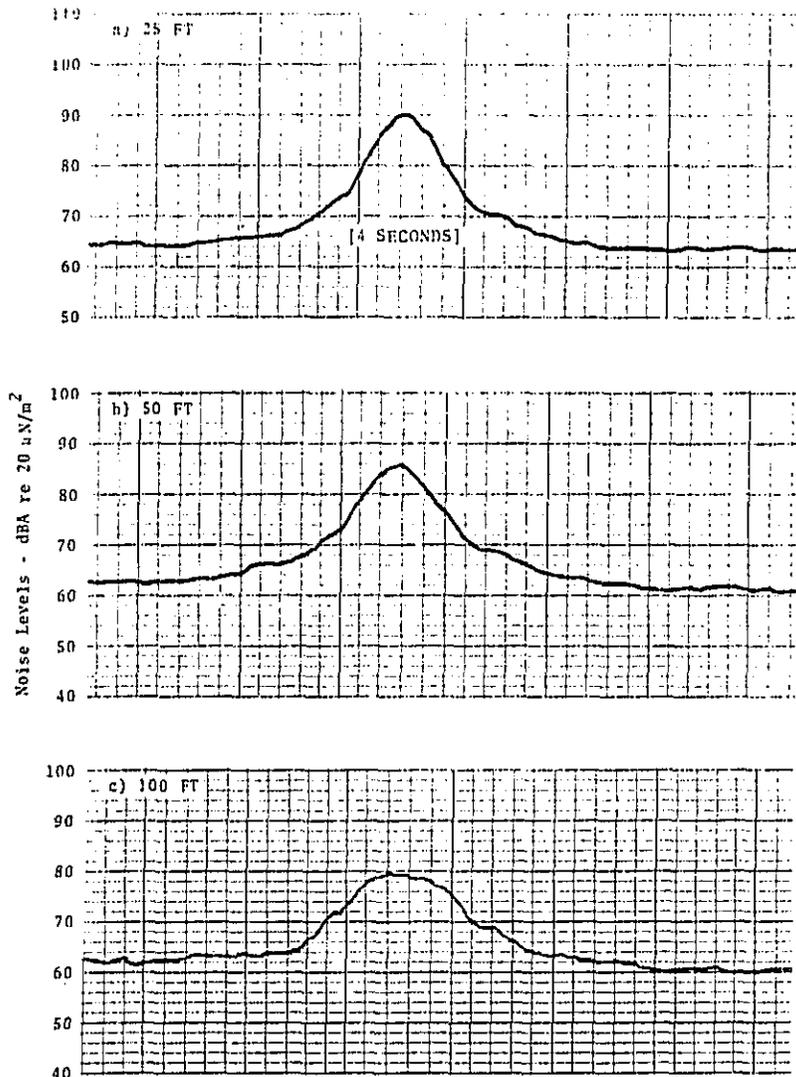
Figure C-4 Coincident Time Histories - Wayside Noise Levels at 25, 50 and 100 ft. from centerline of northbound track. MBTA Red Line (So. Shore Extension) April 27, 1972. 2-Car Train northbound, Ser. Nos 1503, 1506, at 49.5 mph.

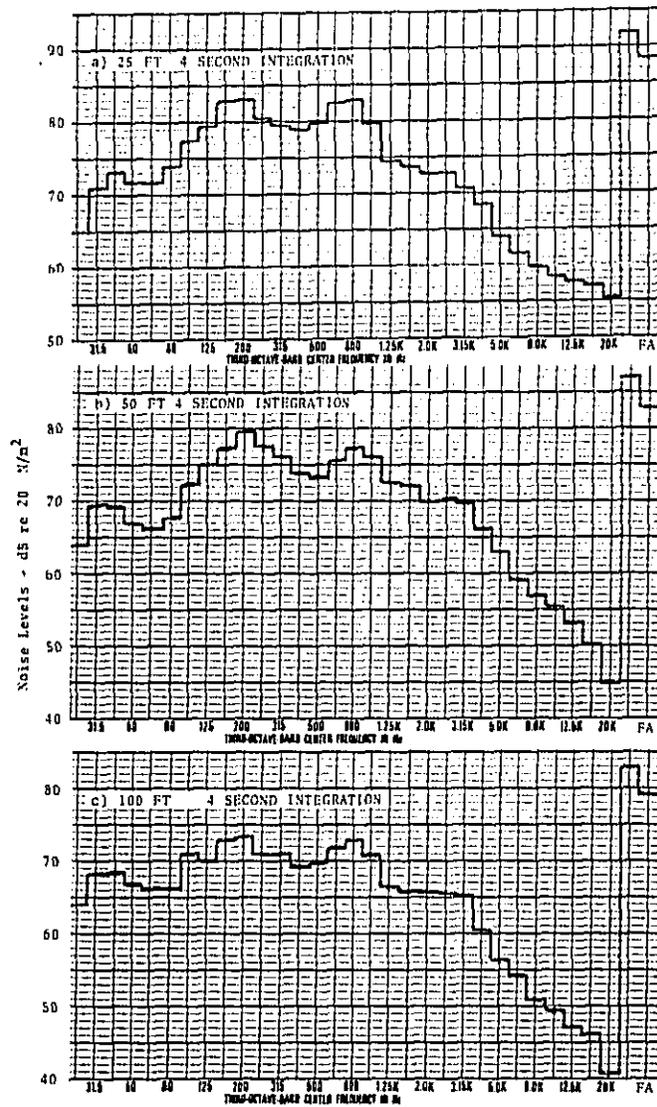
Figure C-5 Wayside Noise Spectra at 25, 50, and 100 ft. from centerline of northbound track. MBTA Red Line (So. Shore Extension) April 27, 1972. 2-Car Train northbound, Ser. Nos 1503, 1506 at 49.5 mph. See Figure G4.

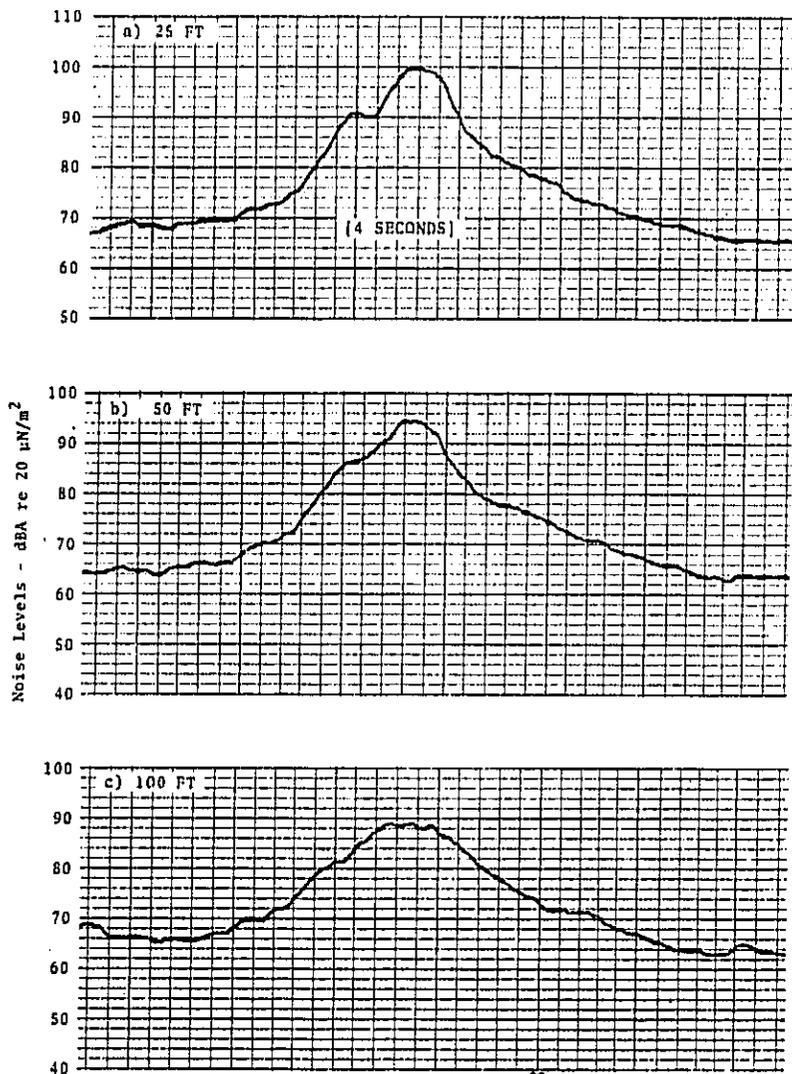
Figure C-6 Coincident Time Histories - Wayside Noise Levels at 25, 50 and 100 ft. from centerline of northbound track. MBTA Red Line (So. Shore Extension). April 27, 1972. 4-Car Train northbound - Ser. Nos 1503, 1506, 1611, 1610 at 49.7 mph. See Figure G1.

at the 25-ft. microphone location exemplified this since the double peak in the noise-level history figure C-6a is caused by the passing of 2-car trains (Serial Nos 1503 and 1506 followed by the noisy pair Serial Nos 1611 and 1610. This is less obvious at the other two microphone locations but nevertheless also true.

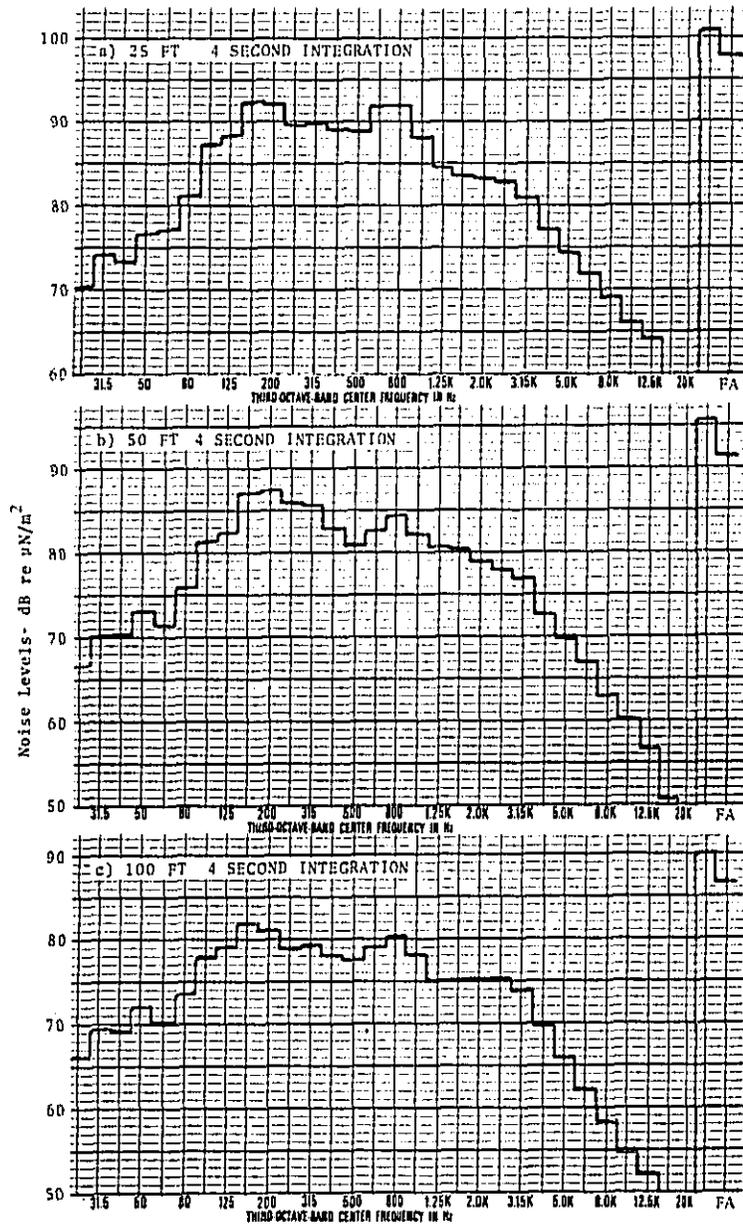
Figure C-7 Wayside Noise Spectra at 25, 50, and 100 ft. from centerline of northbound track. MBTA Red Line (So. Shore Extension) April 27, 1972. 4-Car Train northbound - Ser. Nos 1503, 1506, 1611, 1610 at 49.7 mph. See Figure C6.

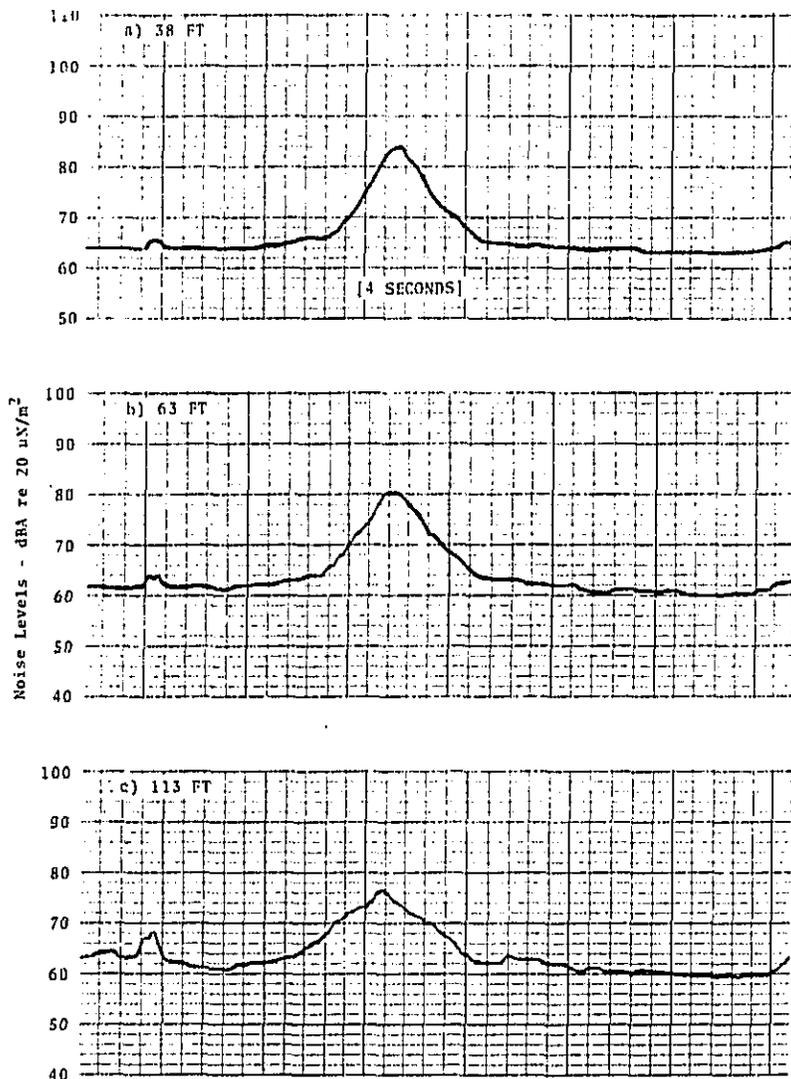
Figure C-8 Coincident Time Histories - Wayside Noise Levels at 38, 63, and 113 ft. from centerline of southbound track. MBTA Red Line (So. Shore Extension) April 27, 1972. 2-Car Train southbound - Ser. Nos 1618, 1619 at 49.9 mph.

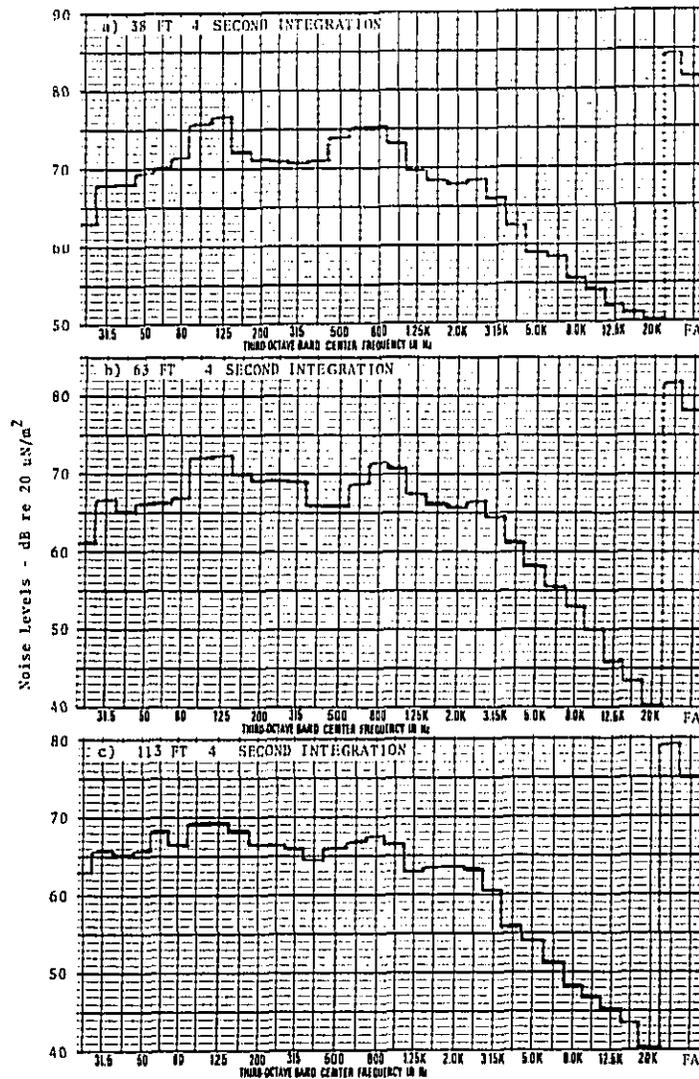
Figure C-9 Wayside Noise Spectra at 38, 63, and 113 ft. from centerline of southbound track. MBTA Red Line (So. Shore Extension) April 27, 1972. 2-Car Train southbound - Ser. Nos 1618, 1619 at 49.9 mph. See Figure G8.

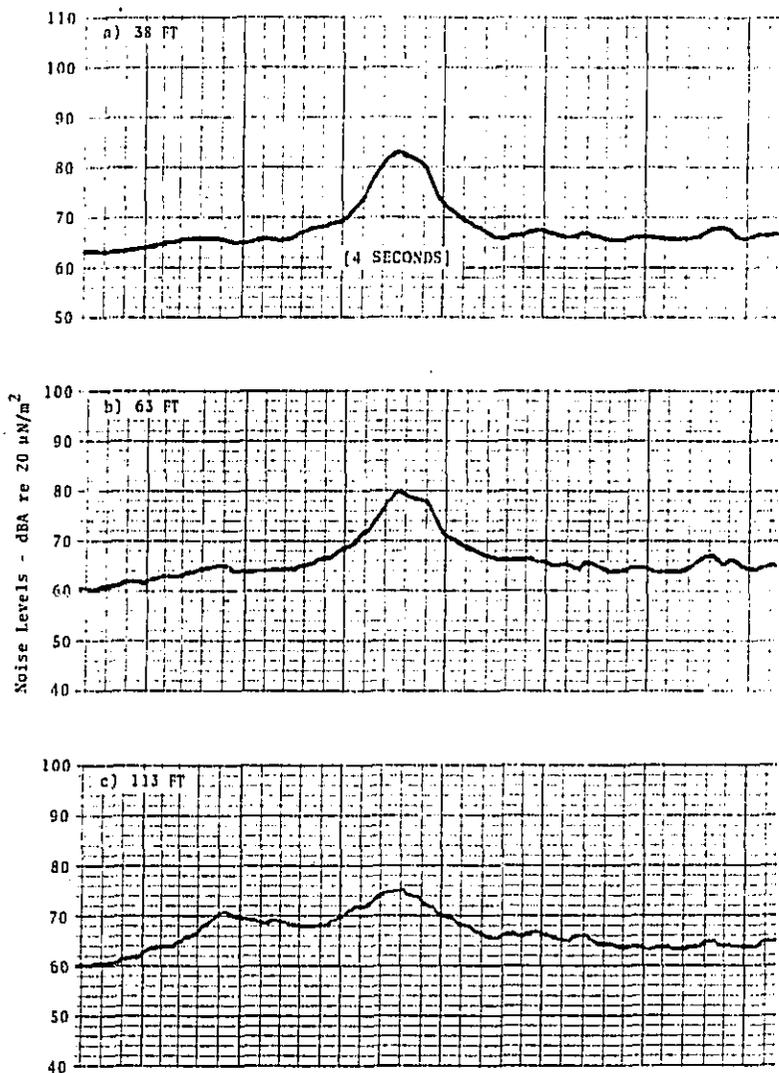
Figure C-10 Coincident Time Histories - Wayside Noise Levels at 38, 63 and 113 ft. from centerline of southbound track. MBTA Red Line (So. Shore Extension) April 27, 1972. 2-Car Train southbound - Ser. Nos 1604, 1605 at 50.4 mph.

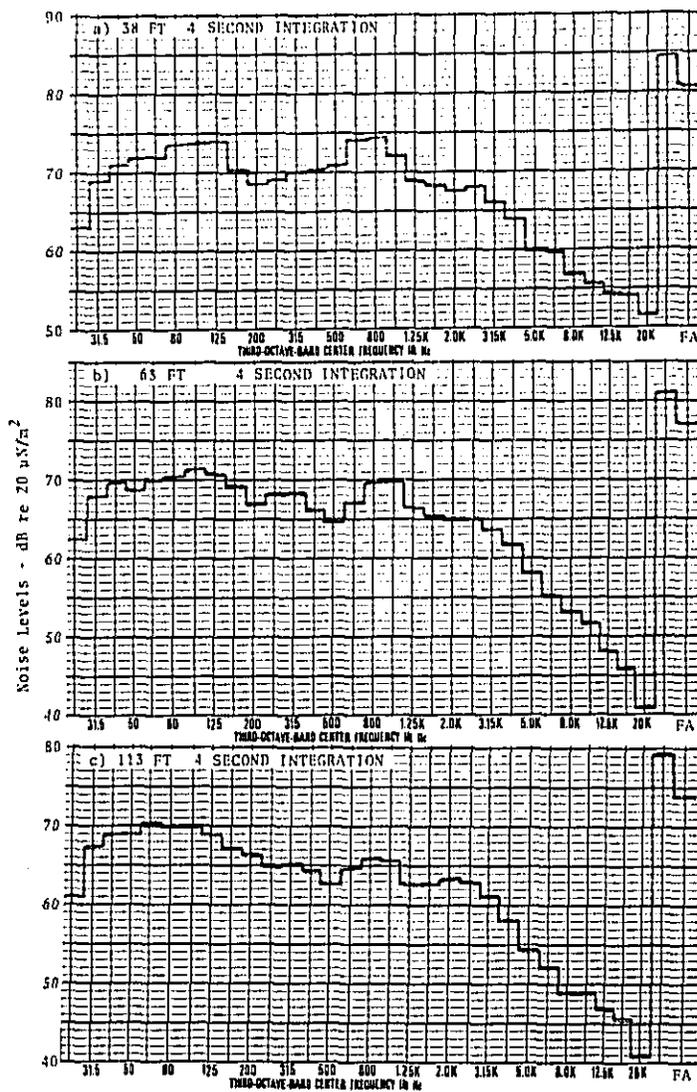
Figure C-11 Wayside Noise Spectra at 38,63 and 113 ft. from centerline of southbound track. MBTA Red Line (So. Shore Extension) April 27, 1972. 2-Car Train southbound - Ser. Nos 1604, 1605 at 50.4 mph See Figure G10.

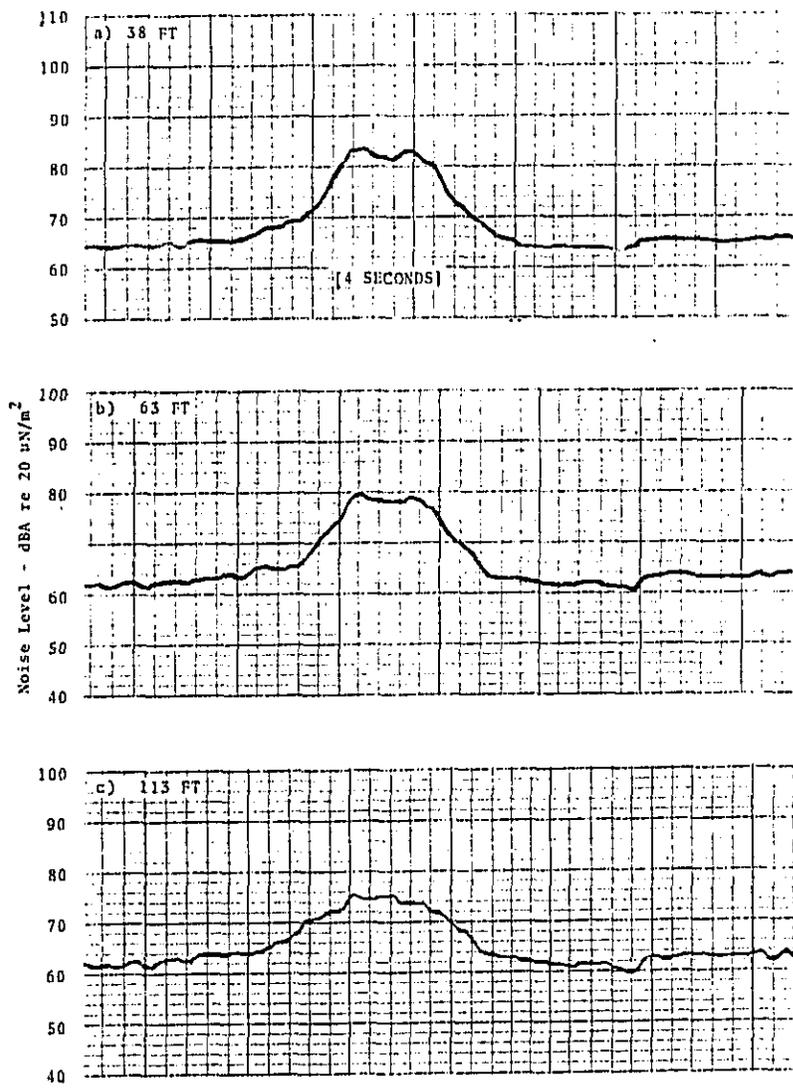
Figure C-12 Coincident Time Histories - Wayside Noise Levels at 38, 63, and 113 ft. from centerline of southbound track. MBTA Red Line (So. Shore Extension). April 27, 1972. 4-Car Train southbound - Ser. Nos 1604, 1605, 1618, 1619 at 48.9 mph.

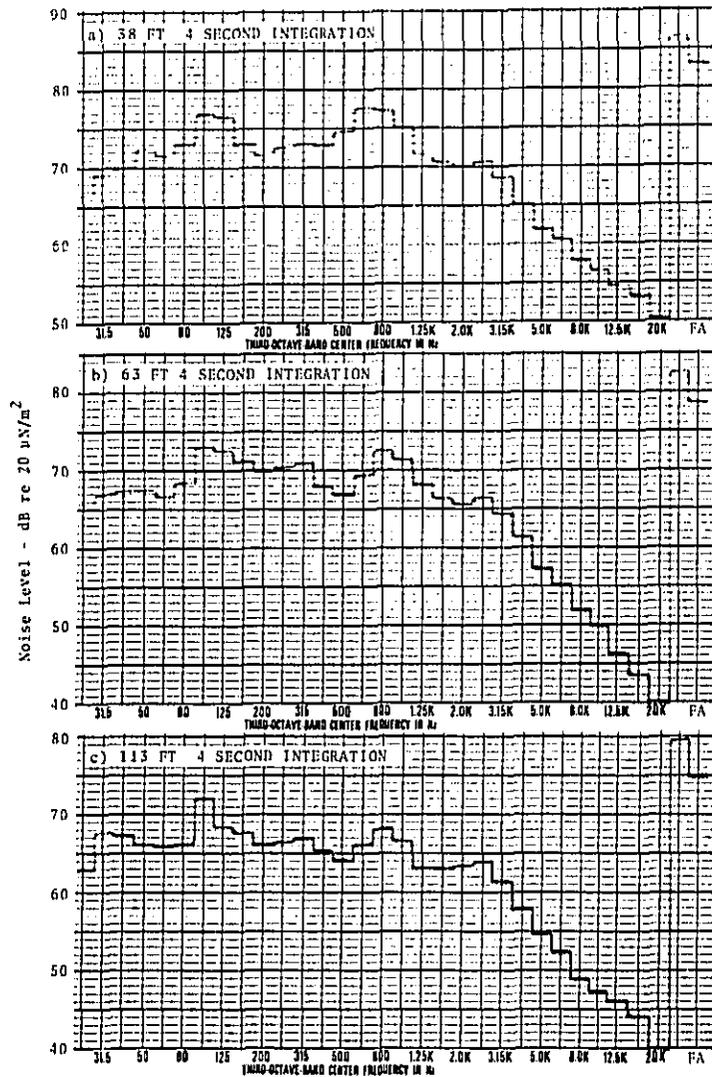
Figure C-13 Wayside Noise Spectra 38,63 and 113 ft. from centerline of southbound track. MBTA Red Line (So. Shore Extension) April 27, 1972. 4-Car Train southbound - Ser. Nos 1604, 1605, 1619, 1618 at 48.9 mph.

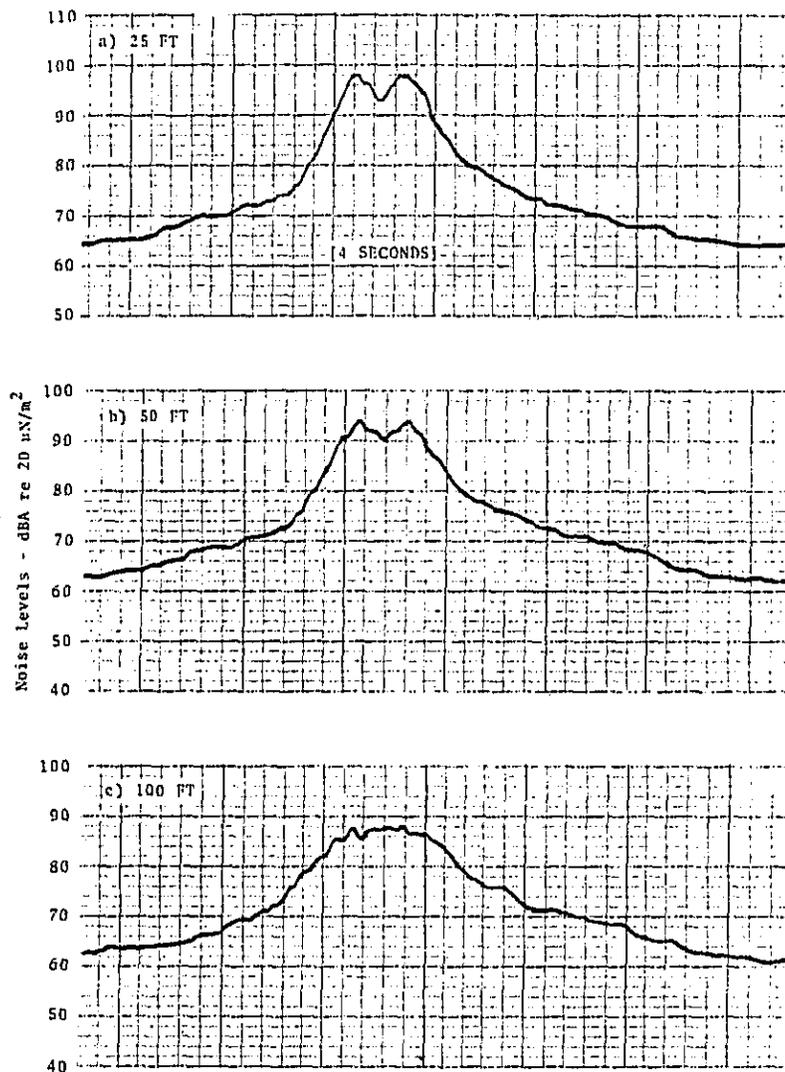
Figure C-14. Coincident Time Histories - Wayside Noise Levels at 25,50, and 100 ft. from center line of northbound track. MBTA Red Line (So. Shore Extension). April 27, 1972. 4-Car Train northbound - Ser. Nos 1604, 1605, 1619, 1618 at 49.9 mph

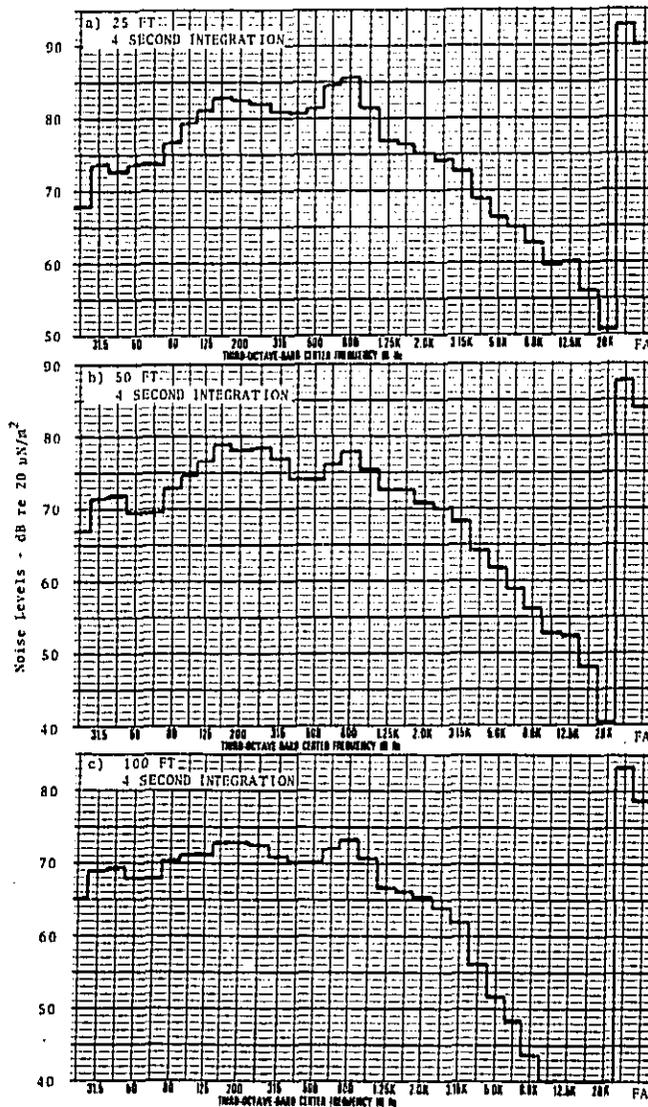
Figure C-15 Wayside Noise Spectra at 25, 50, and 100 ft. from centerline of northbound track. MBTA Red Line (So. Shore Extension) April 27, 1972. 4-Car Train northbound - Ser. Nos 1604, 1605, 1619, 1618 at 49.9 mph. See Figure G14.

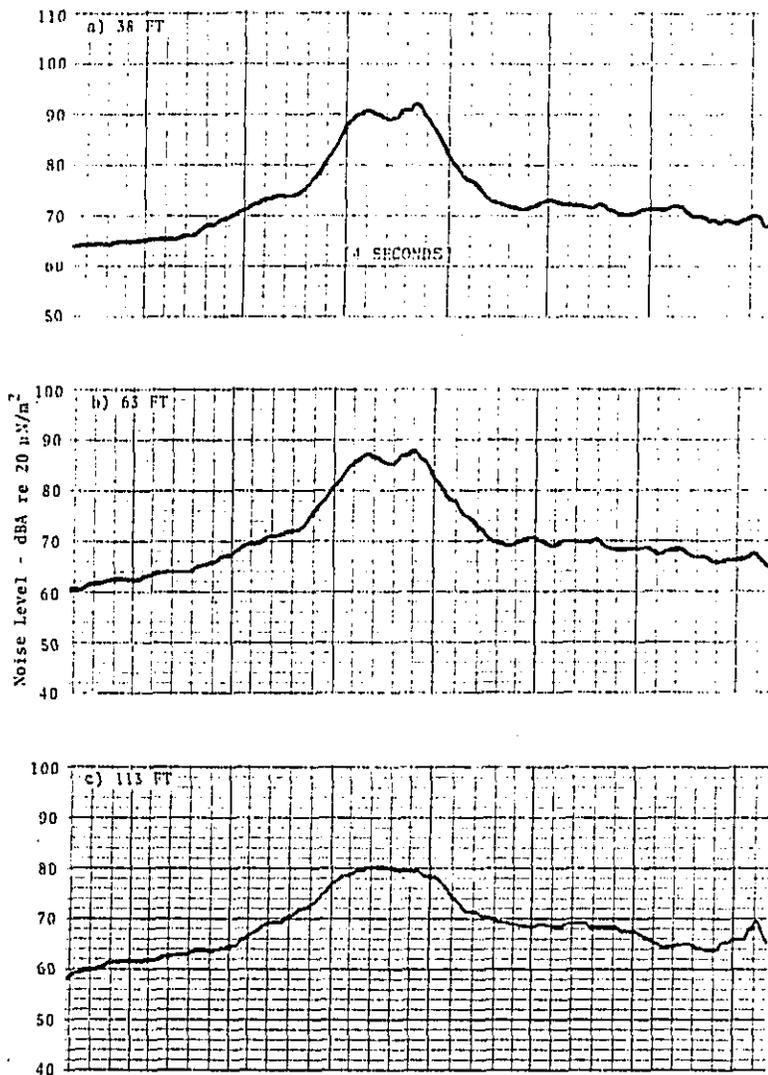
Figure C-16 Coincident Time Histories - Wayside Noise Levels at 38, 63, and 113 ft. from centerline of southbound track. MBTA Red Line (So. Shore Extension). April 27, 1972. 4-Car Train southbound - Ser. Nos 1616, 1617, 1634, 1635 at 50.7 mph. See Figure G1.

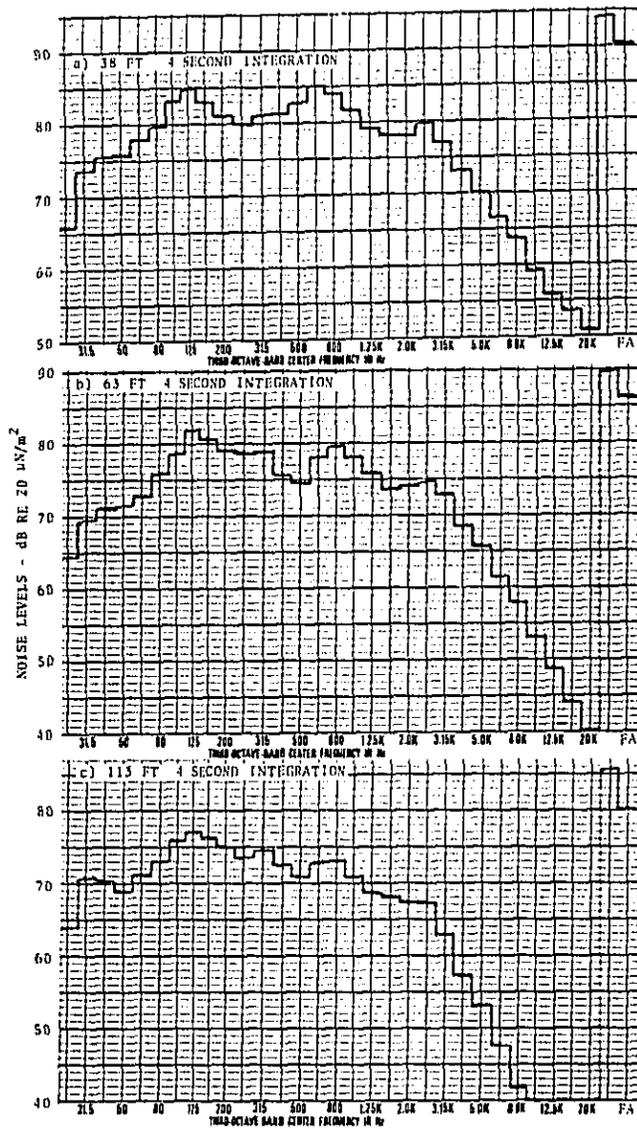
Figure C-17 Wayside Noise Spectra at 38, 63, and 113 ft. from centerline of southbound track. MBTA Red Line (So. Shore Extension) April 27, 1972. 4-Car Train southbound - Ser. Nos 1616, 1617, 1634, 1635 at 50.7 mph. See Figure G16.

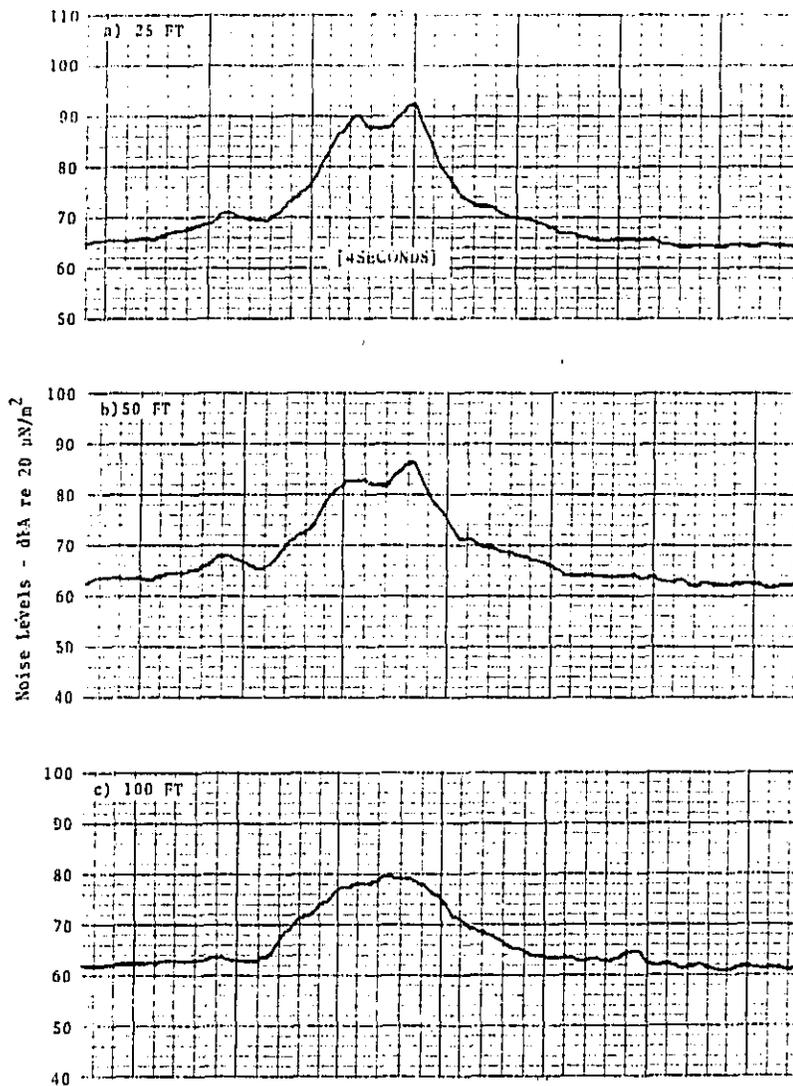
Figure C-18 Coincident Time Histories - Wayside Noise Levels at 25, 50 and 100 ft. from centerline of northbound track. MBTA Red Line (So. Shore Extension). April 27, 1972. 4-Car Train northbound - Ser. Nos 1616, 1617, 1634, 1635 at 49.3 mph.
