Report No. DOT-TSC-OST-72-31

MBTA RAPID TRANSIT SYSTEM (RED LINE)  
WAYSIDE AND IN-CAR  
NOISE AND VIBRATION LEVEL MEASUREMENTS

Edward J. Rickley  
Robert W. Quinn

AUGUST 1972  
FINAL REPORT

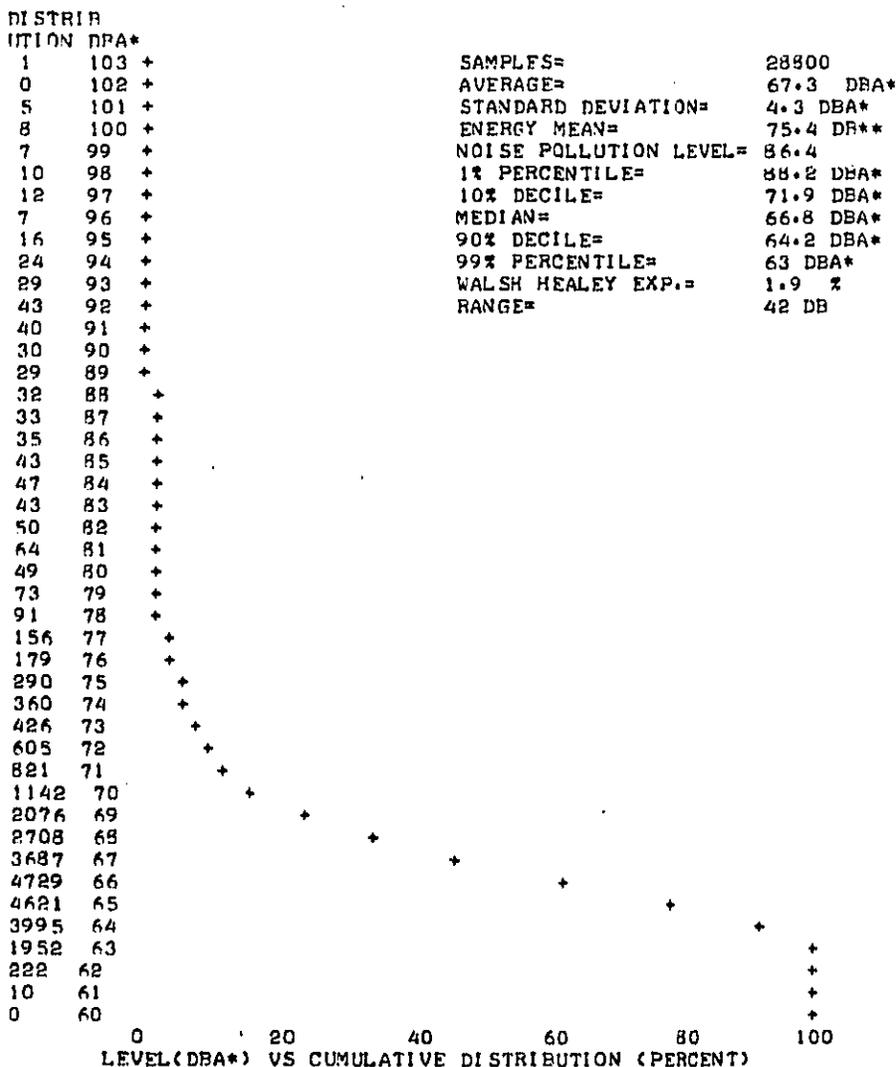
Figure C-20. Statistical Analysis - Wayside Noise Data - MBTA Red Line-25 ft  
 (So. Shore Extension), April 27, 1972

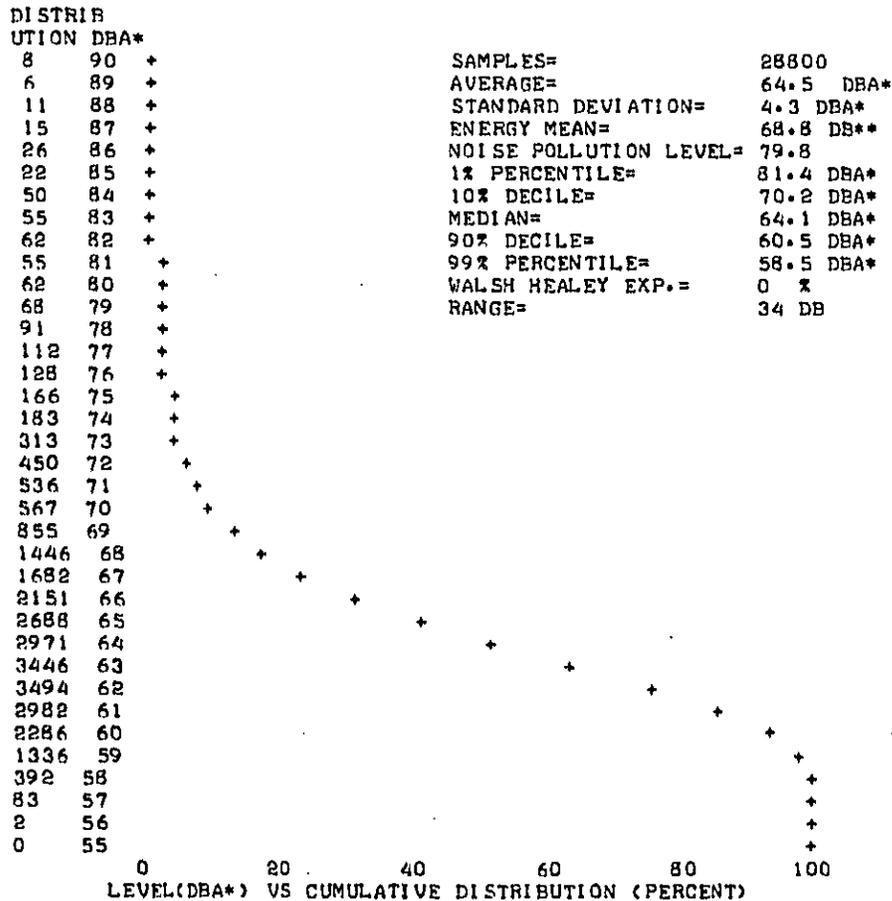
Figure C-22. Statistical Analysis - Wayside Noise Data - MBTA Red Line-100 ft  
 (So, Shore Extension) April 27, 1972

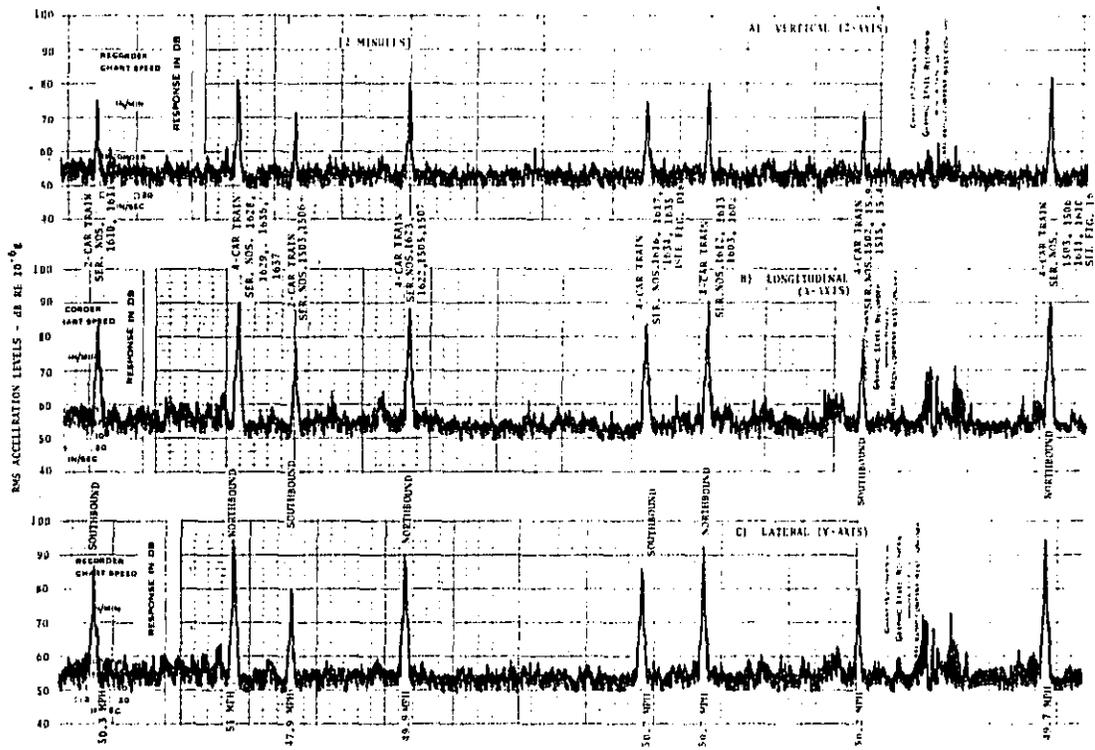
Figure D-1. Coincident Time Histories - Wayside Ground-Vibration Levels in 3 Axes at a point which is 25 ft from the centerline of the northbound track and 38 ft from the centerline of the southbound track. MBTA Red Line (So. Shore Extension) April 27, 1972. See Figure G-1 for accelerometer location and mounting.

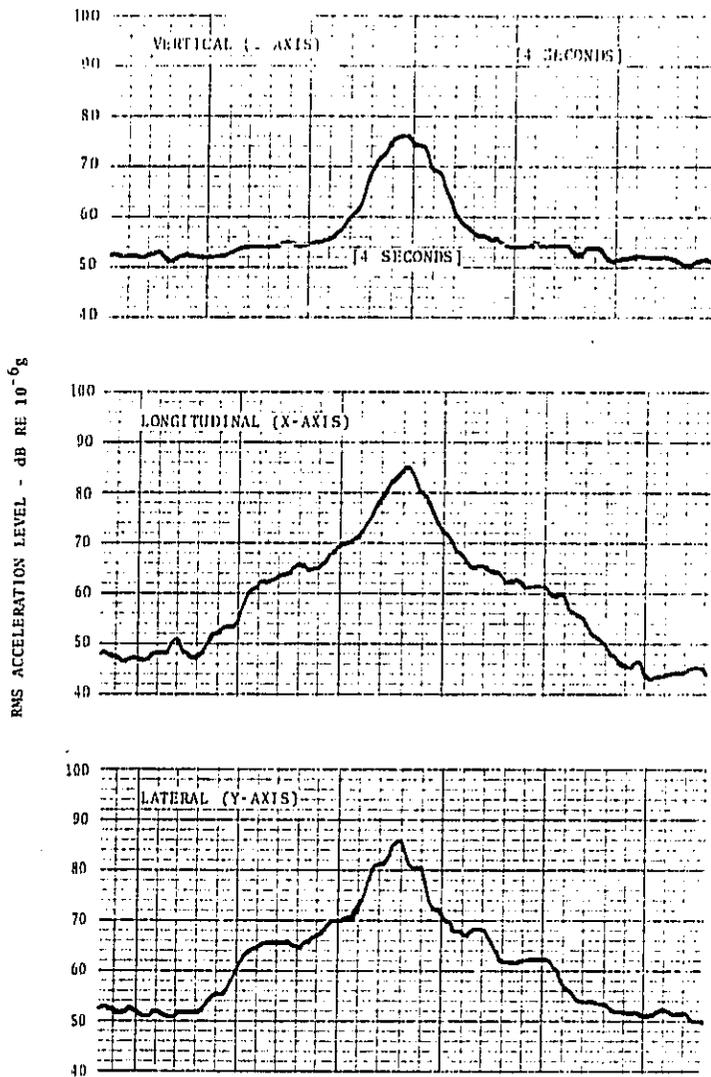
Figure D-4 Coincident Time Histories - Ground Vibration Levels in three axes 25 ft. from track centerline. MBTA Red Line (So. Shore Extension) April 27, 1972. 2-Car Train northbound Ser. Nos 1503, 1506 at 49.5 mph.

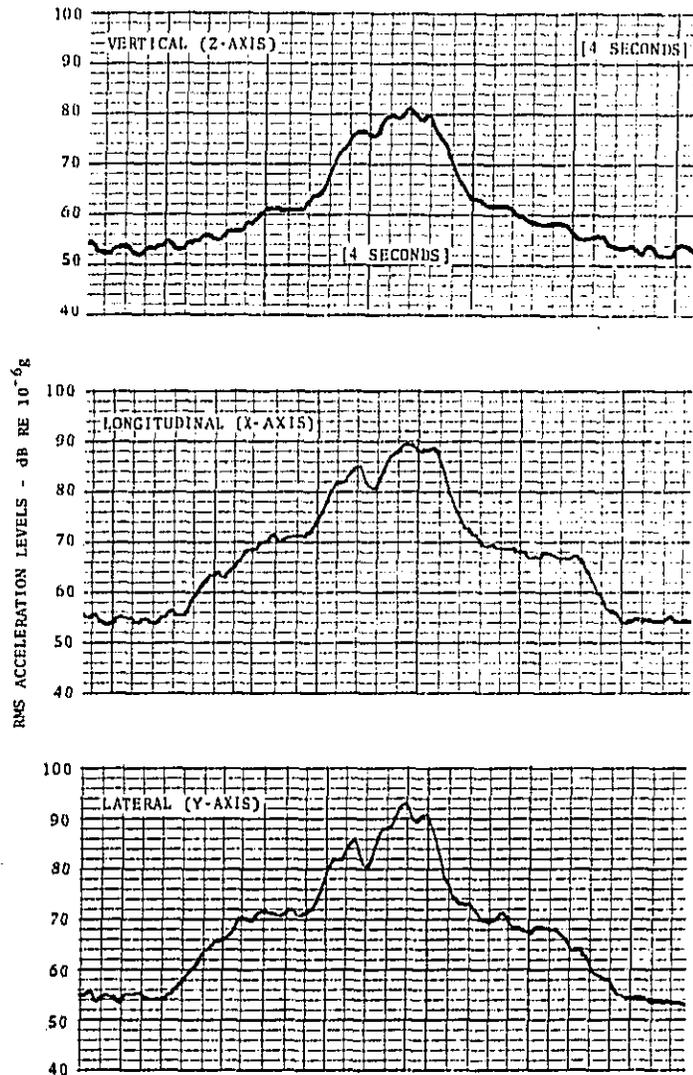
Figure D-6 Coincident Time Histories - Ground Vibration Levels in three axes 25 ft. from track centerline. MBTA Red Line (So. Shore Extension) April 27, 1972. 4-Car Train northbound, Ser. Nos 1503, 1506, 1611, 1610 at 49.7 mph. See Figure D1.

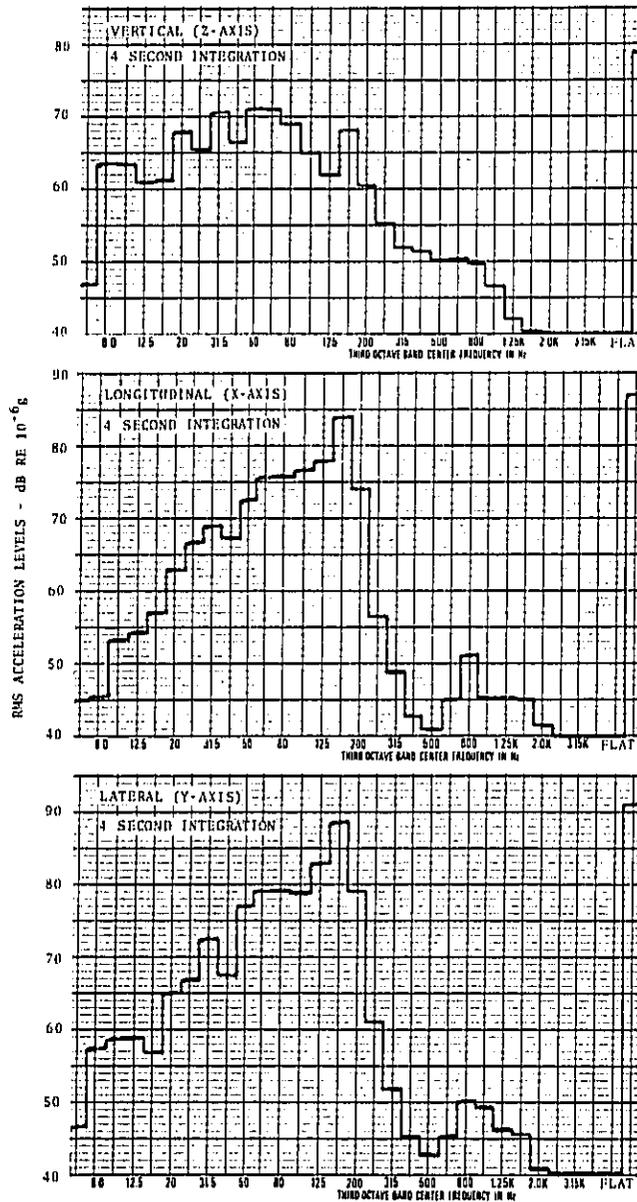
Figure D-7 Coincident Ground Vibration Spectra in three axes 25 ft. from track centerline. MBTA Red Line (So. Shore Extension) April 27, 1972. 4-Car Train northbound, Ser. Nos 1503, 1506, 1611, 1610 at 49.7 mph.

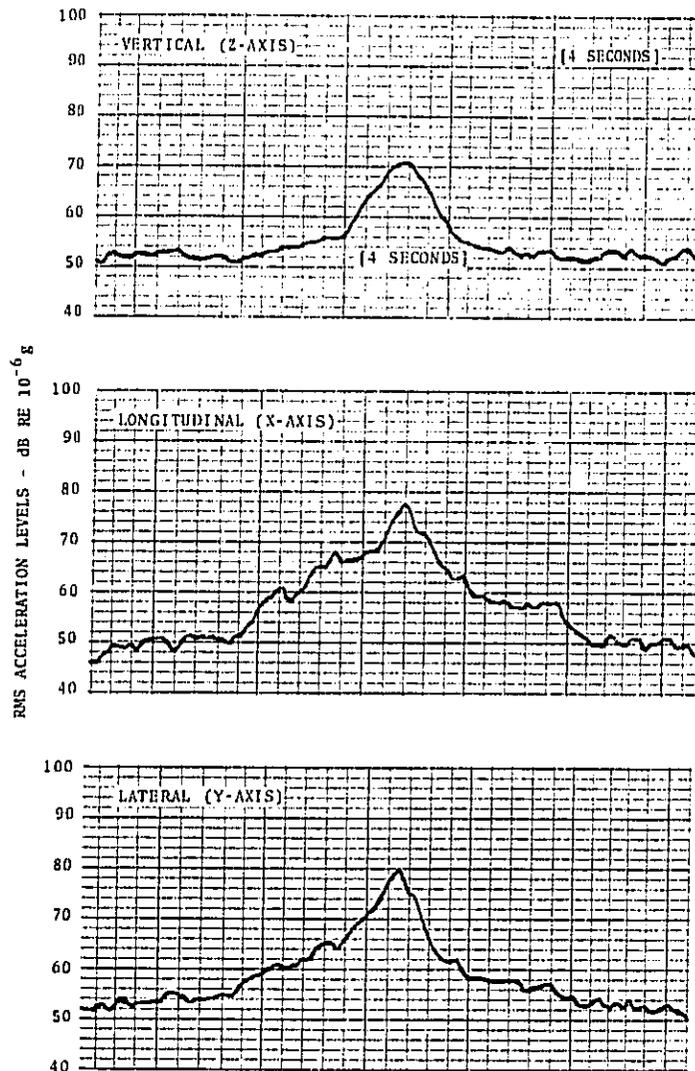
Figure D-8 Coincident Time Histories - Ground Vibration Levels in three axes 38 ft. from track centerline. MBTA Red Line (So. Shore Extension) April 27, 1972. 2-Car Train southbound Ser. Nos 1618, 1619, at 49.9 mph.

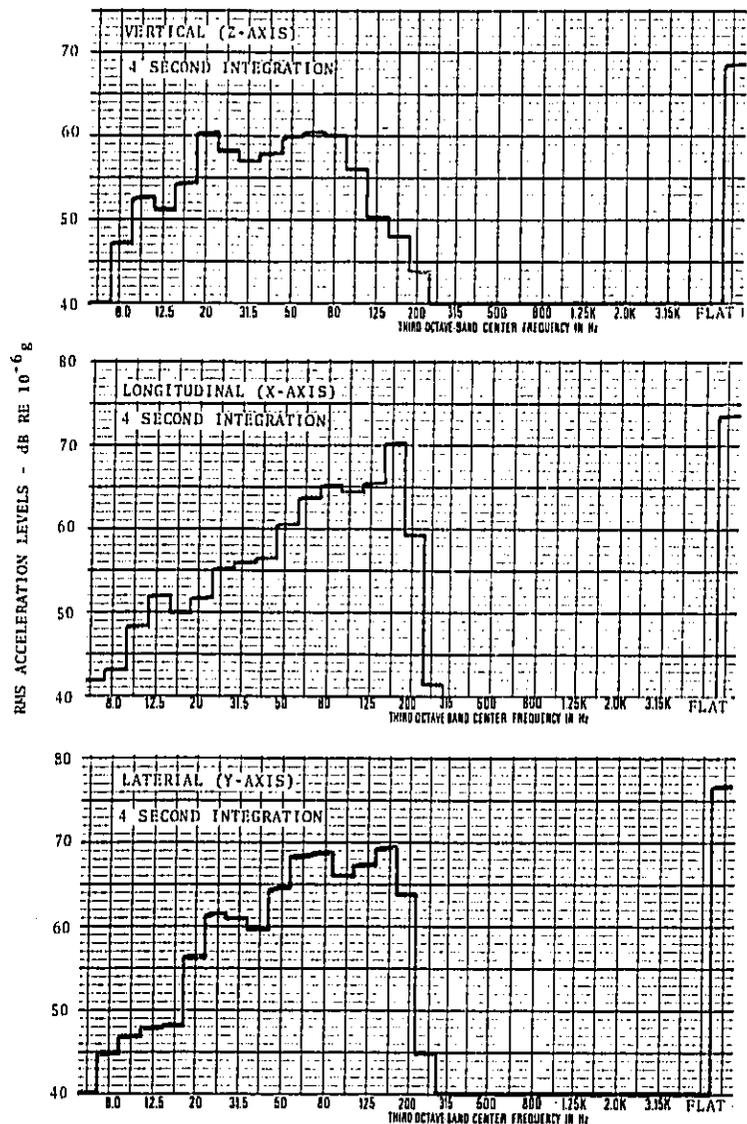
Figure D-9 Coincident Ground Vibration Spectra in three axes 38 feet from track centerline. MBTA Red Line (So. Shore Extension) April 27, 1972. 2-Car Train southbound, Ser. Nos 1618, 1619 at 49.9 mph. See Figure D-8.

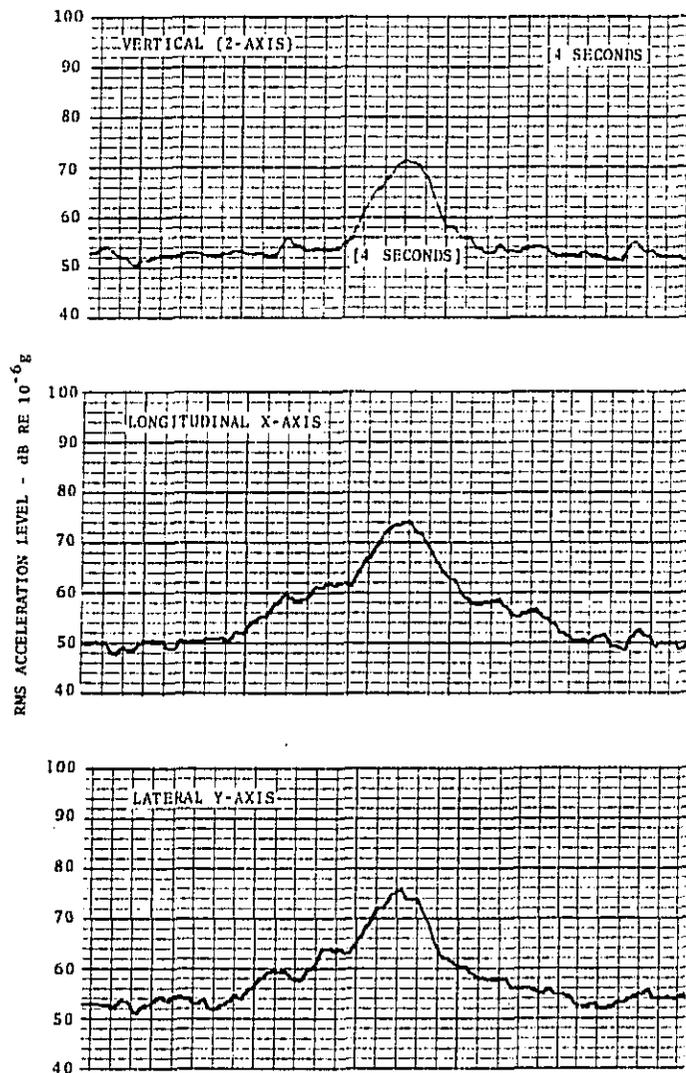
Figure D-10 Coincident Time Histories - Ground Vibration Levels in three axes 38 ft. from track centerline. MBTA Red Line (So. Shore Extension) April 27, 1972. 2-Car Train southbound Ser. Nos 1604, 1605 at 50.4 mph.

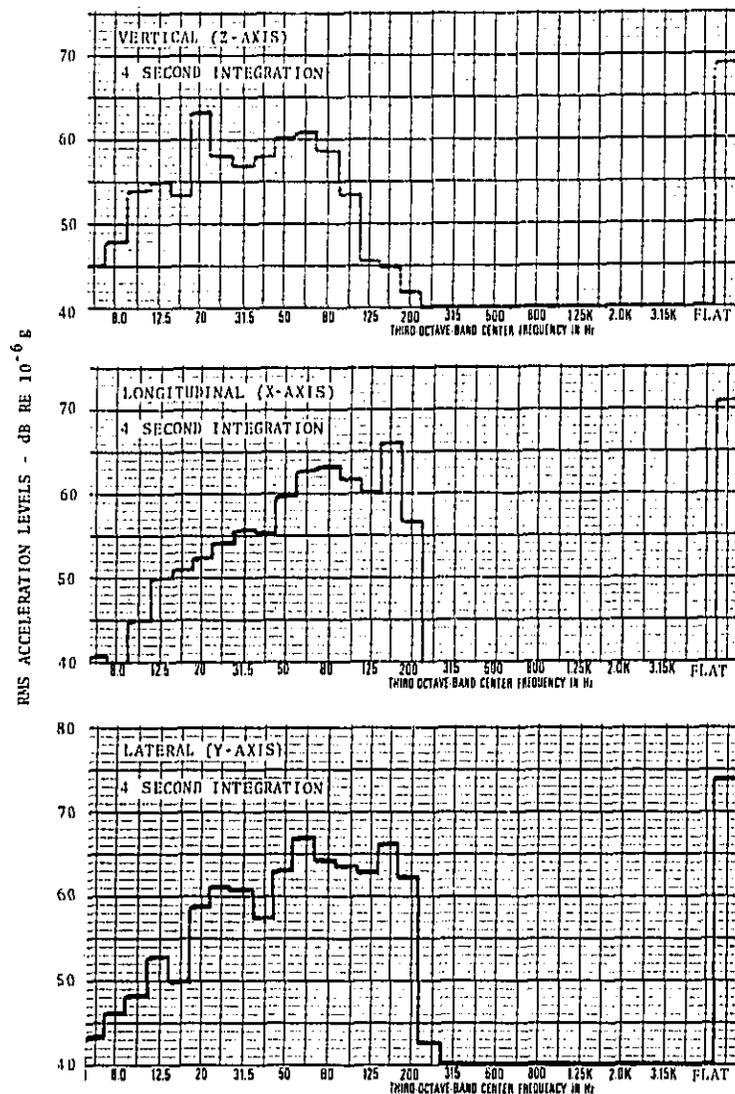
Figure D-11 Coincident Ground Vibration Spectra in three axes 38 ft. from track centerline. MBTA Red Line (So. Shore Extension) April 27, 1972. 2-Car Train south-bound Ser. Nos 1604, 1605, at 50.4 mph. See figure D10.

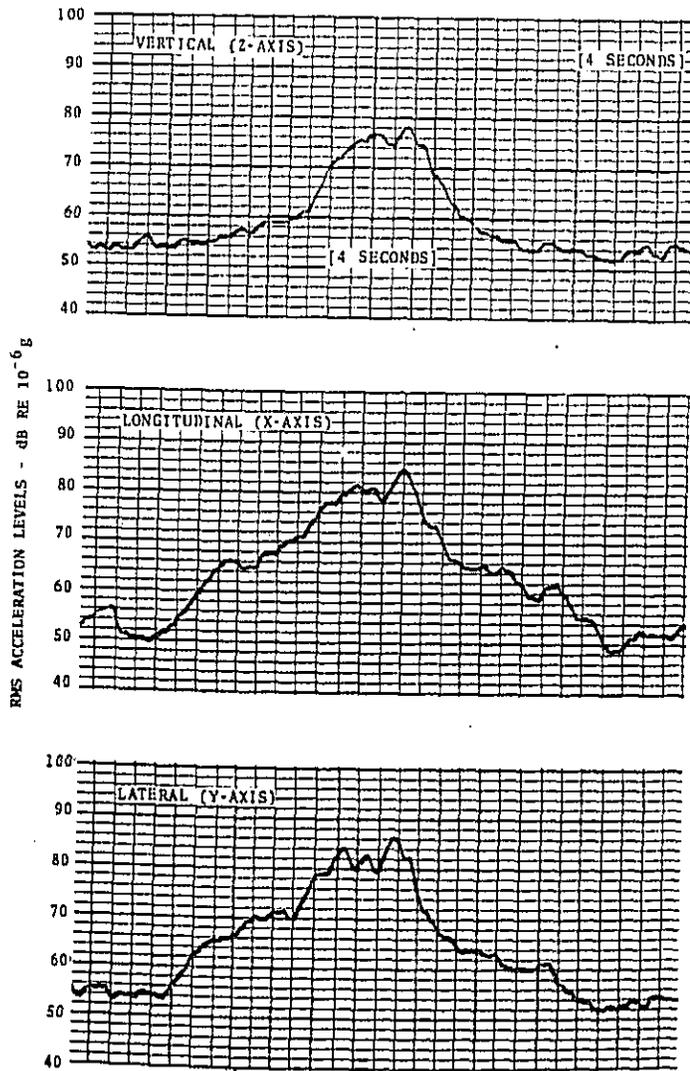
Figure D-14 Coincident Time Histories - Ground Vibration Levels in three axes 25 ft. from track centerline. MBTA Red Line (So. Shore Extension) April 27, 1972. 4-Car Train northbound, Ser. Nos 1604, 1605, 1619, 1618 at 49.9 mph.

However, when these trains are combined into a 4-car train traveling on the northbound track, the levels are higher and the peaks more distinguishable (figure D-14). It is obvious that the vibration level of the peaks are lower and more uniform in figure D-14 than those in figure D-6 suggesting all wheels on these 4-car trains were more uniform and in good condition. The noise level measured for these 2-car trains and their combination as a four-car train, (figures C-8, C-10, C-12 and C-14) confirms the uniformity between trains and the less-than-average noise generated.

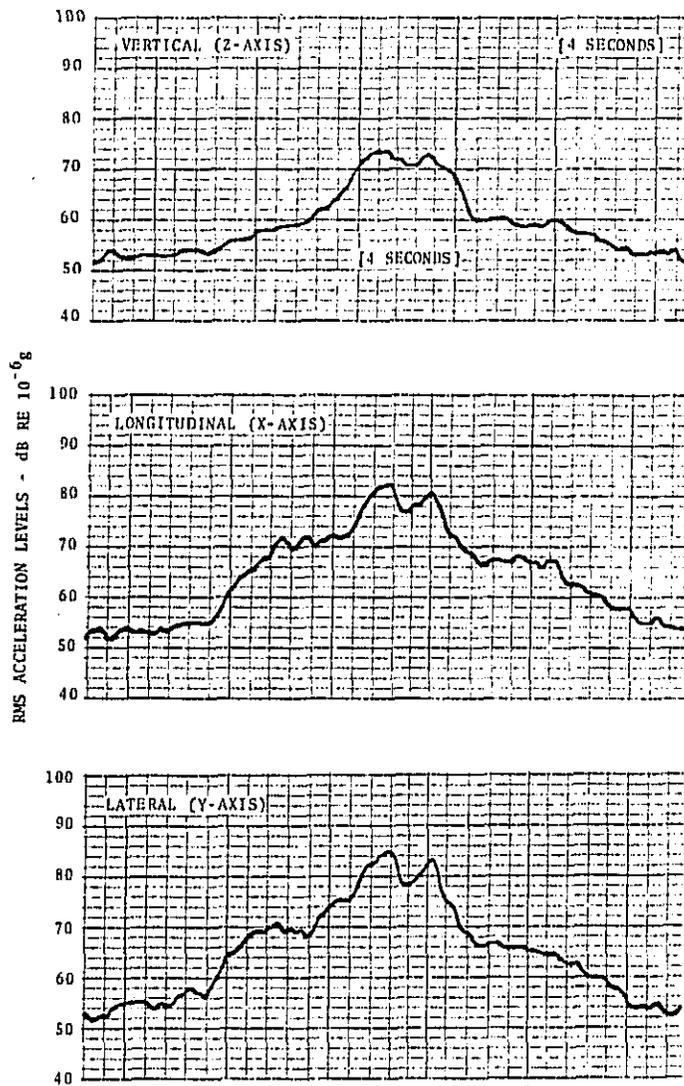
Figure D-16 Coincident Time Histories - Ground Vibration Levels in three axes 38 ft. from track centerline. MBTA Red Line (So. Shore Extension) April 27, 1972. 4-Car Train southbound Ser. Nos 1616, 1617, 1634, 1635 at 50.7 mph. See Figure D4.

Figures D-16 through D-19 contain data and analysis of a 4-car train with car Serial Nos 1616, 1617, 1634 and 1635 traveling north-and southbound. No measurements were made on these individual 2-car trains: however, the vibration-level peaks suggest a mix of wheels both in good and questionable condition. It appears that the front-wheel trucks on the lead car, and perhaps, the rear wheels on the third car were all in good condition with the remaining trucks containing wheels in questionable condition.

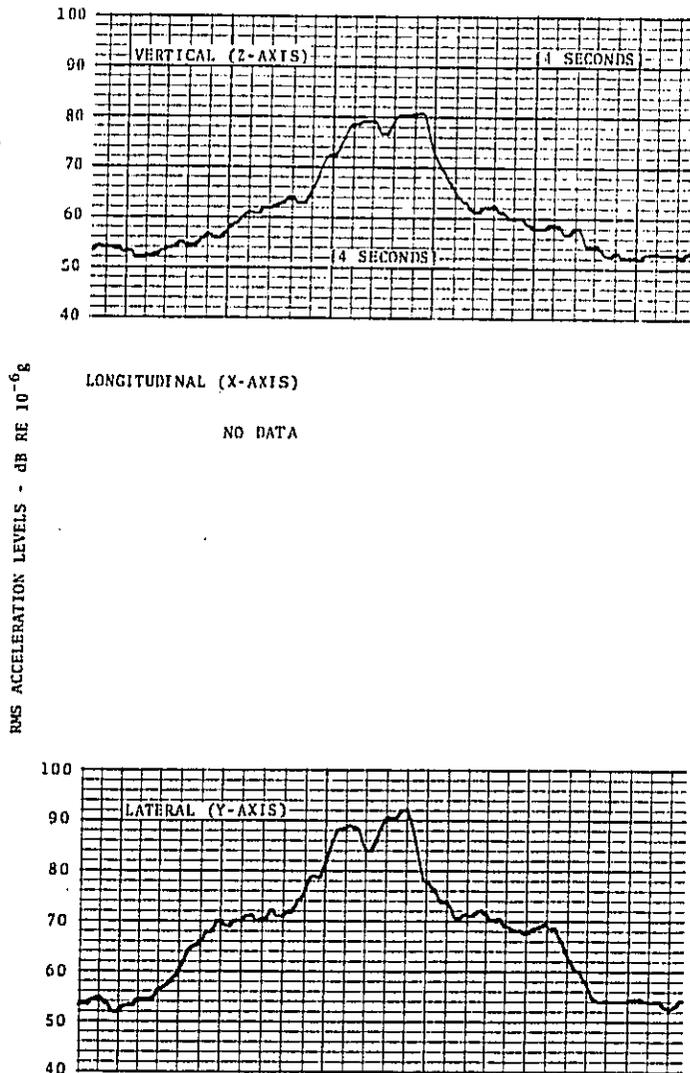
Figure D-18 Coincident Time Histories - Ground Vibration Levels in three axes 25 ft. from the track center line. MBTA Red Line (So. Shore Extension) April 27, 1972. 4-Car Train northbound Ser. Nos 1616, 1617, 1634, 1635 at 49.3 mph.

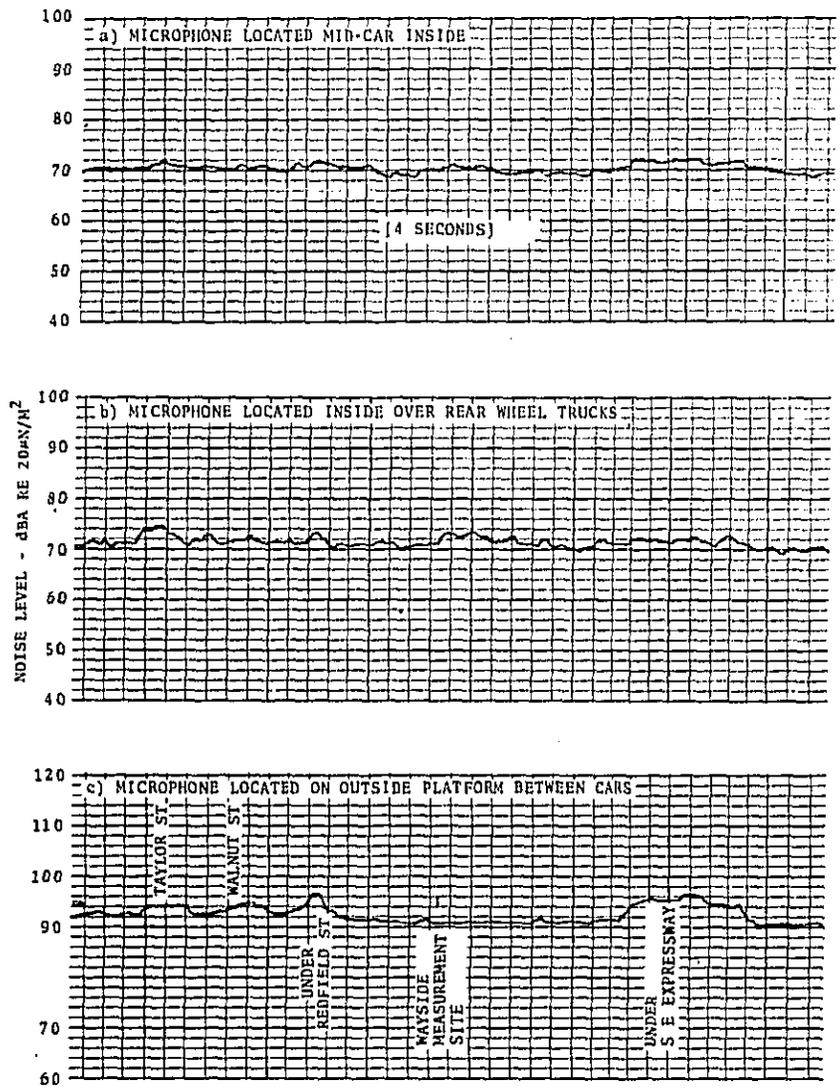
Figure E-2 Coincident Time Histories - Noise Levels at three locations. Tenean St. Wayside Measurements Site Area. MBTA Red Line (So. Shore Extension) April 29, 1972. (See Figure E1).

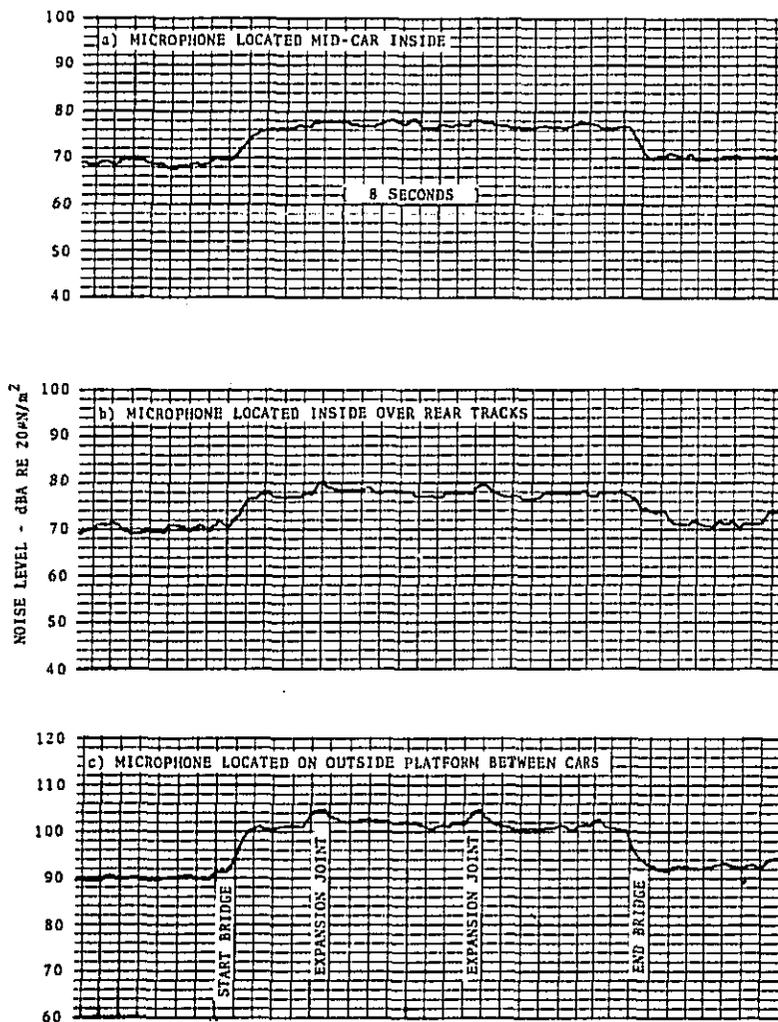
Figure E-4 Coincident Time Histories - Noise Levels at three locations. Neponset River Bridge, MBTA Red Line (So. Shore Extension). (See Figure E1.)

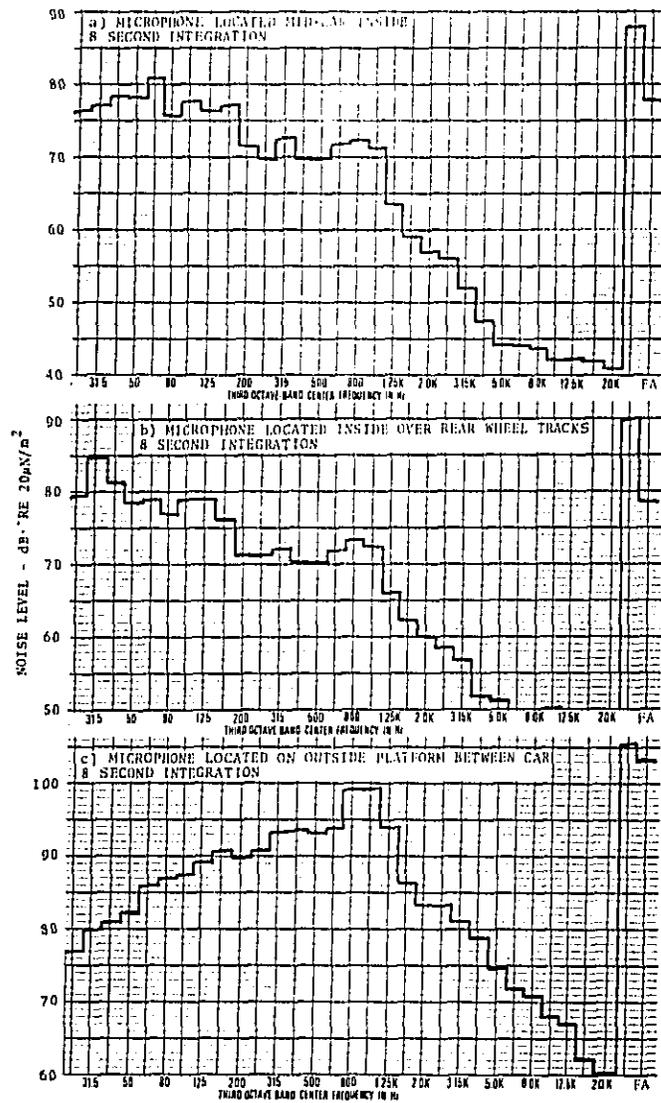
Figure E-5 Coincident Noise Spectra at three locations, Neponset River Bridge, MBTA Red Line (So. Shore Extension). April 29, 1972. (See Figure E4).

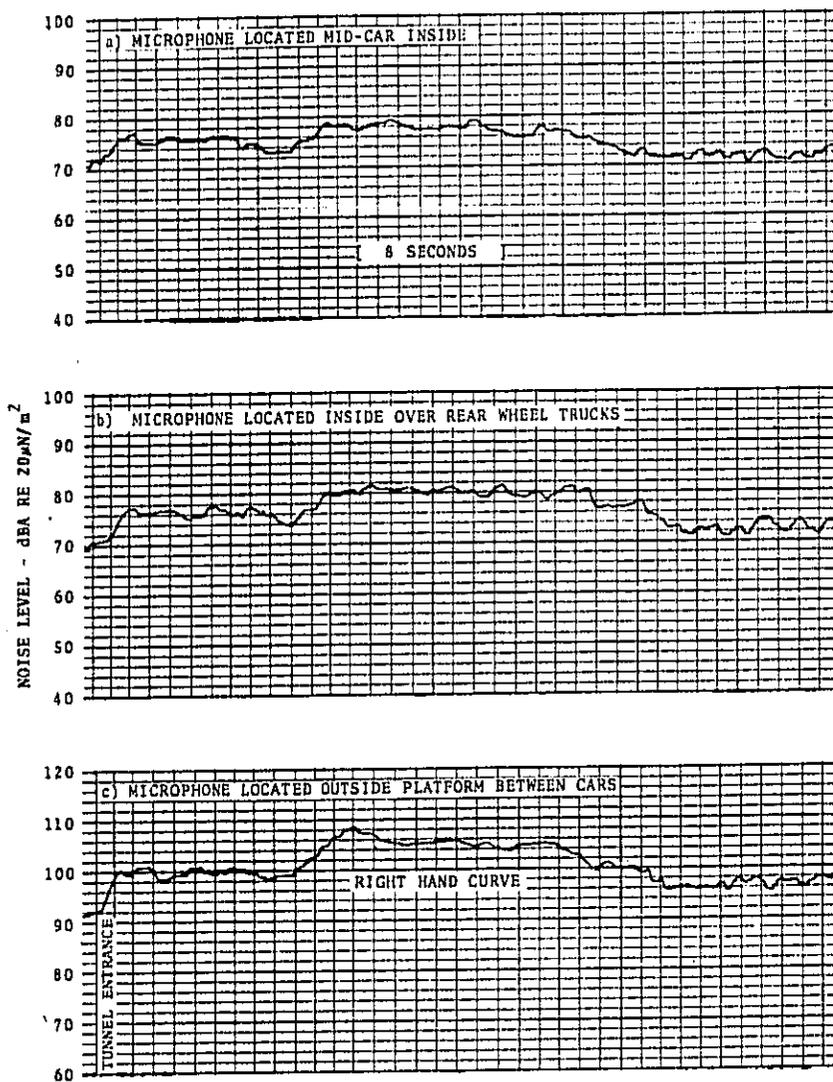
Figure E-6. Coincident Time Histories - Noise Levels at three locations. Sharp right-hand curve after entering tunnel before Andrew Station. MBTA Red Line April 29, 1972. See figure E-1.

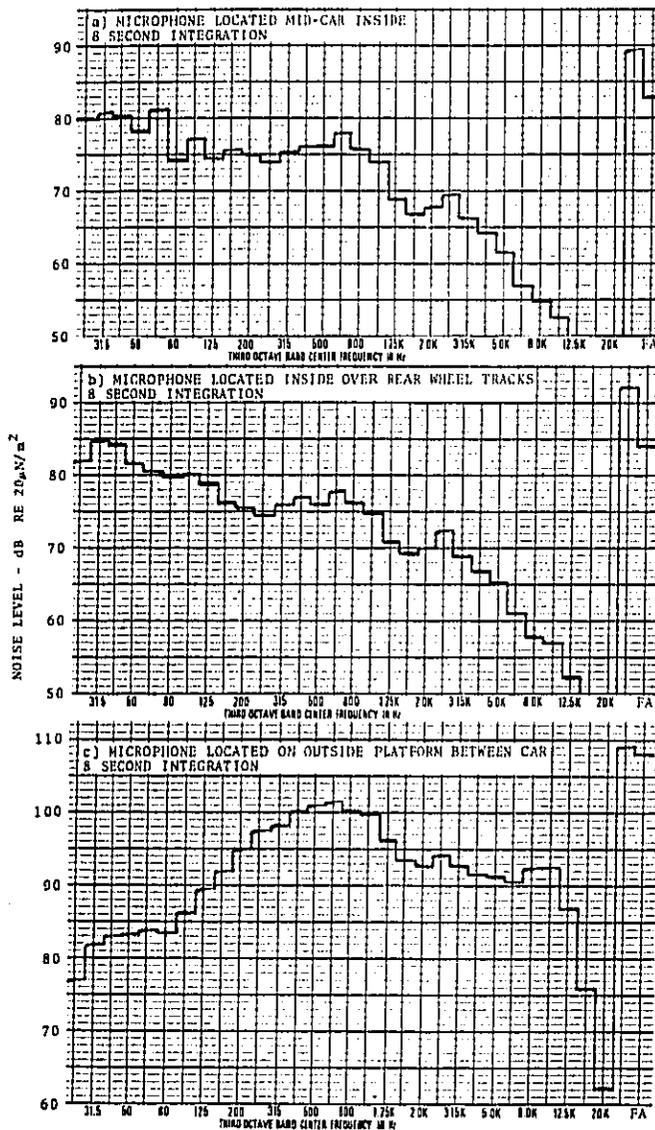
Figure E-12 Coincident Noise Spectra at three locations.  
 Circular Tunnel between Broadway and So. Station.  
 MBTA Red Line. April 29, 1972. See Figure E1.  
 See Figure J-4 for tunnel cross section.

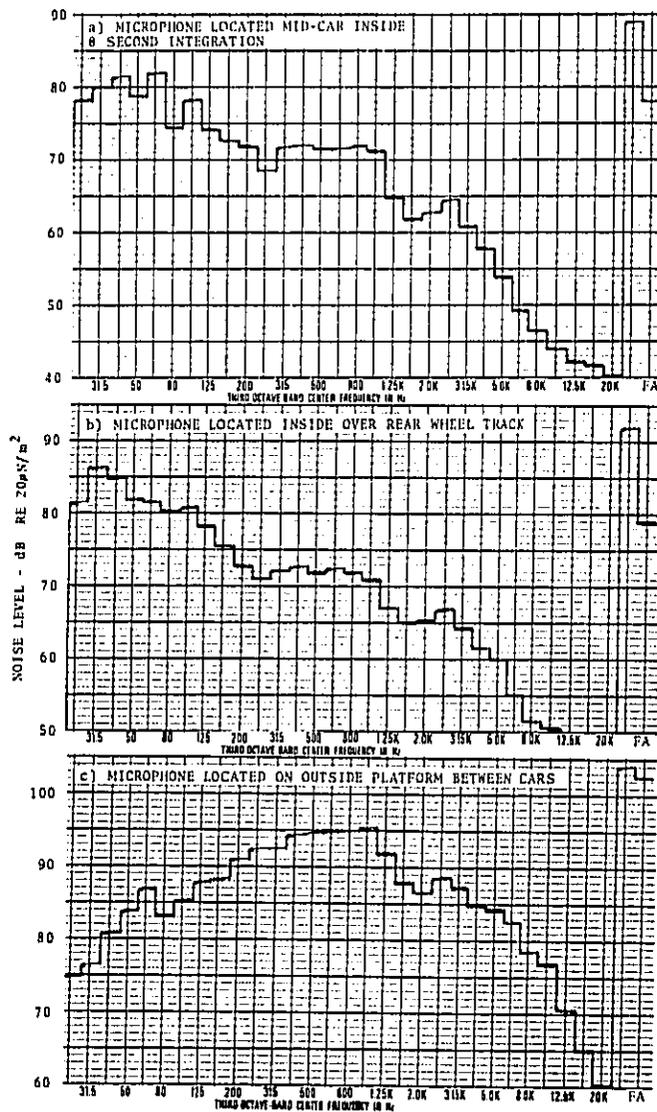
Figure E-13 Coincident Noise Spectra at three locations, Beacon Hill Tunnel between Park St and Charles St. Stations, MBTA Red Line, April 29, 1972. See Figure E-1. See Figure J-5 for tunnel cross section.

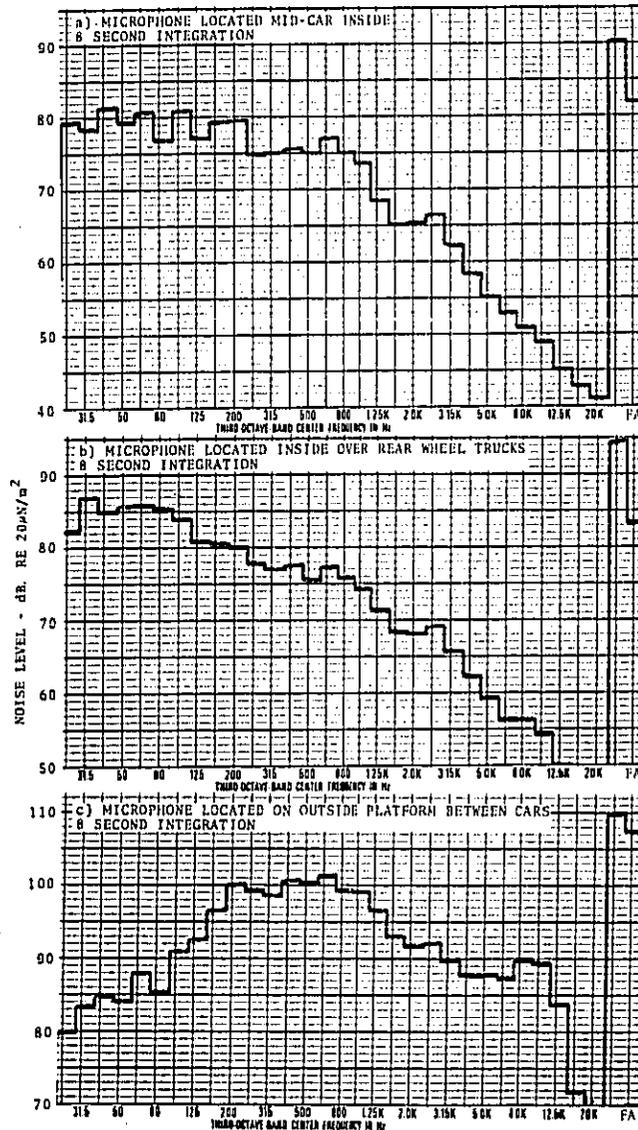
Figure E-16 Coincident Noise Spectra at three locations. Ashmont Tunnel between Ashmont and Shawmut Stations. MBTA Red Line (Ashmont Extension). April 29, 1972. See Figure E15. See Figure J7 for tunnel cross section.

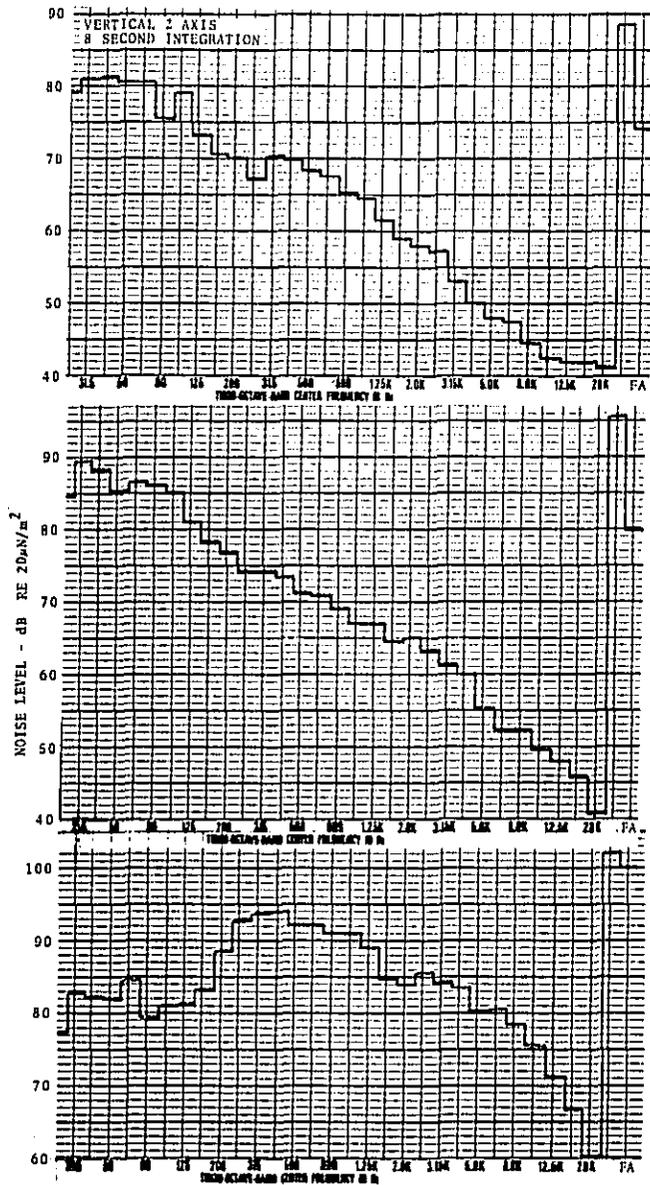
Figure E-17 Coincident Noise Spectra at three locations. Cruising on straight-run surfaceline between Fields Corner and Savin Hill Stations. MBTA Red Line (Ashmont Extension). April 29, 1972 See Figure E15.

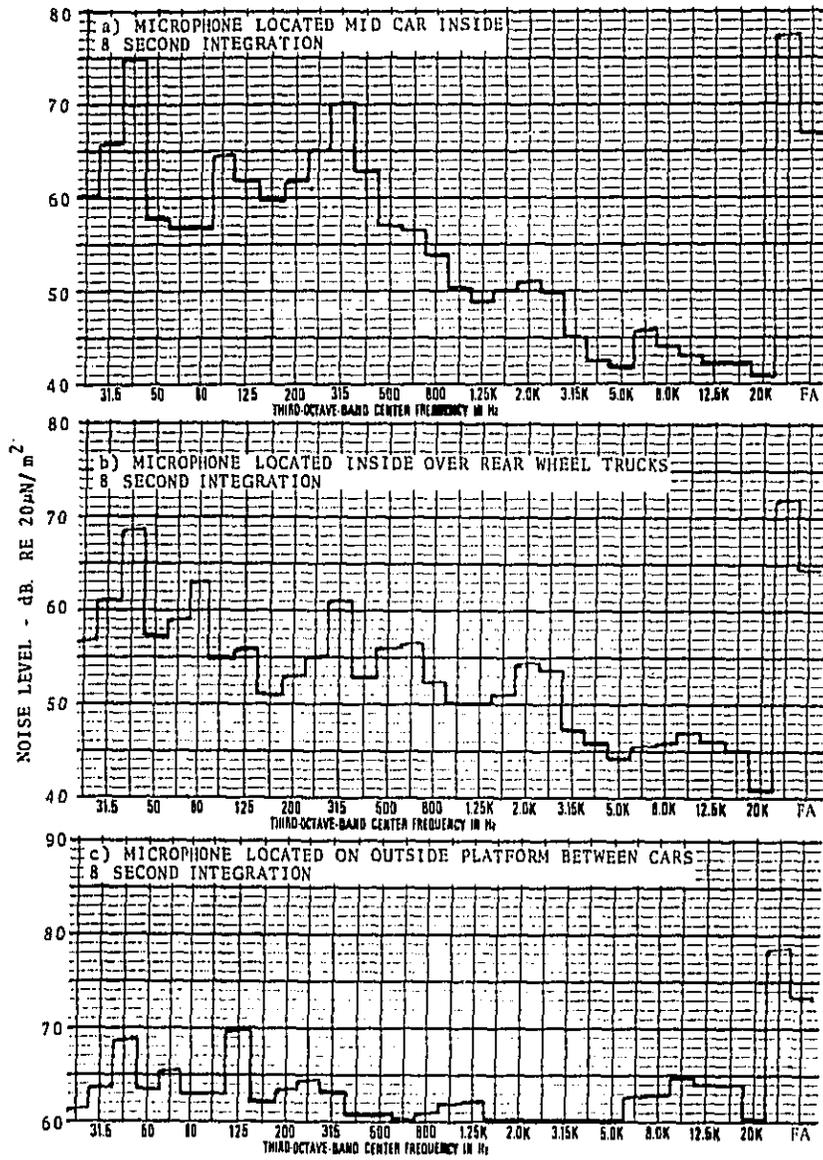
Figure E-18 Coincident Noise Spectra at three locations. Stopped with doors open at Savin Hill Station. MBTA Red Line (Ashmont Extension). April 29, 1972. See Figure E-15.

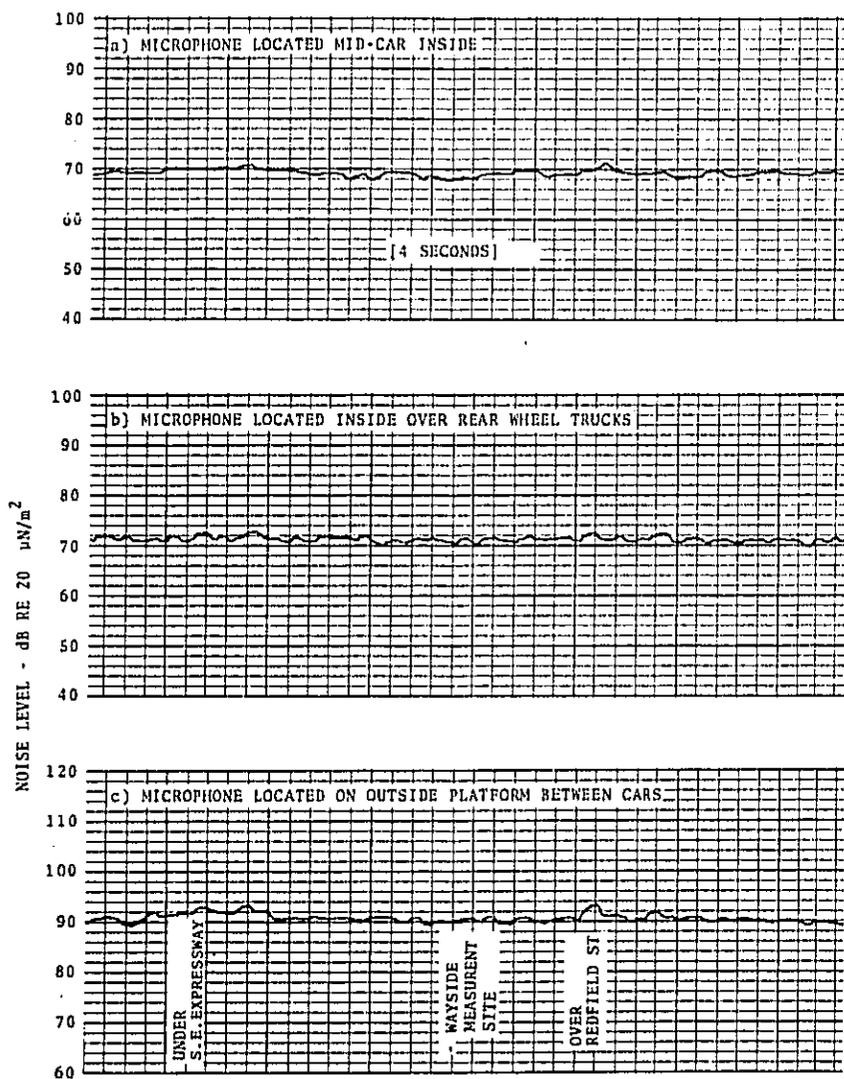
Figure E-20 Coincident Time Histories - Noise Level at three locations. Southbound Tenean St. Wayside Measurement Site, MBTA Red Line (So. Shore Extension) April 29, 1972. See Figure E-19.

Figures E-20 and E-21 contain expanded time histories and noise spectra at the three in-car microphone locations southbound on the straight section of surface track by the Tenean St. wayside measurement site area. A comparison of levels measured at a train speed of 50 mph, 69, 77 and 90 dBA on this track, with levels measured of 71-, 75-, and 92-dBA at 51 mph measured on the northbound track at Tenean St. measurement site (figure E-3) again confirms a configuration condition with the northbound track and/or rail bed. (See discussion in sections 3, 4, 5, and 6.) In addition, a comparison of the above data measured on welded track with the data measured on a non-welded section of track shows the marked effect that track condition has on the noise level generated.

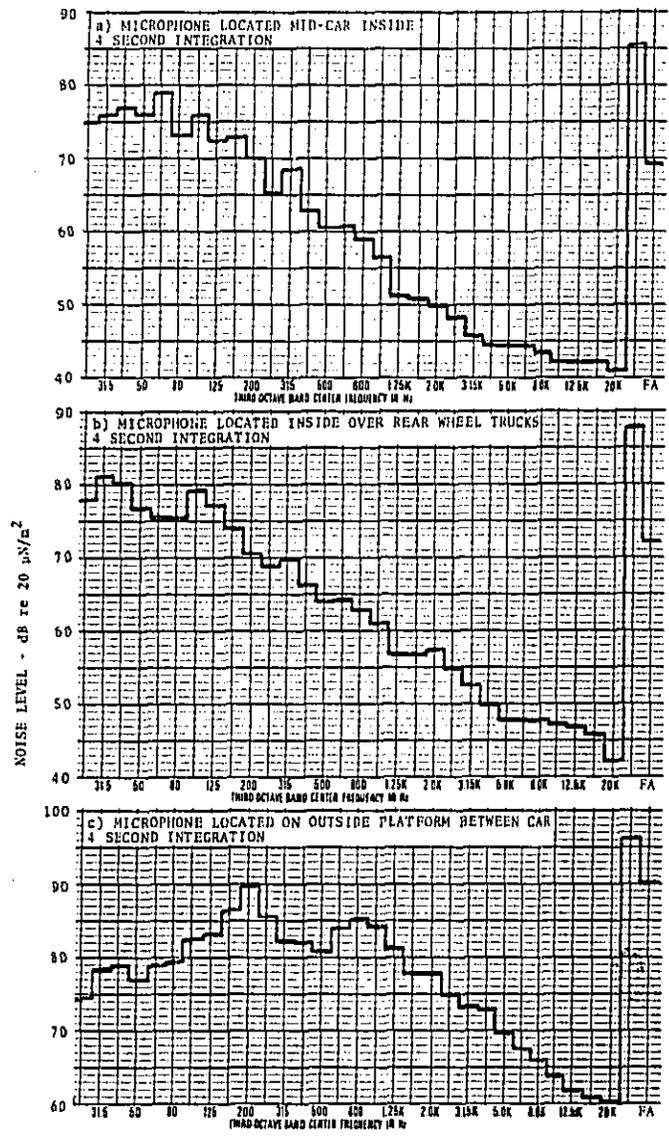
Figure E-21 Coincident Noise Spectra at three locations. Southbound Tenean St. Wayside Measurement Site, MBTA Red Line (So. Shore Extension). April 29, 1972. See Figure E20.

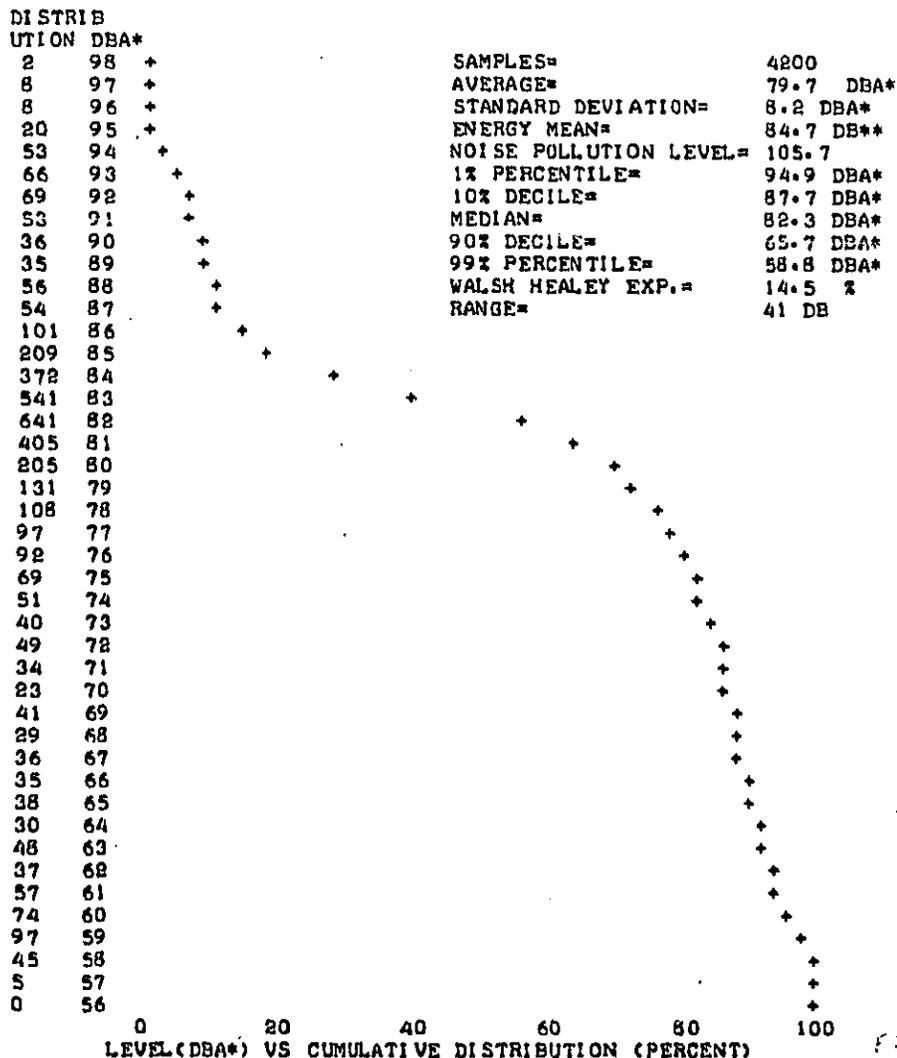
Figure E-24. Statistical Analysis - In-Car Noise Data, MBTA Type 1 So. Shore Rapid Transit Car Serial Nos 1503,1506 on the MBTA Red Line (So. Shore Extension) Northbound. Microphone located on outside platform between cars, April 29, 1972

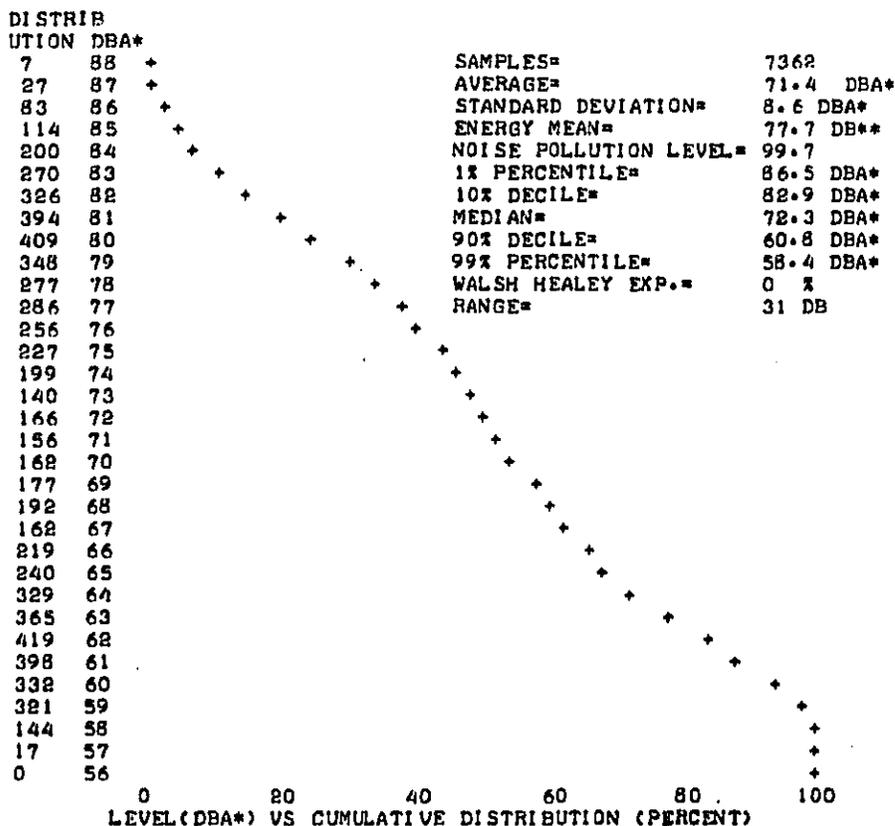
Figure E-26. Statistical Analysis - In-Car Noise Data, MBTA Type 1 So. Shore Rapid Transit Cars Serial Nos 1503, 1506 on the MBTA Red Line Northbound. Microphone located over the rear wheel truck inside car Serial No. 1503, April 27, 1972

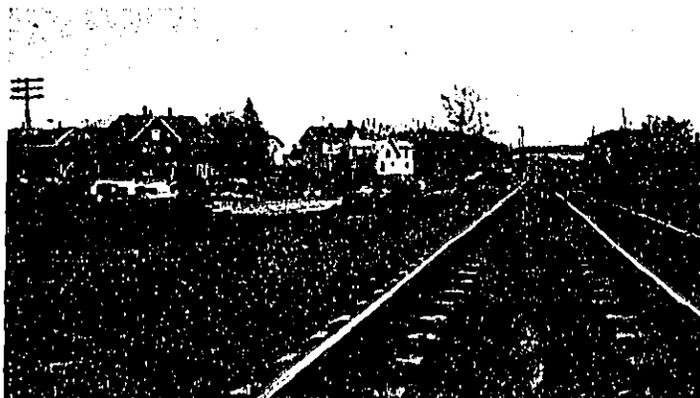
Figure G-2. Two Views at Tenean Street Wayside Measurement Site

b) South bound - Redfield Street Bridge in Background
