Report No. DOT-TSC-OST-72-31

MBTA RAPID TRANSIT SYSTEM (RED LINE)  
WAYSIDE AND IN-CAR  
NOISE AND VIBRATION LEVEL MEASUREMENTS

Edward J. Rickley  
Robert W. Quinn

AUGUST 1972  
FINAL REPORT

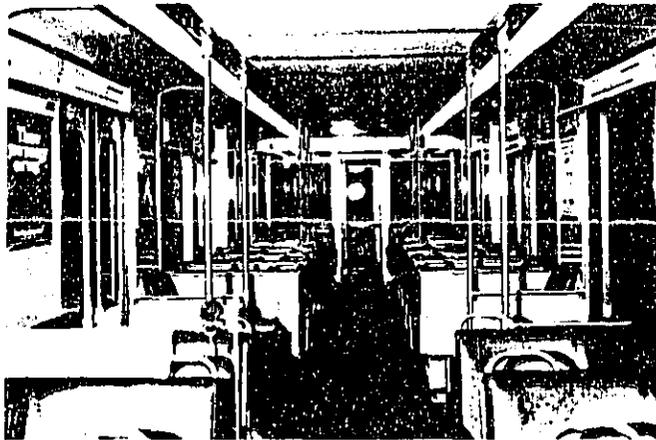
Figure G-7. Inside View - MBTA Type 1 So. Shore Rapid Transit Car. Microphone mid-car in foreground; microphone over rear wheel truck in background.

1. Microphone located mid-car at ear level to a seated passenger (3.5 feet above floor).
2. Microphone located over rear wheel truck at ear level to a seated passenger (3.5 feet above floor).
3. Microphone located on outside platform between cars at ear level to a standing passenger (5.5 feet above platform).
4. Triaxial Accelerometer mounted on floor tiles with bee's wax.
