EPA 550/9-82-331F

Field
Test
of a
Quieted
Ford CLT 9000
Heavy-Duty
Diesel Truck

October 1981

4. TITLE AND SUBTITLE Field Test of a Quieted Ford CLT 9000 Heavy-Duty Diesel Truck	5. REPORT DATE October 1981	6. PERFORMING ORGANIZATION CODE
	7. AUTHOR(S) E.K. Bender and J.A. Kane	8. PERFORMING ORGANIZATION REPORT NO. BBN Report No. 4700

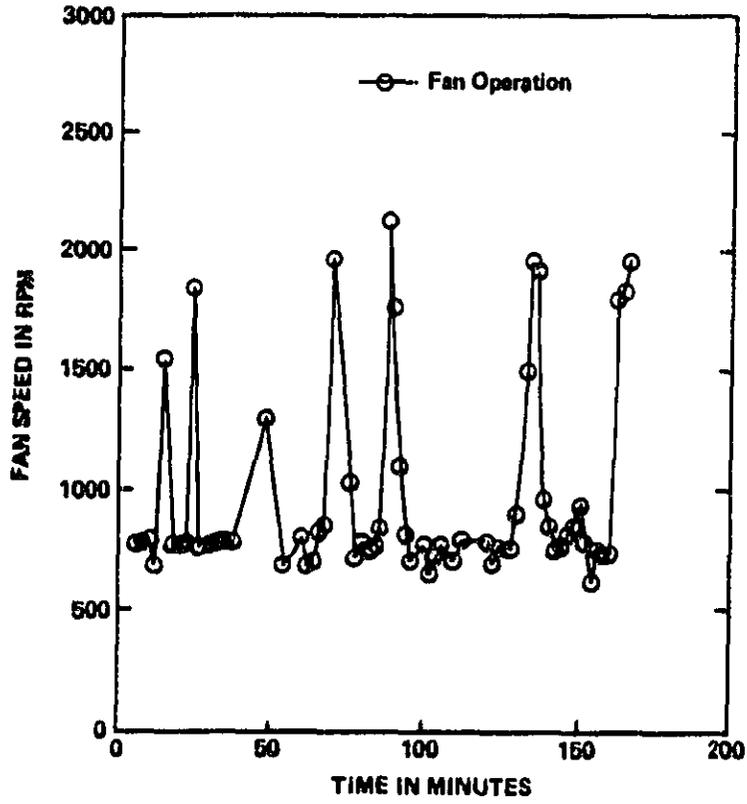
Figure 25 shows the fan speed as a function of time from the start of the outbound test. The fan is activated occasionally but spends most of the time idling at about 700 to 800 rpm. Figure 26 shows ambient, fan outlet, and transmission oil temperatures vs time. The ambient was 97.5°F at the start of the trip, reached a low of 92.7°F, and ended at 96.1°F. The transmission oil temperature required about 3 hours to reach a peak of 219°F and ended at 215.1°F. The fan outlet temperature ranged primarily from about 110°F to 170°F. The peak transmission oil temperature of 219°F is safely below the 250°F specification and well below the reported 275°F.

FIG. 25. ROAD TEST OF FORD CLT 9000 WITH ACOUSTICAL PANELS.

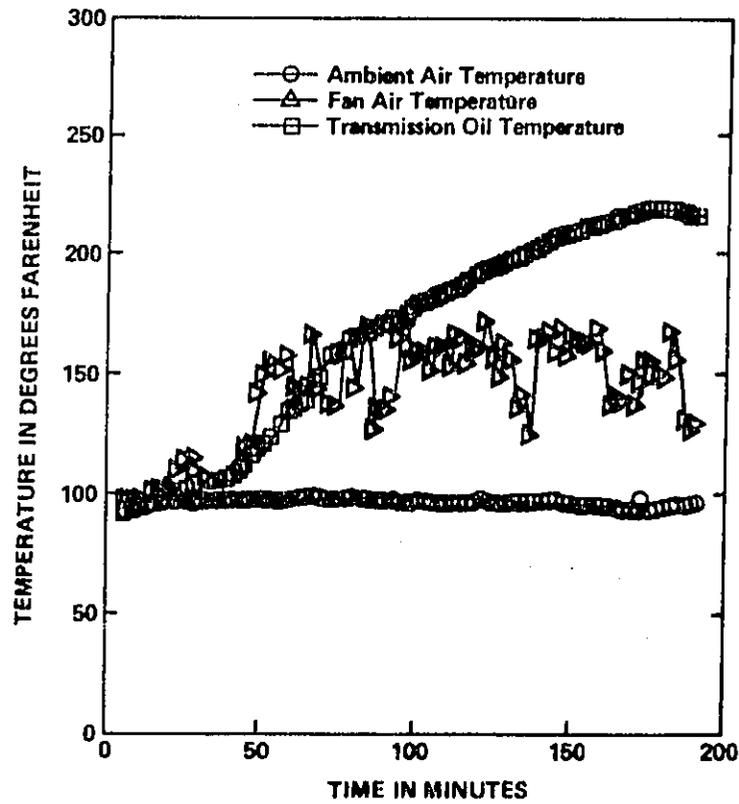
FIG. 26. TEMPERATURE TESTS OF FORD CLT 9000 WITH ACOUSTICAL PANELS.

We conclude that the engine and transmission enclosure was not the cause of the 275° transmission oil temperature. The test results show that while the enclosure did increase the oil temperature, the increase was well within the manufacturer's specification.

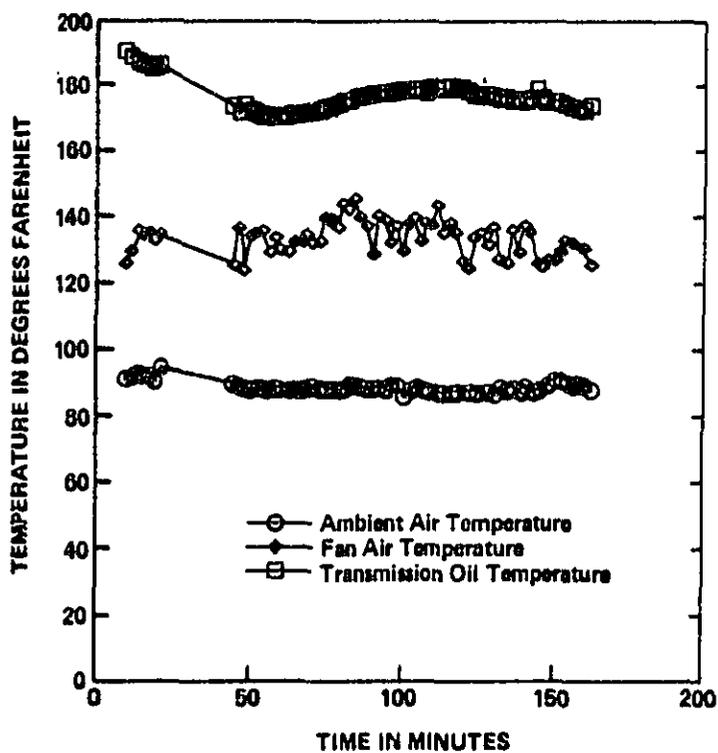
Figure 27 is a graphical summary of the return trip (Test 2) showing ambient, fan, and transmission oil temperatures. The transmission oil temperature stabilized at about 177°F, at an ambient temperature of about 88°F, and at a fan air temperature of 135°F.

FIG. 27. ROAD TEST OF FORD CLT 9000 WITHOUT ACOUSTICAL PANELS.

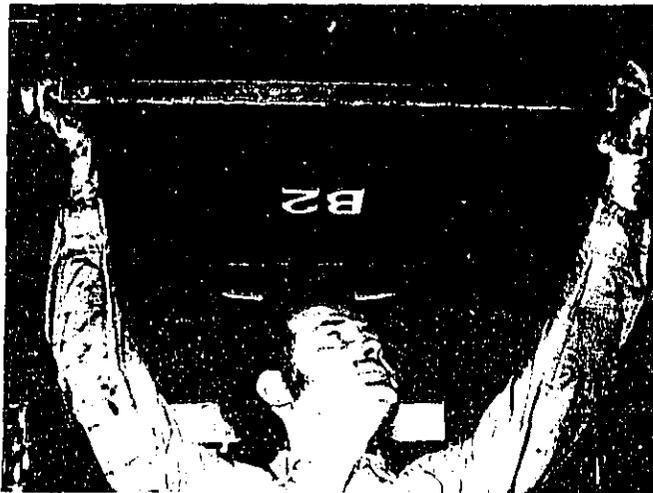
Much of the truck maintenance is performed from a service pit under the vehicle. To access major drive train service points (e.g., lubrication fittings), it is necessary to remove and replace panels as illustrated in Fig. 30. The time required

FIG. 30. REMOVAL OF BELLYPAN PANELS.

to remove and replace bellypan panels from a grease pit was measured. First, a mechanic removed the panels to familiarize himself with the location of latches, etc. Then he was timed as he installed and removed them. He was instructed to work at a normal pace. Table 12 shows the time spent on this operation:
