Field  
Test  
of a  
Quieted  
General Motors  
Brigadier  
Heavy-Duty  
Diesel Truck

Environmental Protection Agency

December 1981

Report No. 4796

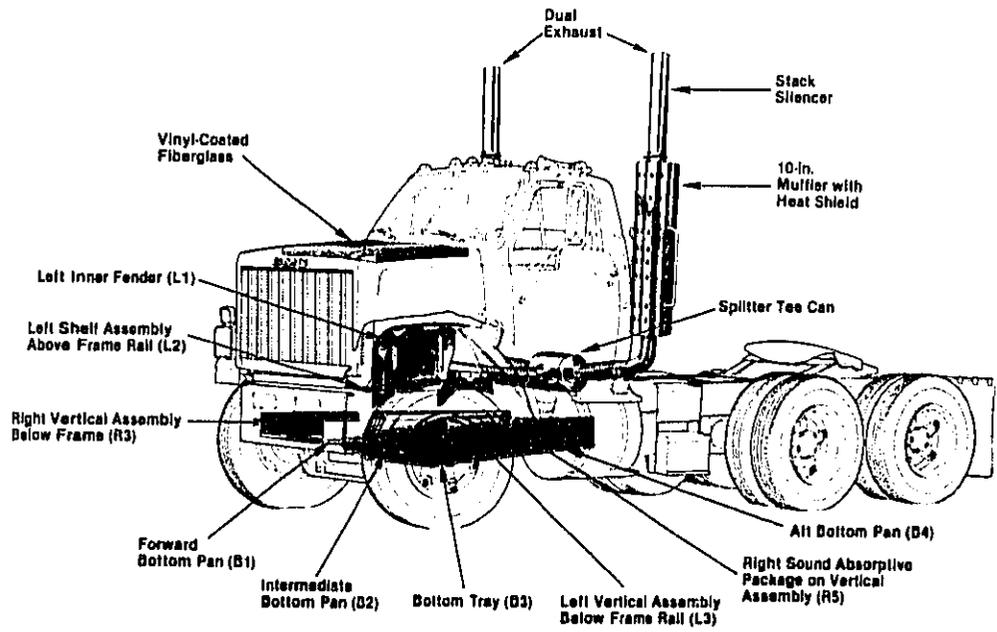
FIG. 3. NOISE CONTROL TREATMENTS INSTALLED ON GMC BRIGADIER.

As shown in Fig. 3, the enclosure is a tunnel-like structure leading from the radiator to the rear of the cab. As much of the existing cab and chassis structure as is practical is used to form this structure. Spaces between the cab and top of the frame rails are filled in with side shields and shelves, and a bellypan extends from one frame rail, under the engine and transmission, to the opposite frame rail.

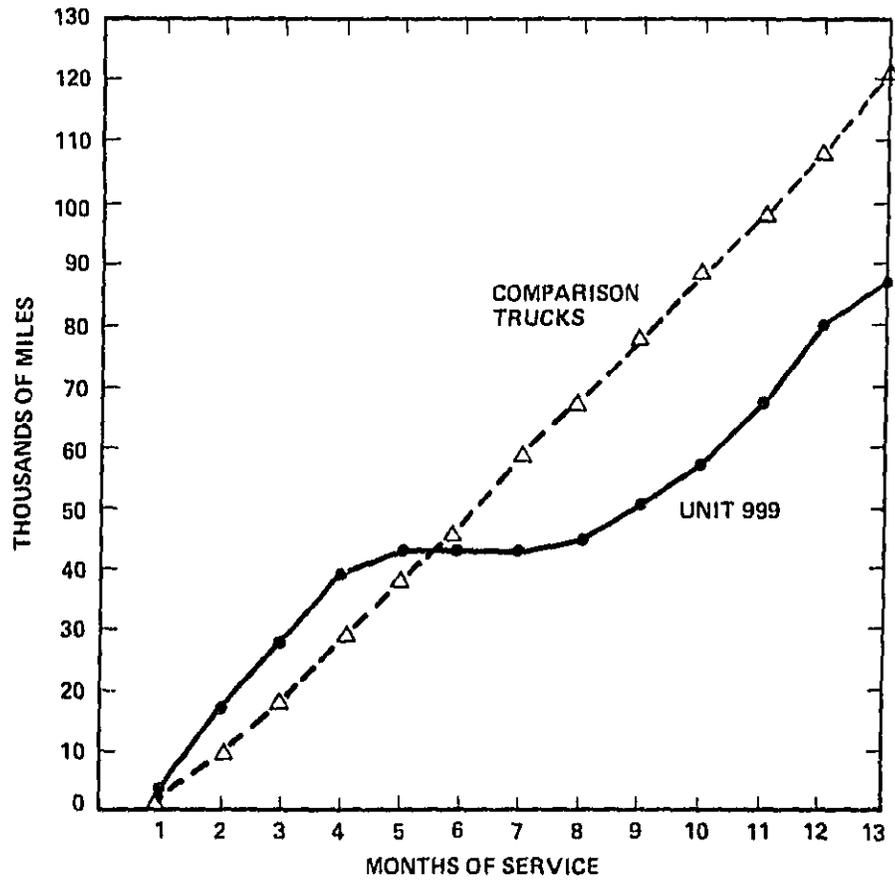
A comparison of the Brigadier and the comparison trucks is shown in Table 6 and Fig. 9. The data show two distinct trends. When the Brigadier was in regular service it typically accumulated more mileage than the average comparison truck. However, the data also show that the quieted Brigadier accumulated significantly lower mileage in its yearlong test than the comparison trucks. The average comparison vehicle logged 121,433 miles in 13 calendar months. The quieted Brigadier logged only 86,865 miles, 28% below the average comparison truck. The lower overall mileage is attributable to the truck being out of service during much of early 1981. The quieted Brigadier was above average during the first five months, as shown in Fig. 9. However, it fell behind during the next few months, while the comparison trucks kept averaging 8,000 to 11,000 miles per month.

FIG. 9. COMPARATIVE MILEAGE.

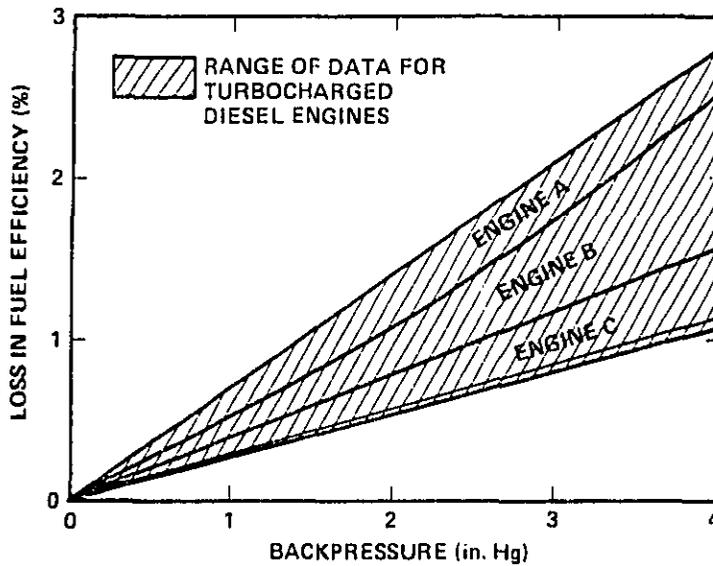
To estimate the effect of backpressure, consider the relationships between fuel efficiency and backpressure illustrated in Fig. 23. The shaded area corresponds to a published composite of data [7], while the three curves within this area are for proprietary data supplied to BBN by several engine manufacturers. Reference 7 suggests that, for turbocharged diesel engines, fuel economy improves by an average rate of 0.5% per inch of mercury decrease in backpressure. This number is consistent with the data in Fig. 23 and will be used for our estimates.

FIG. 23. RELATIONSHIP OF DIESEL ENGINE FUEL EFFICIENCY TO EXHAUST BACKPRESSURE.

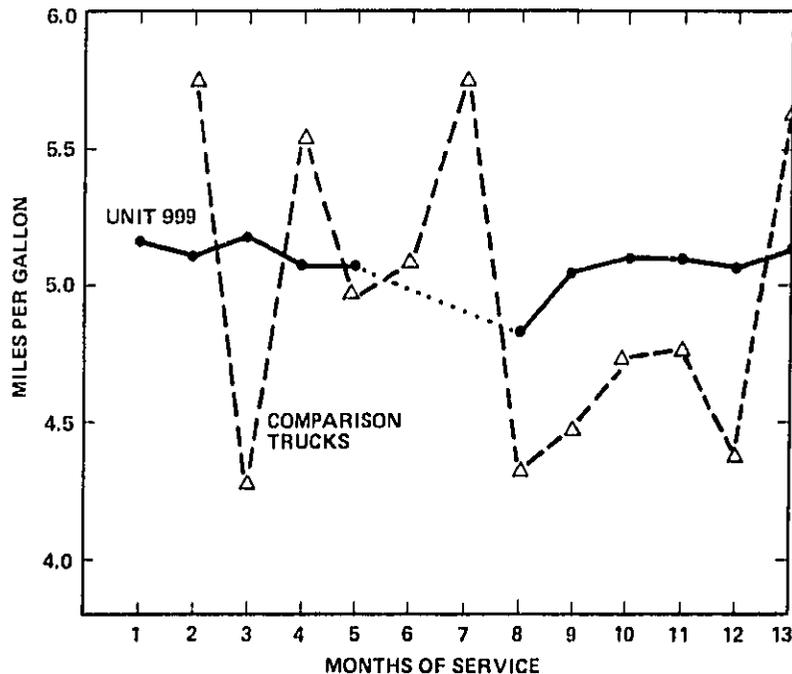
The quieted Brigadier had a fuel economy of 5.109 miles per gallon (mpg) during the yearlong field test. This figure is based on 86,865 miles of service and 17,003 gallons of fuel. The monthly pattern of fuel economy for the quieted Brigadier is shown in Table 9 and as the solid line in Fig. 24. There was relatively little variation in fuel economy from month to month, both because of the regular route over which the vehicle operated and the small variation in payload. Monthly fuel economy ranged from a low of 4.834 mpg to a high of 5.240 mpg.

FIG. 24. COMPARATIVE FUEL ECONOMY.

Table 9 and Fig. 24 also present fuel economy data for the comparison trucks. These trucks had lower fuel economy - 4.939 mpg vs 5.109 for the quieted Brigadier. The month-to-month variation for the comparison trucks was also much greater than the Brigadier's. Fuel economy ranged from 4.313 to 5.741 mpg. This probably reflects variation in payloads, terrain, and weather condition, since the comparison trucks operated throughout the entire ABF system.

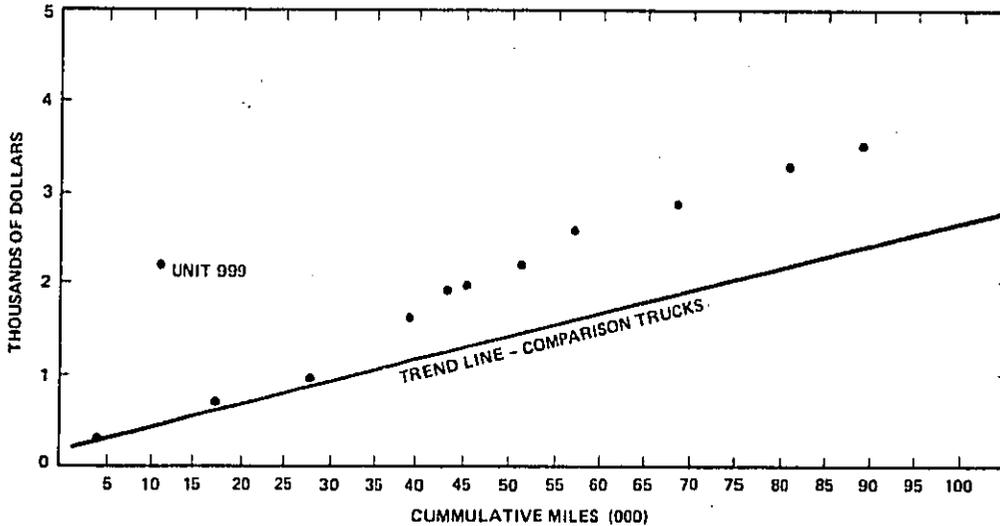
The regression line derived from this equation is shown as the solid line in Fig. 30. The actual maintenance costs for Unit 999 are shown as solid dots in Fig. 30. As is evident from the Figure, Unit 999's maintenance costs are above the trend line for the comparison trucks. The extent of the deviation is summarized

FIG. 30. COMPARATIVE MAINTENANCE COSTS.

in Table 13. Unit 999's maintenance costs are 46% above the fleet trend based on 86,865 miles of fleet service.
