NBS BUILDING SCIENCE SERIES 77

# Acoustical and Thermal Performance of Exterior Residential Walls, Doors and Windows

Issued November 1975

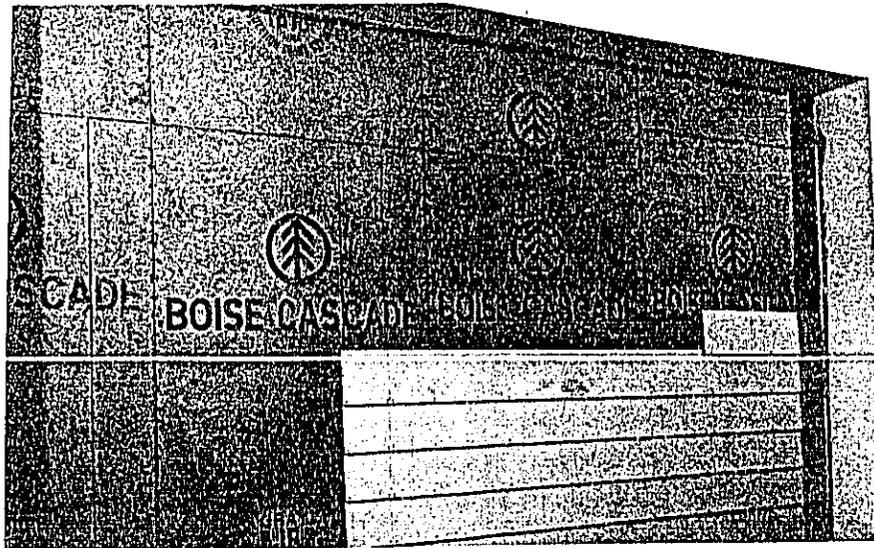
Figure 1. Application of wood siding to frame wall installed in sound transmission facility.

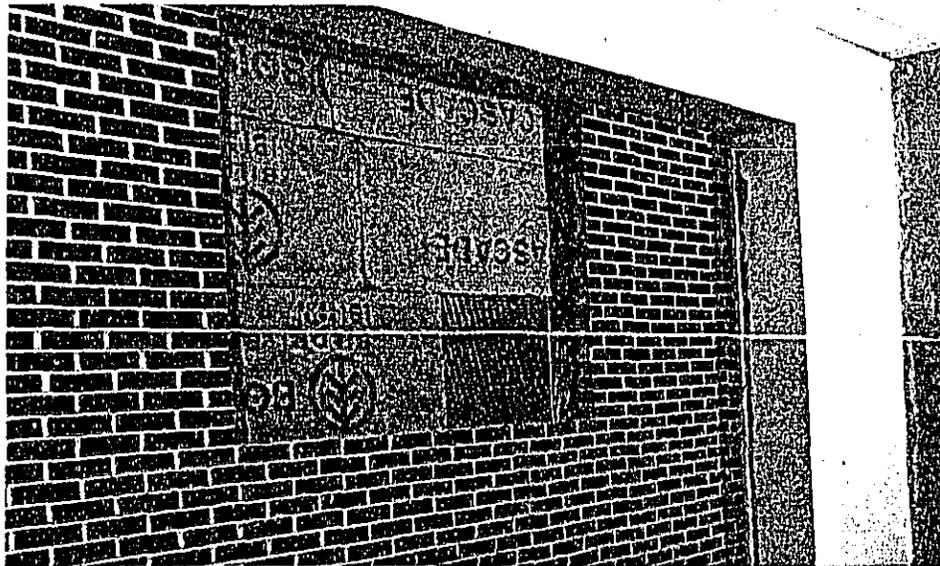
Figure 3. Brick veneer wall with opening cut for picture window.

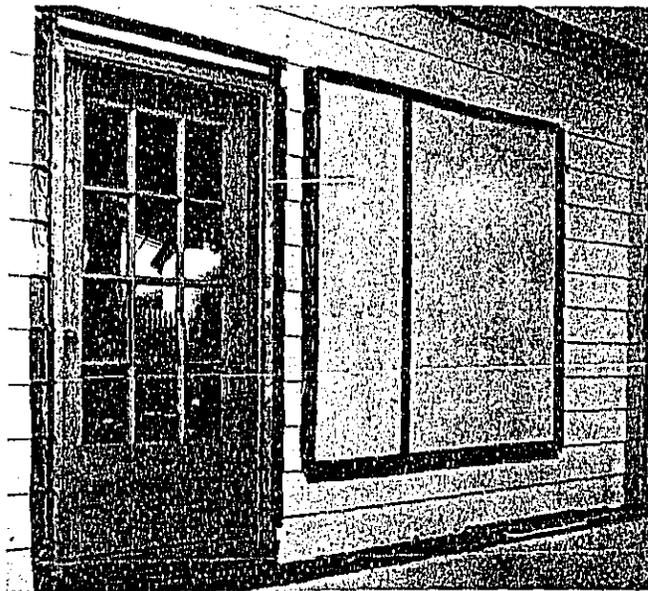
Figure 6. Wood french door mounted in wood siding wall for sound transmission and air infiltration test. Auxiliary construction on opposite side eliminates significant flanking sound transmission.

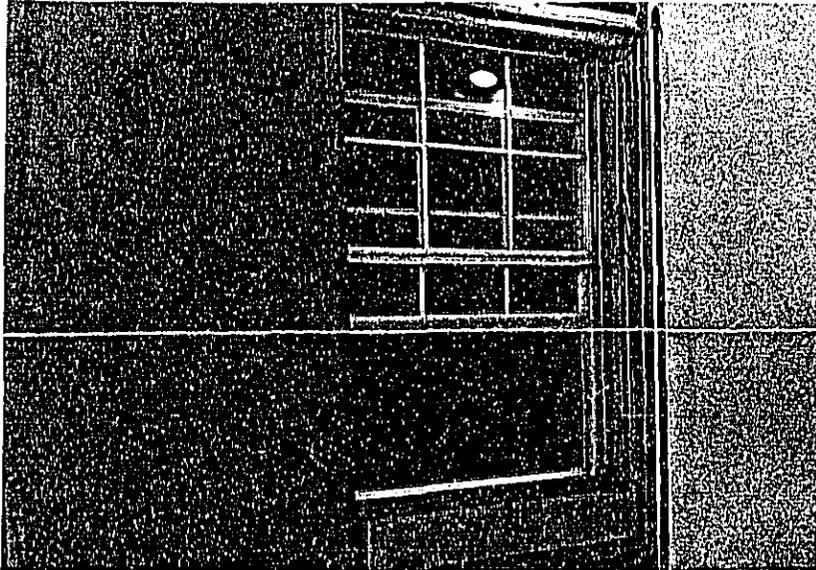
Figure 8. Aluminum single hung window.

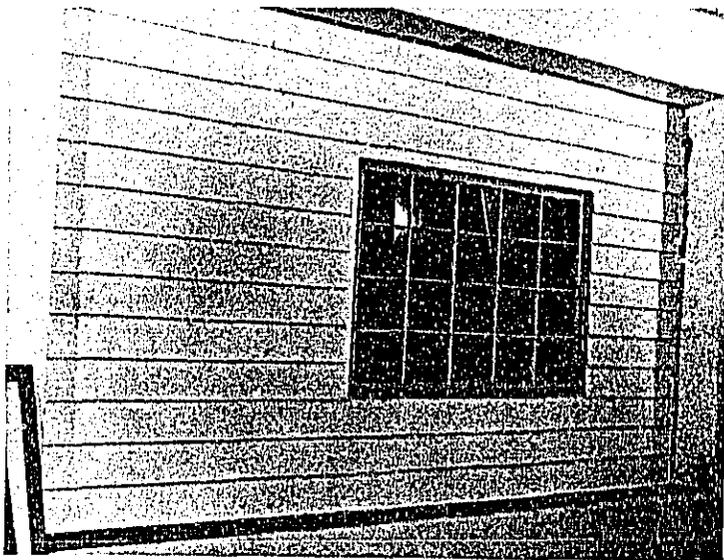
Figure 9. 6 x 5 ft picture window installed in wood siding wall.

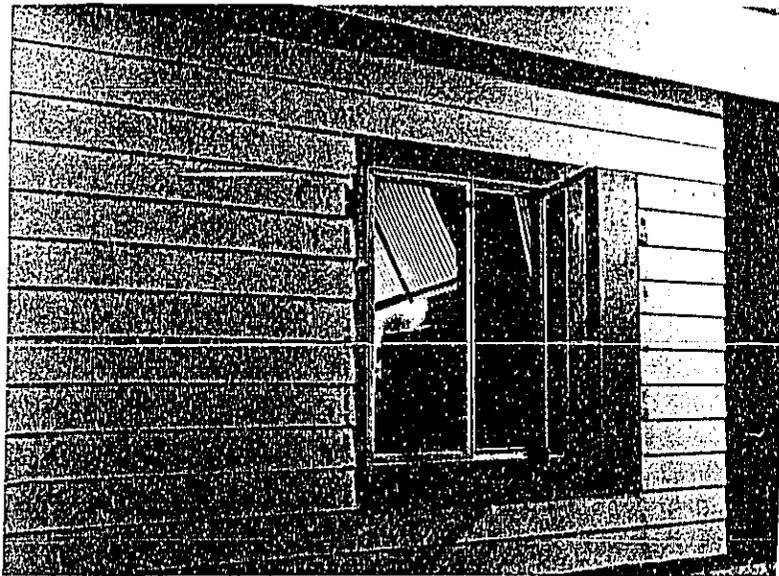
Figure 11. Plastic coated wood operable casement window.

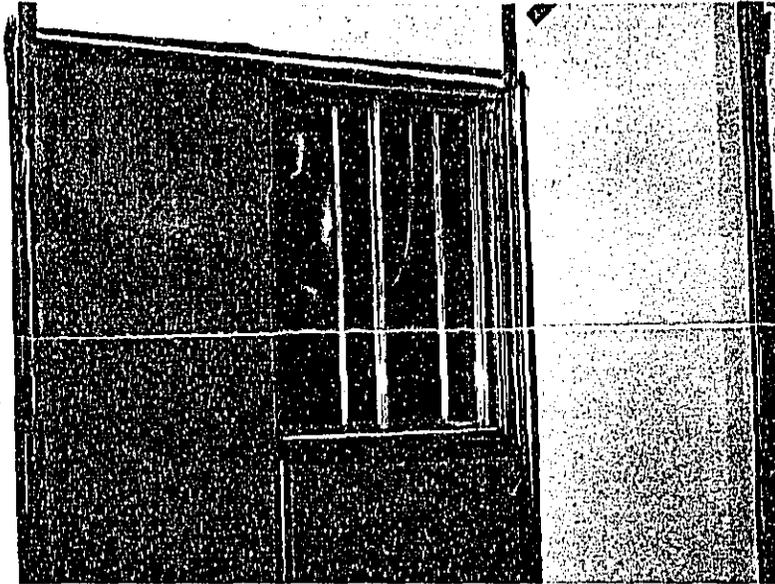
Figure 12. Aluminum Sliding window.

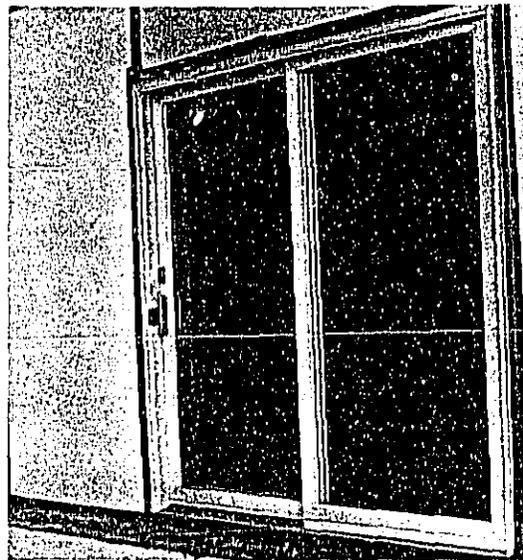
Figure 13. Plastic coated wood sliding glass door.

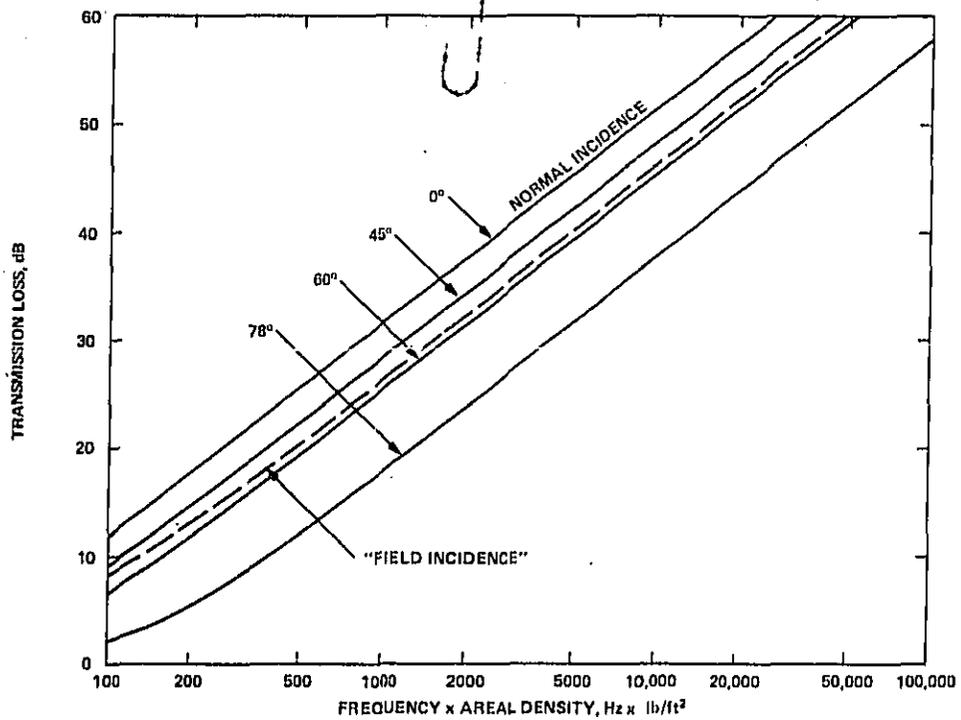
Figure 14. Limp-wall mass law transmission loss. The solid curves correspond to a plane wave arriving at a discrete angle of incidence. The dashed curve corresponds to "field-incidence mass law", a sum over all angles of incidence up to 78°.

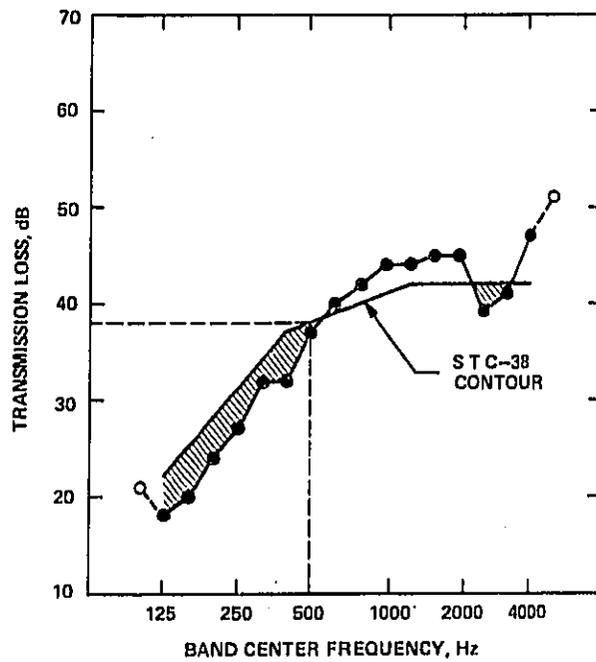
Figure 16. An example of a Sound Transmission Class contour fitted to a sound transmission loss curve. The fitting procedure is described in the text.

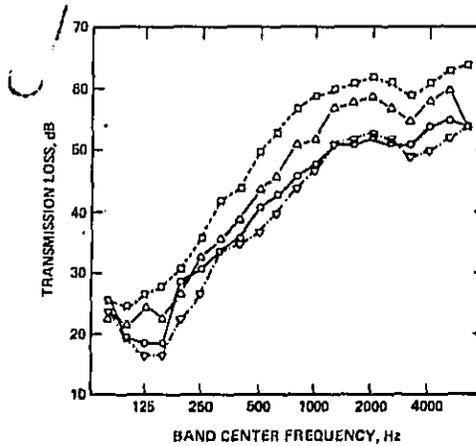
Figure 18. Sound transmission loss vs frequency data for wood-siding, wood-stud exterior walls of four different constructions (with or without resilient channels and with or without cavity insulation).

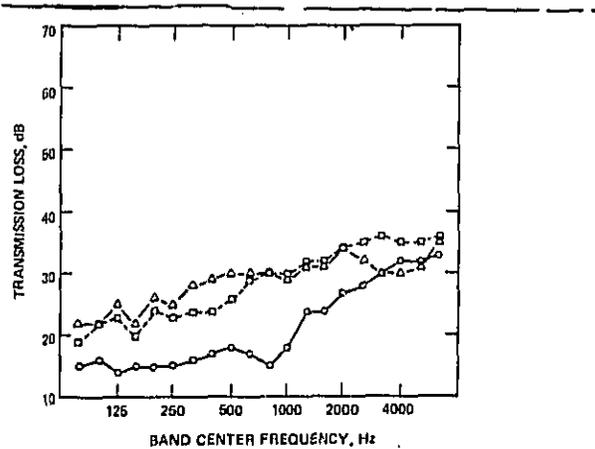
Figure 22. Sound transmission loss vs frequency data for the three wood doors sealed into the frame.

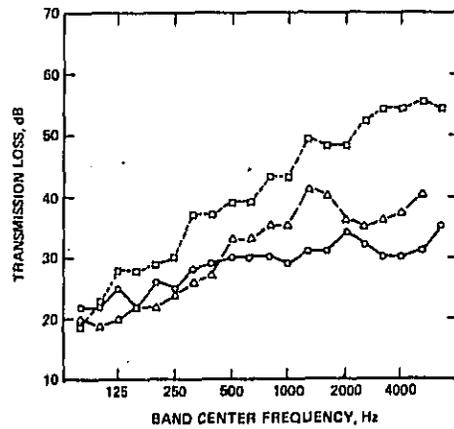
Figure 26. Comparison showing the effect of adding a storm door on the sound transmission loss vs frequency of a solid core wood door.

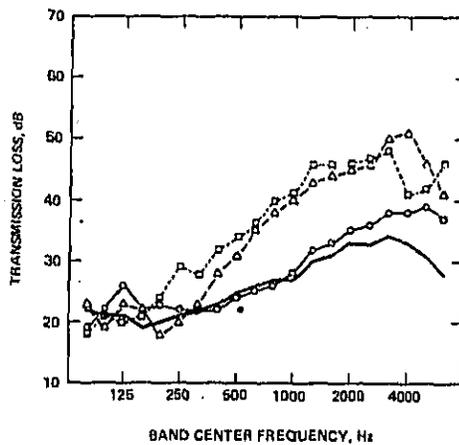
Figure 31. Comparison of sound transmission loss vs frequency data for sealed single-strength windows with storm sash (at various spacings from primary glazing) with data for sealed windows, glazed single-strength with storm sash. In the following table the spacing is the average between panes for upper and lower sash.

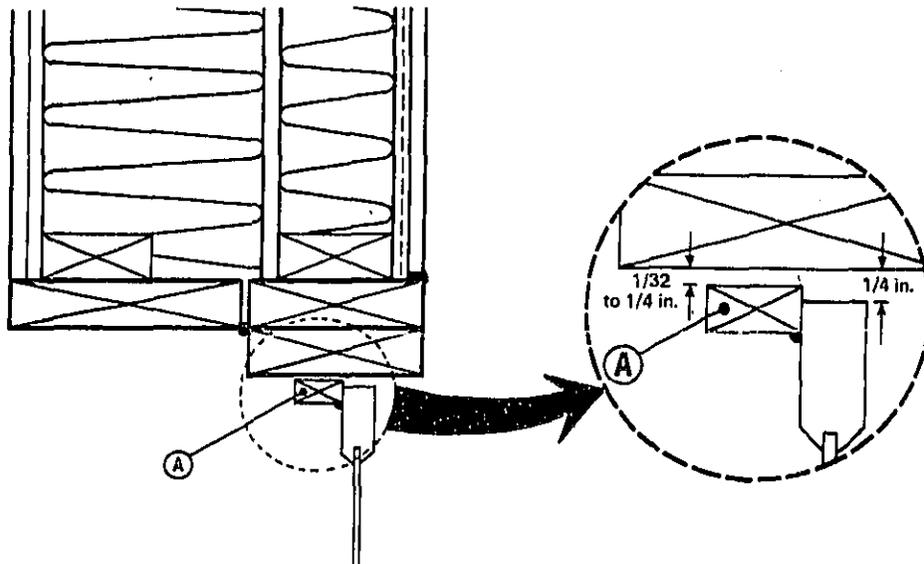
Figure 32. Detail of framing in filler wall to receive picture window sashes. Strip A was shimmed out to provide perimeter cracks ranging from 1/32 to 1/4 in.

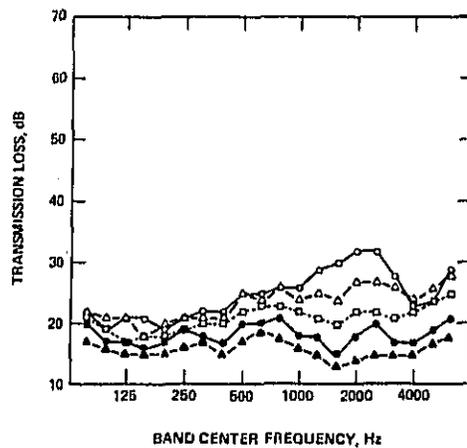
Figure 33. Sound transmission loss vs frequency data for 6 x 5 ft picture window, double-strength glazing, with perimeter cracks of controlled size.

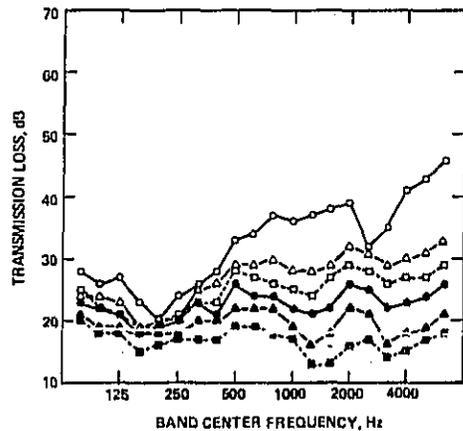
Figure 34. Sound transmission loss vs frequency data for 6 x 5 ft picture window, glazed with 1 in. insulating glass, with perimeter cracks of controlled size.

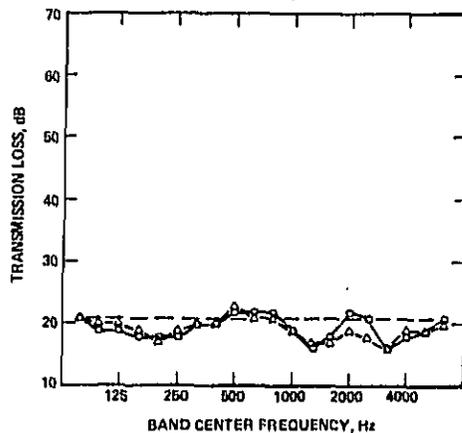
Figure 35. Comparison of effect of perimeter cracks of the same area, but different widths, on the sound transmission loss vs frequency for a 6 x 5 ft picture window, glazed with 1 in. insulating glass. The dashed horizontal line corresponds to the theoretical transmission loss, based on the ratio of crack area to window area, assuming the transmission loss of the crack is 0 dB.

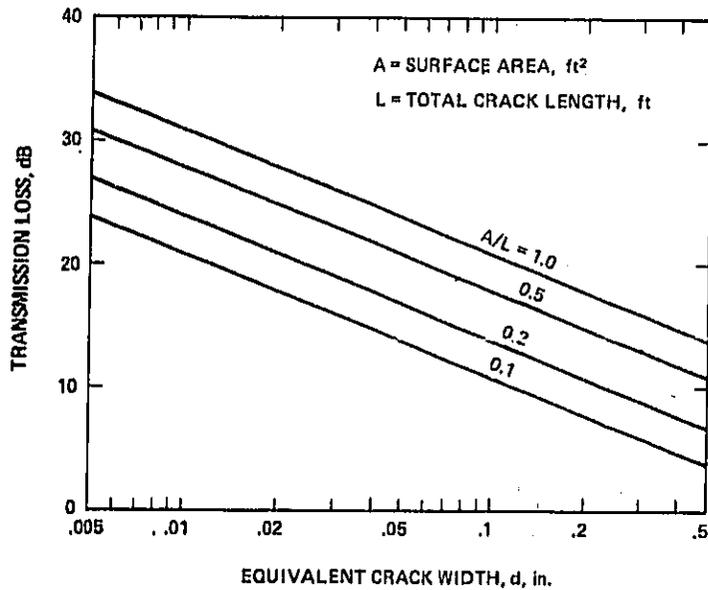
Figure 36. Theoretical sound transmission loss of surface with cracks, assuming the sound transmission loss of the sealed surface is at least 10 dB higher than that of the surface with cracks (see text).

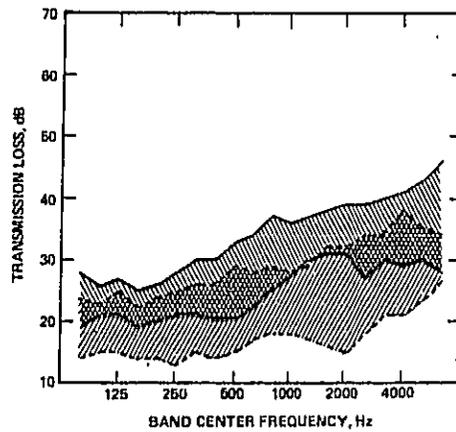
Figure 37. Comparison of the envelope (corresponding to STC 26-34) of sound transmission loss vs frequency data for all sealed windows with the envelope (STC 17-30) of data for all unsealed windows, locked and unlocked.

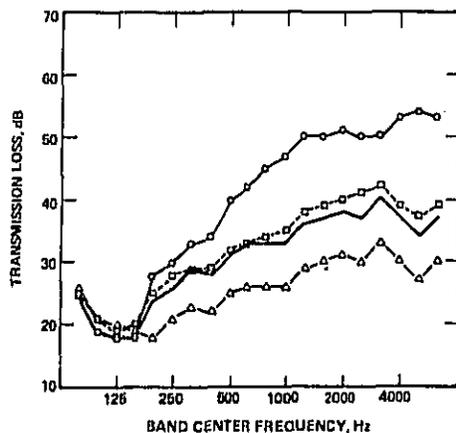
Figure 40. Comparison of measured sound transmission loss vs frequency data for a 6 x 5 ft picture window, glazed single strength, in a wood siding wall with that predicted from the transmission losses and areas of the wall and window (window area = 25.6 sq ft, wall plus window area = 126 sq ft).

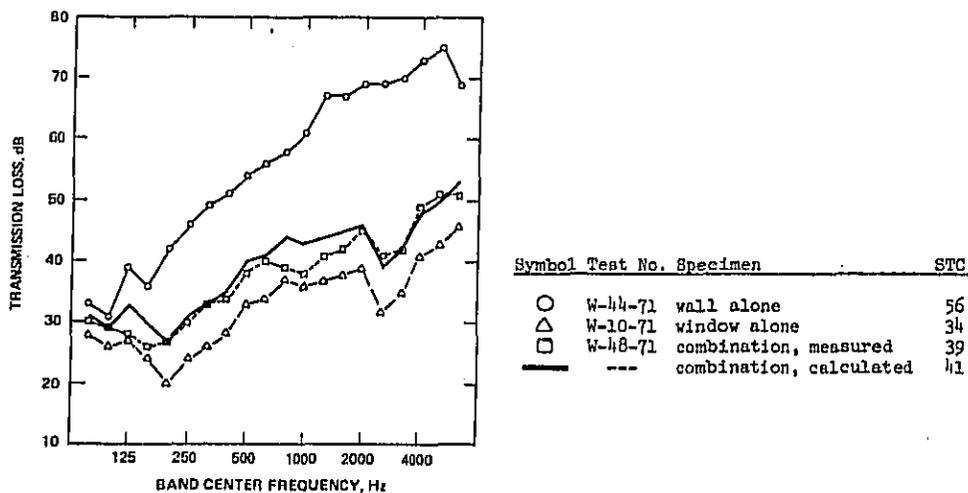
Figure 43. Comparison of measured sound transmission loss vs frequency data for a 6 x 5 ft picture window, glazed 1 in insulating glass, in a brick veneer wall with that predicted from the transmission losses and areas of the wall and window (window area = 25.6 sq ft, wall plus window area = 126 sq ft).

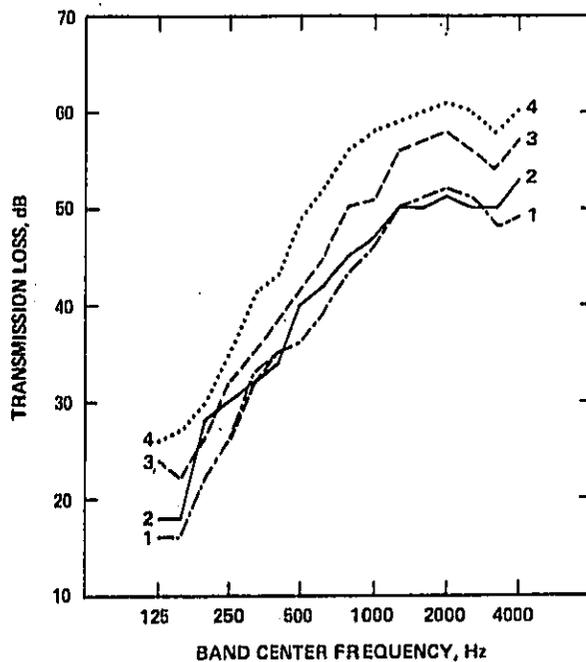
Figure 44. Sound transmission loss vs frequency data for wood-siding, wood-stud, exterior walls. The data are from the present investigation and correspond to walls with or without resilient channels and with or without cavity insulation.

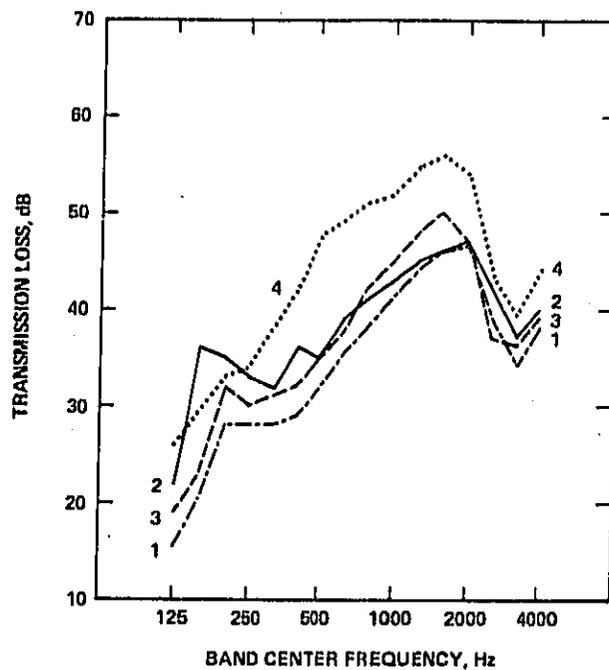
Figure 45. Sound transmission loss vs frequency data for plasterboard interior walls. The data are from Northwood [61] and correspond to walls with wood or metal studs and with or without cavity insulation.

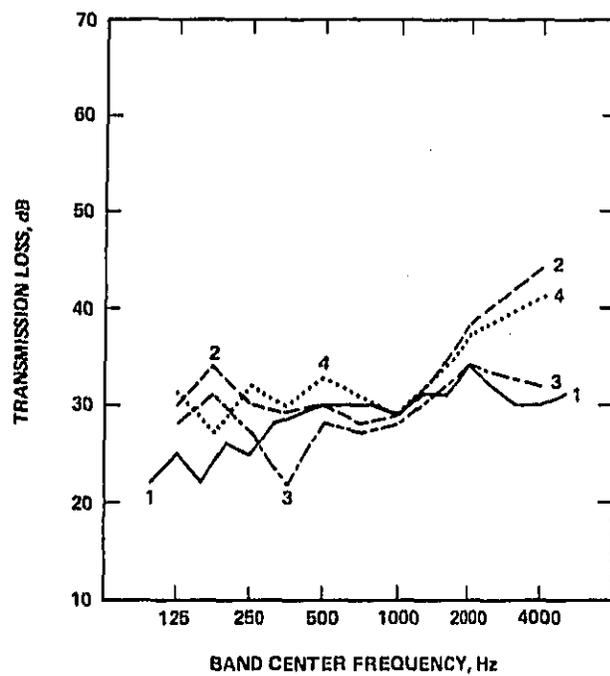
Figure 46. Sound transmission loss vs frequency data for solid core wood doors.

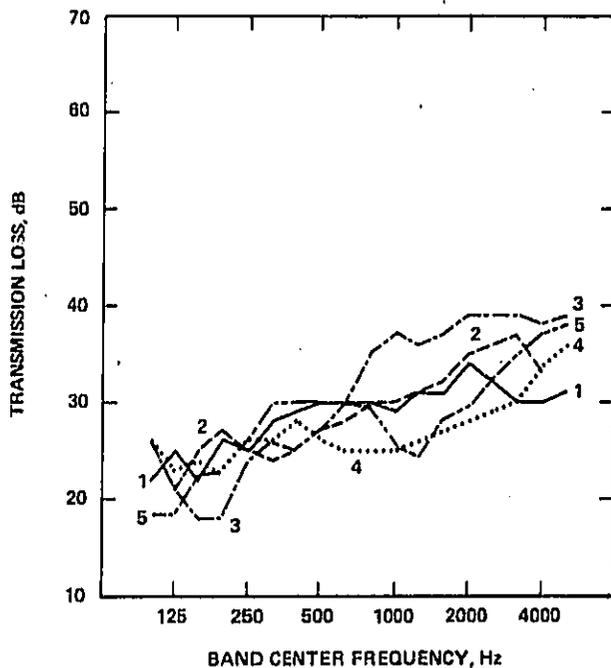
Figure 47. Sound transmission loss vs frequency data for solid core wood doors. Curve 1 is the same as in Figure 46.

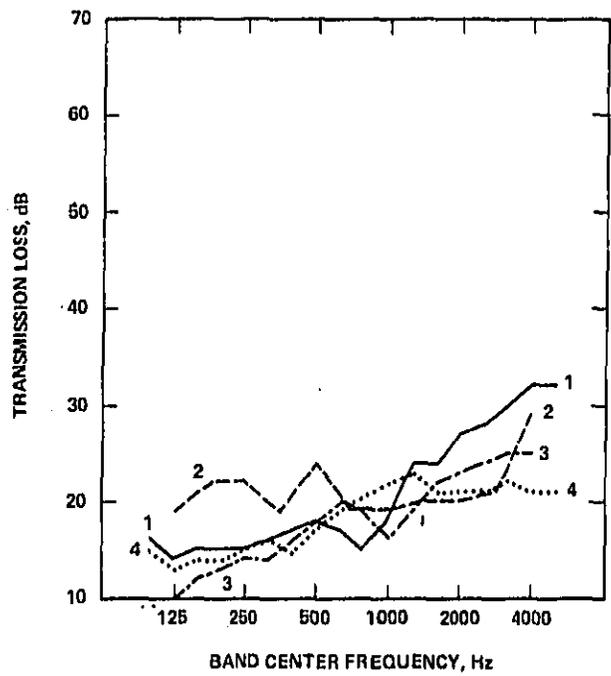
Figure 48. Sound transmission loss vs frequency data for hollow core wood cores.

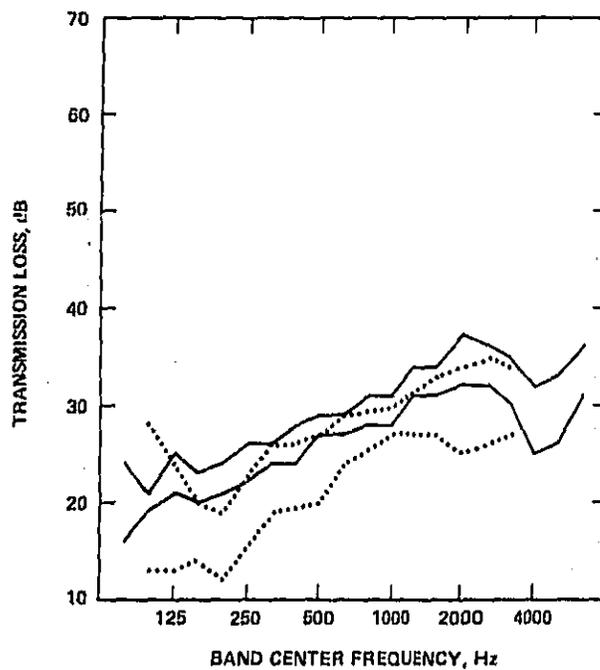
Figure 49. Sound transmission loss vs frequency data for sealed windows, of various types and sizes, with double-strength (3 mm) glazing. The solid curves represent the envelope of data obtained in the present investigation (Tests W-7-71, W-32-71, W-34-71, W-64-71, W-66-71, and W-21-72). The dotted curves represent the envelope of data, on sealed windows only, from Table A5 of Marsh [63] (the sets of data included are the 2nd and 3rd of Aston, the 1st of Wooley, and the 1st, 2nd and 4th of Saint-Gobain).

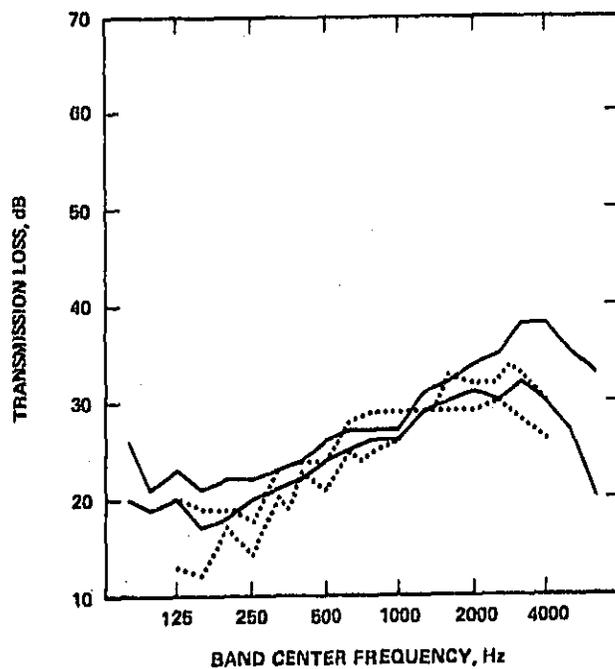
Figure 50. Sound transmission loss vs frequency data for sealed windows, of various types and sizes, with single-strength glazing. The solid curves represent the envelope of data obtained in the present investigation (Tests W-8-71, W-33-71, W-41-71, W-76-71, and W-26-72). The dotted curves represent the envelope of the following data: Brandt (2 mm glass) and Libbey-Owens-Ford (3/32 in. glass) from Table A6 of Marsh [63]; caulked steel frame casement window (3/32 in. glass) from Bishop and Hirtle [62].

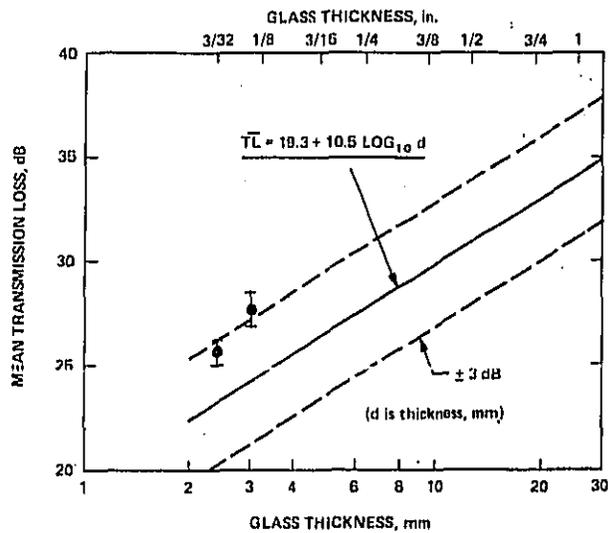
Figure 51. Mean sound transmission loss (arithmetic average of the values over the range 100 to 3150 Hz) of sealed windows vs glass thickness. The solid line is that which was fitted to literature data by Marsh [63]. The dashed lines enclose all but two of the data points she used to derive the solid line. The solid circles represent the average and range of data on single- and double-strength glazing from the present investigation.

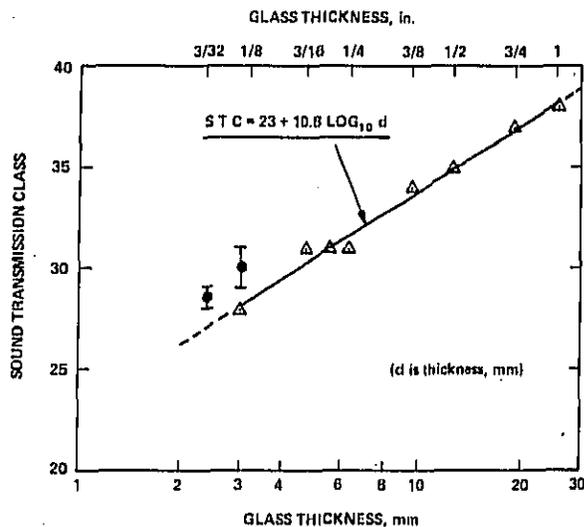
Figure 52. Sound Transmission Class of sealed windows vs glass thickness. The triangles and the line fitted through them represent the data reported by Patil [64]. The solid circles represent the average and range of data on single- and double-strength glazing from the present investigation.

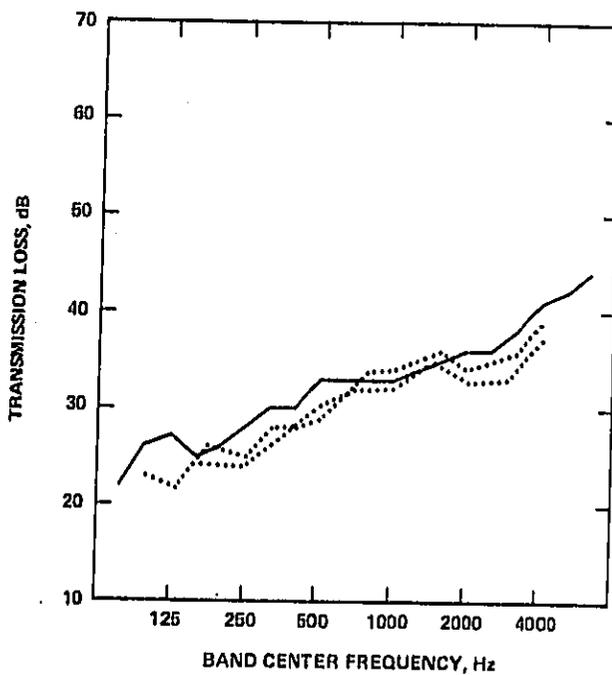
Figure 53. Sound transmission loss vs frequency data for  $1/4$  in. laminated glass with an internal damping layer. The solid curve represents the data from the present investigation (Test No. W-22-72) while the dotted curves represent the envelope of data from Table A8 of Marsh [63] (the two sets of data are that of Pilkington Bros. and the 1st of Libbey-Owens-Ford).

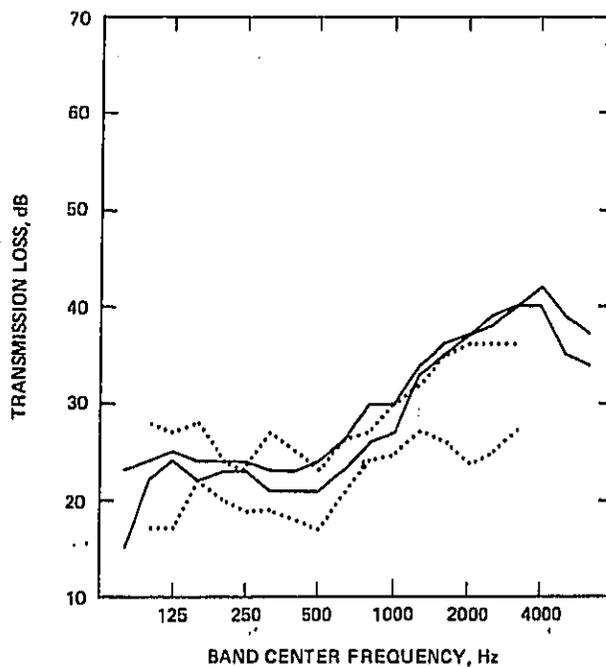
Figure 54. Sound transmission loss vs frequency data for 7/16 in. insulating glass units consisting, nominally, of two 1/8 in. panes of glass separated by a 3/16 in. air space. The solid curves represent the envelope of data obtained in the present investigation (Tests W-31-71 and W-29-72). The dotted curves represent the envelope of data from Table B1 of Marsh [63]. (the sets of data included are the 2nd of Wooley and the two of Saint-Gobain).

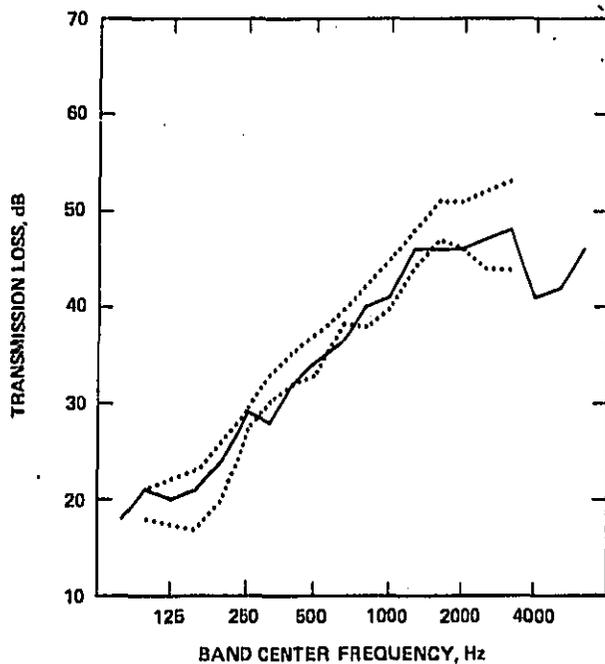
Figure 55. Sound transmission loss vs frequency data for double glazing with a nominal 4 in. separation between the two panes. The solid curve represents a 6 x 5 ft picture window glazed single strength (2.4 mm) with a double strength (3mm) storm window spaced 95 mm (3 3/4 in.) away (Test W-11-71). The dotted curves represent the envelope of data, from Table C2 of Marsh [63], for 3 mm panes separated by 100 to 102 mm (the sets of data are the first listed for each of the following: Aston, Ingemansson, and Woolley).

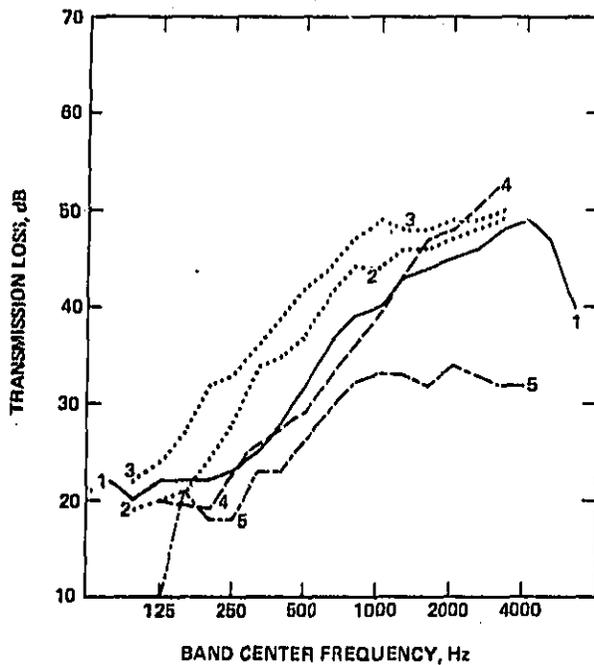
Figure 56. Sound transmission loss vs frequency data for double glazing with an average nominal spacing of about 2 to 3 in. between the two panes.

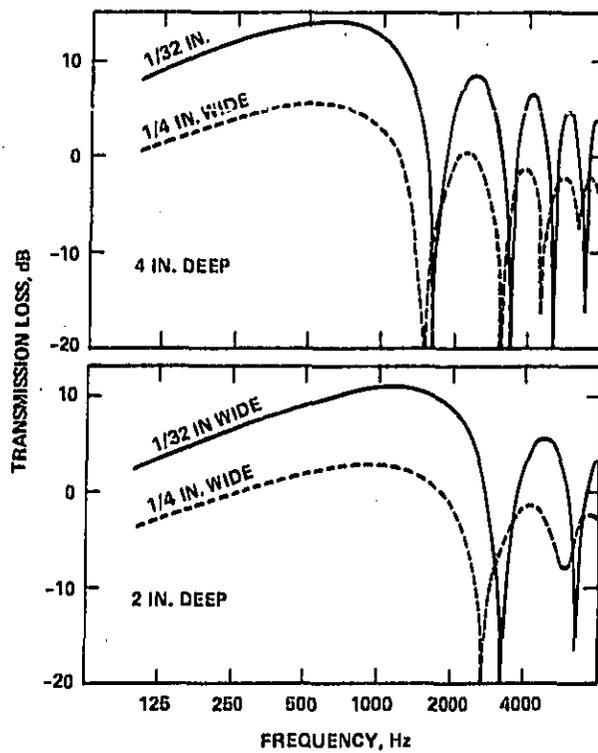
Figure 57. Theoretical sound transmission loss vs frequency data for slits in the middle of a wall between two reverberant rooms, as computed from eq. (69) of Gomperts [76].

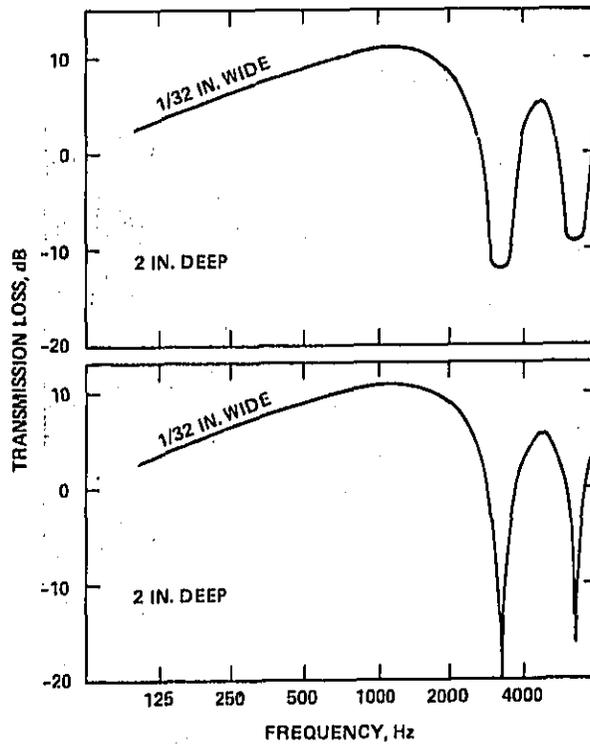
Figure 58. Theoretical sound transmission loss vs frequency data for slits in the middle of a wall between two reverberant rooms. The lower curve represents pure tone behavior while the upper curve corresponds to values averaged over a frequency band that is  $1/3$  octave in width. The lower curve was computed from eq. (69) of Comperts [76] while the upper curve was derived by numerical integration of the transmission coefficient corresponding to the lower curve.

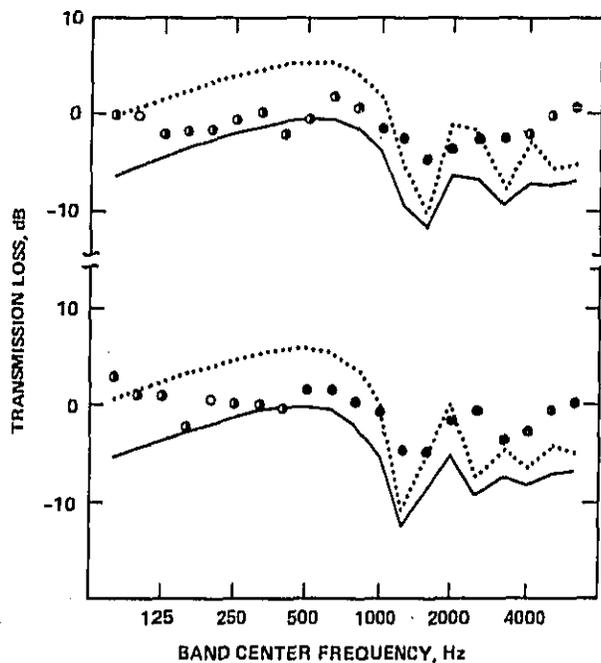
Figure 59. Comparison of experimental results and theoretical predictions for the sound transmission loss of 1/4 in. cracks around picture windows. The data points in the upper portion of the figure are from Test W-16-71 and the average of Tests W-7-71 and W-9-71; those in the lower portion are from Tests W-12-71 and W-10-71. Solid symbols indicate that the transmission loss of the sealed window was at least 9 dB greater than that of the leaky window, while half-filled symbols indicate a 6 to 9 dB difference and open symbols a 3 to 6 dB difference. If the effect of the crack was less than 3 dB for a given frequency band, the data are not plotted. The dotted curves were calculated from equation (69) of Gomperts [76] averaged over a 1/3 octave band, for a slit in the middle of a wall; the solid curves were calculated in a similar manner but correspond to a slit at the edge of a wall between two reverberant rooms. The effective depth of the slit was taken as 4.5 in. for the theoretical calculations in the lower figure and as 4.0 in. for those in the upper figure.

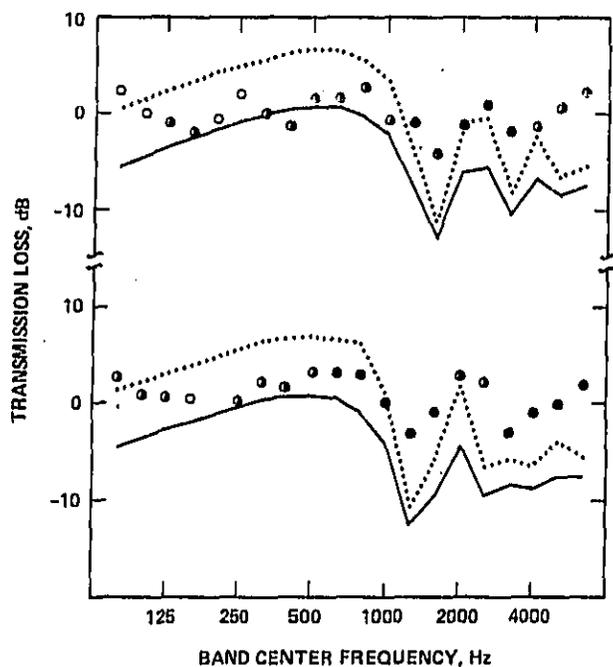
Figure 60. Comparison of experimental results and theoretical predictions for the sound transmission loss of 1/8 in. cracks around picture windows. The data points in the upper portion of the figure are from Test W-15-71 and the average of Tests W-7-71 and W-9-71; those in the lower portion are from Tests W-18-71 and W-10-71. The effective width of the slit was taken as the uniform width which would contain the same mass of air as the actual slit (which consisted of two segments of different widths. (Otherwise, as in Figure 59).

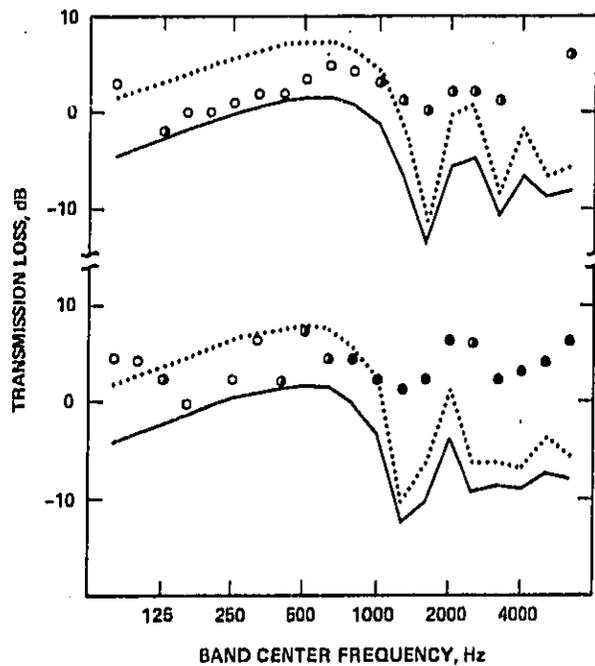
Figure 61. Comparison of experimental results and theoretical predictions for the sound transmission loss of 1/16 in. cracks around picture windows. The data points in the upper portion of the figure are from Test W-17-71 and the average of Tests W-7-71 and W-9-71; those in the lower portion are from Tests W-18-71 and W-10-71 (Otherwise, as in Figure 60).

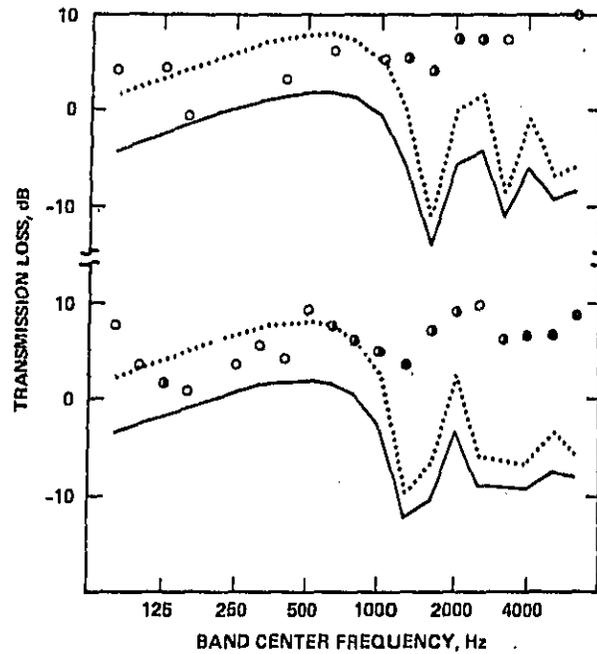
Figure 62. Comparison of experimental results and theoretical predictions for the sound transmission loss of 1/32 in. cracks around picture windows. The data points in the upper portion of the figure are from Test W-21-71 and the average of Tests W-7-71 and W-9-71; those in the lower portion are from Tests W-19-71 and W-10-71. (Otherwise, as in Figure 60).

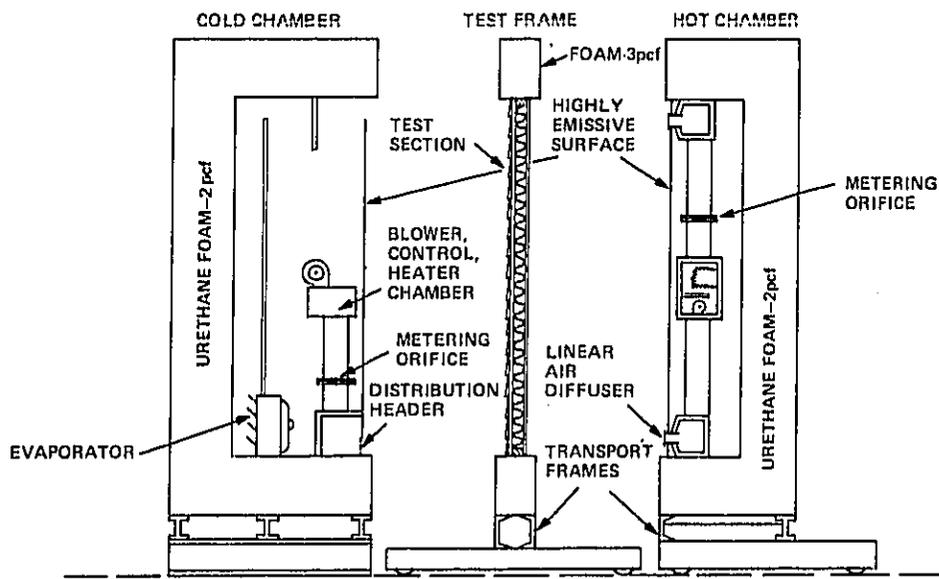
Figure 63. Schematic section of calibrated hot box facility used for thermal tests. Components are described in the text and by Mumaw [119].

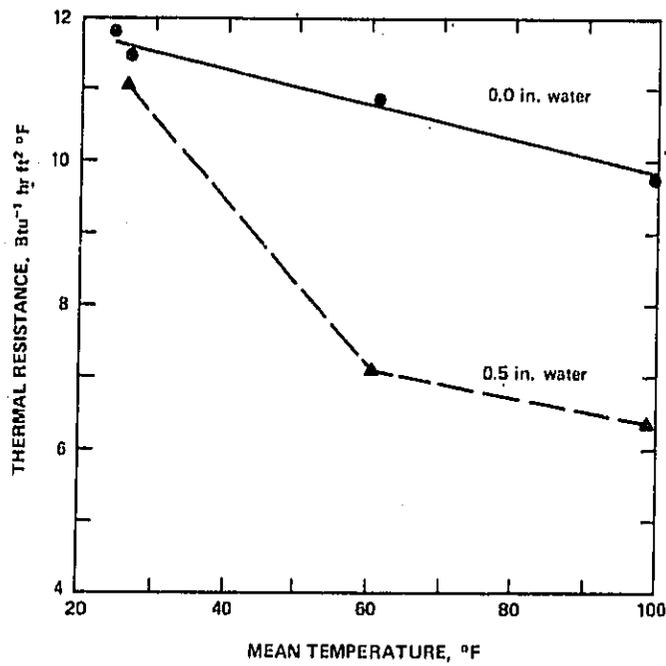
Figure 64. Thermal resistance vs mean temperature data for a 2 x 4 in. stud wall with 1/2 in. gypsum board on the interior surface, redwood lap siding over 1/2 in. wood fiber sheathing on the exterior surface, and 3 1/2 in. Fiberglas Friction Fit Building Insulation plus a polyethylene vapor barrier in the cavity.

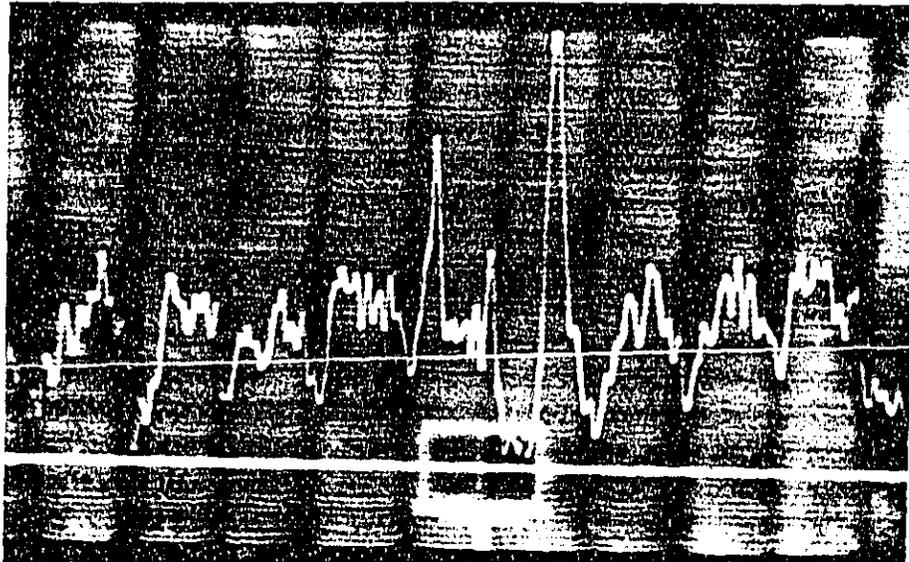
Figure 65. Infrared thermograph of warm side of wall insulated with 3 1/2 in. Fiberglass Friction Fit Insulation. Comparator temperature difference: 2.1 °F.

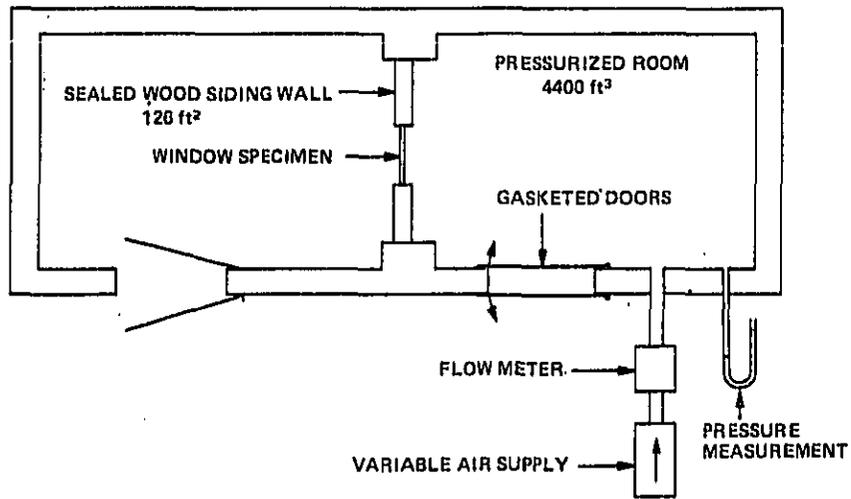
Figure 67. Experimental setup for measuring air filtration of doors and windows in the sound transmission facility.

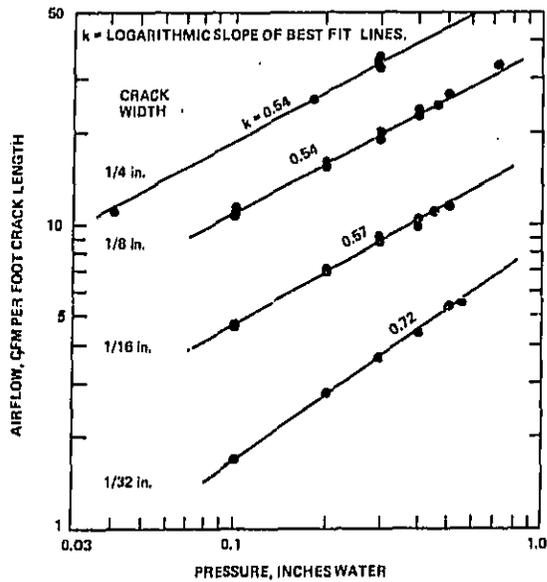
Figure 68. Air infiltration through gauged cracks around picture window. Multiple points at the same pressure and crack width represent crack lengths varying from 2 to 20 ft.

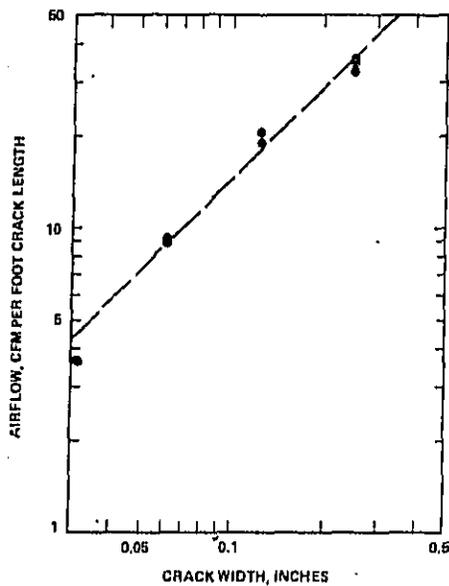
Figure 69. Air infiltration, as a function of crack width, through gauged cracks around picture window at 0.3 in. water pressure.

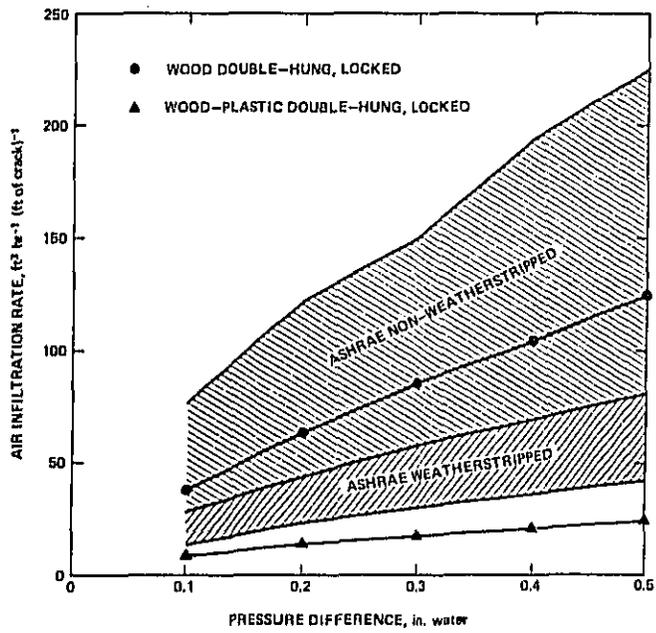
Figure 70. Air infiltration, per foot of crack, for locked wood (Test W-24-71) and wood-plastic (Test W-74-71) double-hung windows compared with ASHRAE design values.

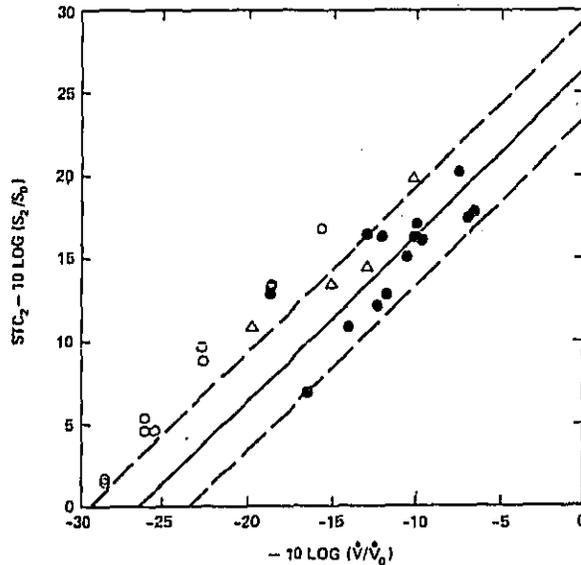
Figure 71. Experimentally determined values for  $STC_2 - 10 \log (S_2/S_0)$  plotted vs experimentally determined values for  $-10 \log (V/V_0)$ ; see text.

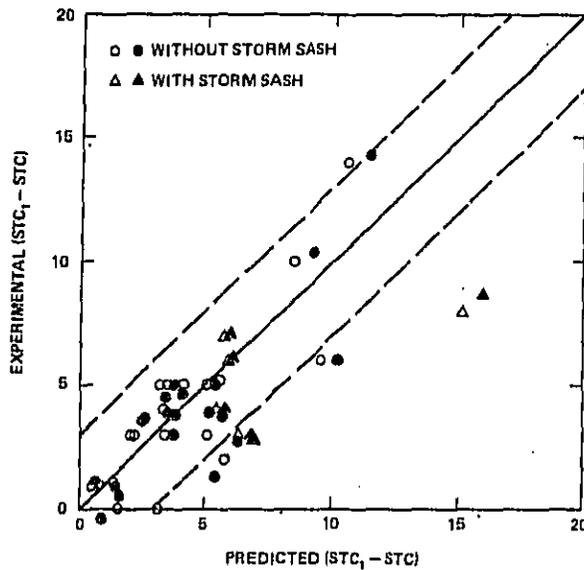
Figure 72. Experimental values for the decrease in sound transmission loss due to leaks around windows or doors versus values predicted using equation (22). The open symbols represent conventional calculations [22] of the Sound Transmission Class. Closed symbols correspond to STC-values computed exactly (rather than to the next lowest decibel) and without invoking the "-8 dB rule".

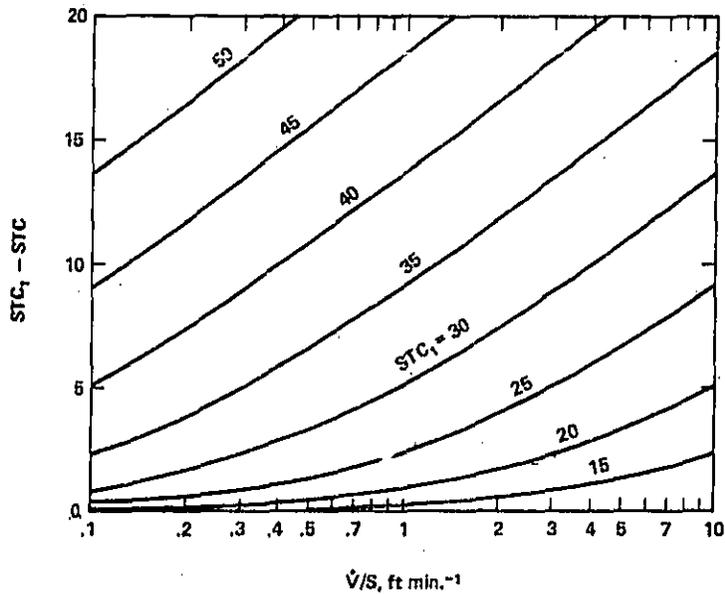
Figure 73. Expected decrease in Sound Transmission Class as a function of air leakage rate divided by area. The air leakage rate,  $\dot{V}$ , measured according to ASTM E283-73 [125] is expressed in  $\text{scfm}$  at a pressure difference of 0.3 in. water. The window or door area,  $S$ , is in  $\text{sq ft}$ . The parameter on the curves is the Sound Transmission Class of the sealed unit (window or door).
