NBS BUILDING SCIENCE SERIES 77

# Acoustical and Thermal Performance of Exterior Residential Walls, Doors and Windows

Issued November 1975

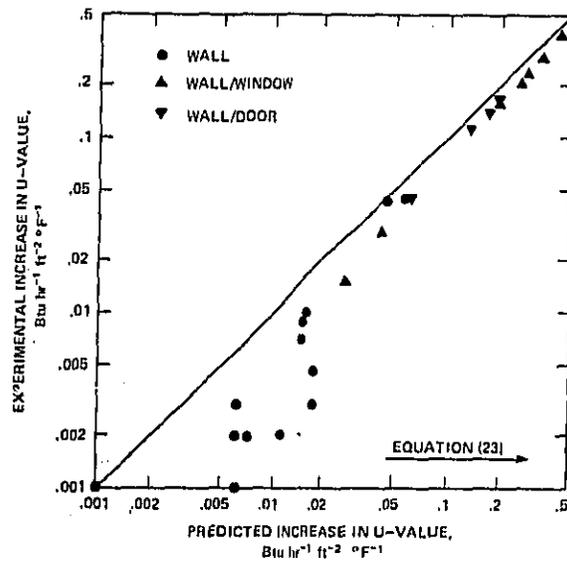
Figure 74. Experimentally observed increase in effective thermal transmittance of 9 x 14 ft walls, with and without penetrating doors or windows, vs the increase predicted by equation (23). The scatter for small values of thermal transmittance arises from imprecisions in both the thermal transmittance data and the air flow rate data (used in equation (23)).

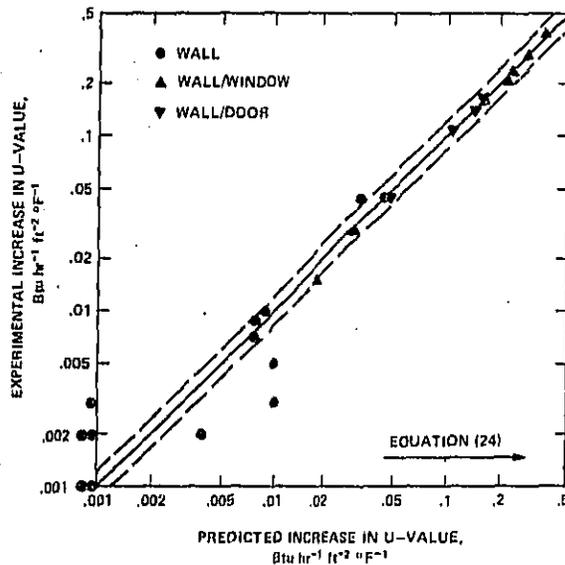
Figure 75. Experimentally observed increase in effective thermal transmittance of 9 x 14 ft walls, with and without penetrating doors or windows, vs the increase predicted by equation (24). The data points shown just to the left of the left-hand ordinate correspond to predicted values below the range of the abscissa (cf. corresponding points in Figure (74)). The dashed lines bound the region  $\pm 20\%$  around the line of perfect concordance.

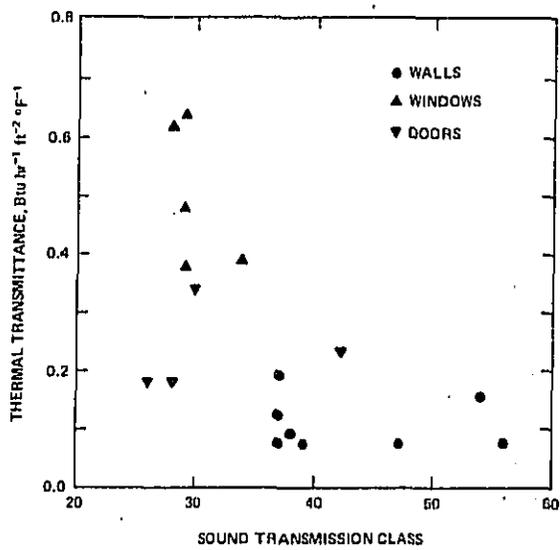
Figure 76. Comparison of Sound Transmission Class and thermal transmittance for basic walls, doors, and windows. The data plotted are listed in Table 6.

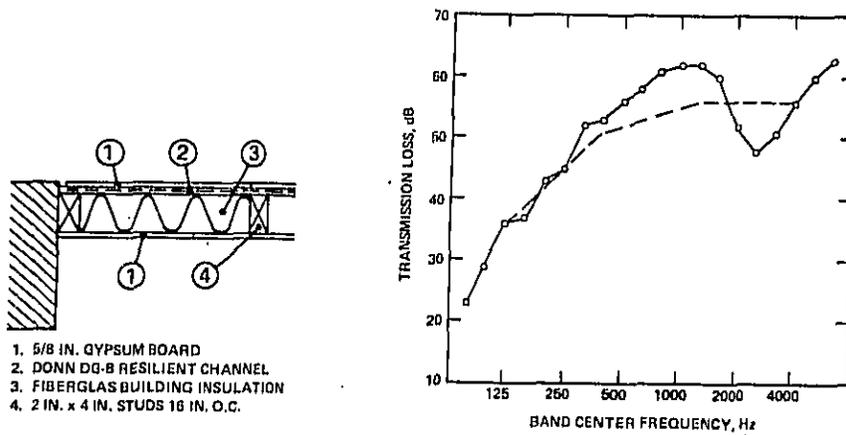
Figure B-2. Sound transmission loss vs frequency data for wood stud drywall with resilient channel and cavity insulation.

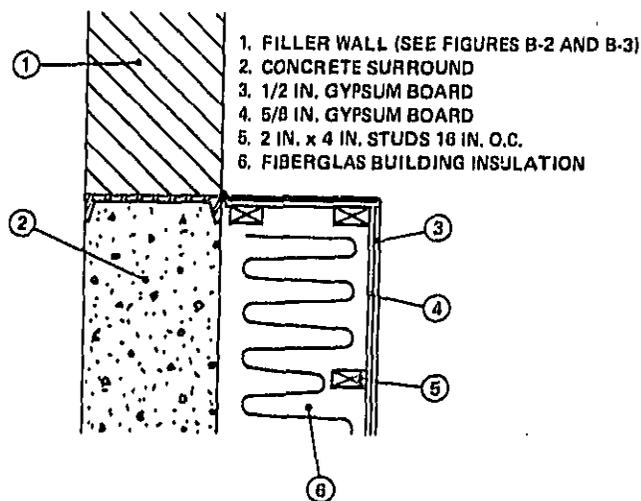
1. FILLER WALL (SEE FIGURES B-2 AND B-3)
2. CONCRETE SURROUND
3. 1/2 IN. GYPSUM BOARD
4. 5/8 IN. GYPSUM BOARD
5. 2 IN. x 4 IN. STUDS 18 IN. O.C.
6. FIBERGLAS BUILDING INSULATION

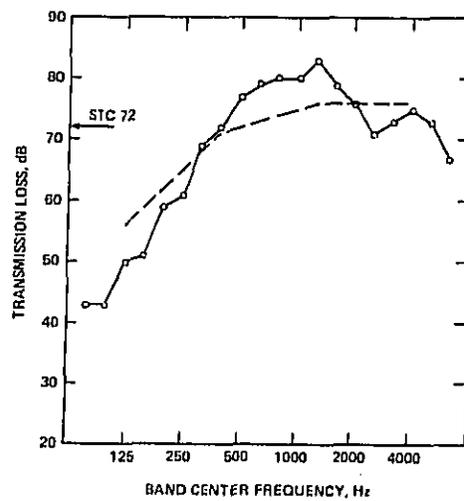
Figure B-6. Apparent sound transmission loss vs frequency data for complete filler wall with auxiliary construction added to concrete surround.
