A Guide to Airborne, Impact, and Structureborne Noise Control in Multifamily Dwellings

U. S. DEPARTMENT OF HOUSING AND URBAN DEVELOPMENT
WASHINGTON, D. C. 20410

Prepared for the
FEDERAL HOUSING ADMINISTRATION

by
National Bureau of Standards
Washington, D.C. 20234

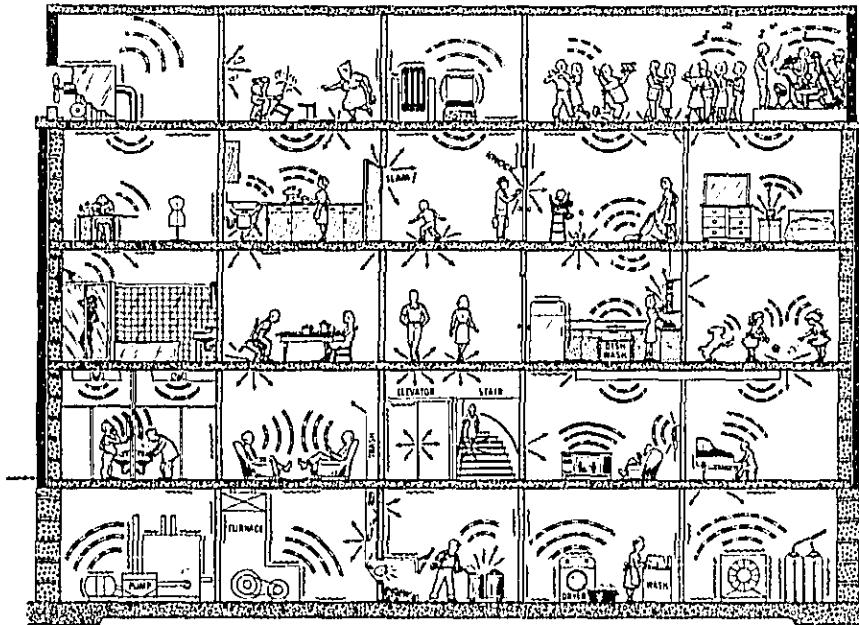
Fig. 1.1. Common Indoor Sources of Noise.

The most prevalent noise complaints among apartment dwellers involve the transmission of noise originating inside the building. Typical noise sources are television, radio or stereo sets, occupant activity, plumbing fixtures, electro-mechanical equipment and household appliances, as illustrated in Figure 1.1.

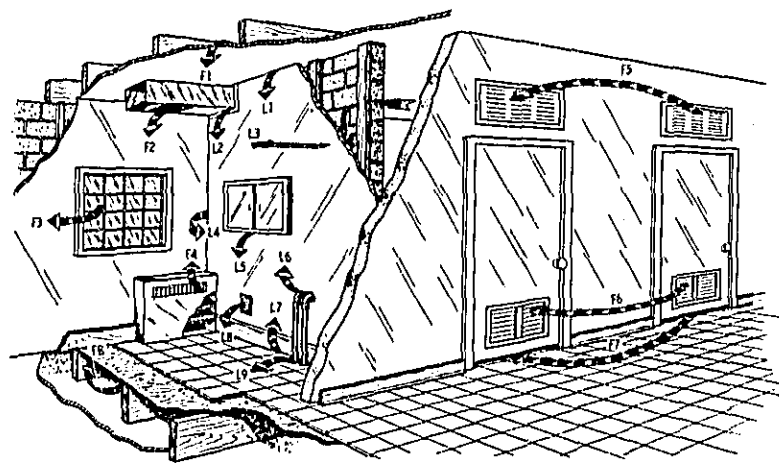
FLANKING NOISE PATHS

NOISE LEAKS

OTHER POINTS TO CONSIDER, RE: LEAKS ARE (A) BATTEN STRIP AND POST CONNECTIONS OF PREFABRICATED WALLS, (B) UNDER FLOOR PIPE OR SERVICE CHASES, (C) RECESSED, SPANNING LIGHT FIXTURES, (D) CEILING & FLOOR COVER PLATES OF MOVABLE WALLS, (E) UNSUPPORTED AND UNBACKED WALL BOARD JOINTS (F) EDGES & BACKING OF BUILT-IN CABINETs & APPLIANCES, (G) PREFABRICATED, HOLLOW METAL, EXTERIOR CURTAIN WALLS.

Obviously, it is not economical to select highly efficient sound insulating partition walls and later inadvertently short circuit their efficiency with noise leaks and flanking paths, as illustrated in Figure 4.1. Such noise problems can be prevented by thoughtful planning in the early stage of the building design and close supervision with proper attention to small details during the construction stage.

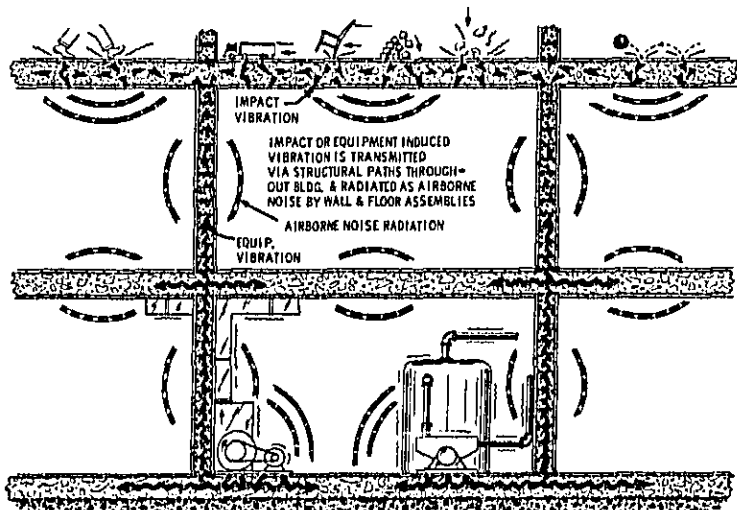
Fig. 4.2. Flanking Transmission of Impact and Structure-Borne Noise.

Flanking transmission paths of structure-borne noises, as illustrated in Figure 4.2, are far more numerous and much more difficult to trace or detect than those of airborne noises. The detection, cause and correction of structure-borne vibration or noise transmission between adjacent rooms are relatively simple. However, determining the reasons for excessively high noise or vibration levels in rooms far removed from noise sources can be difficult and vexing.

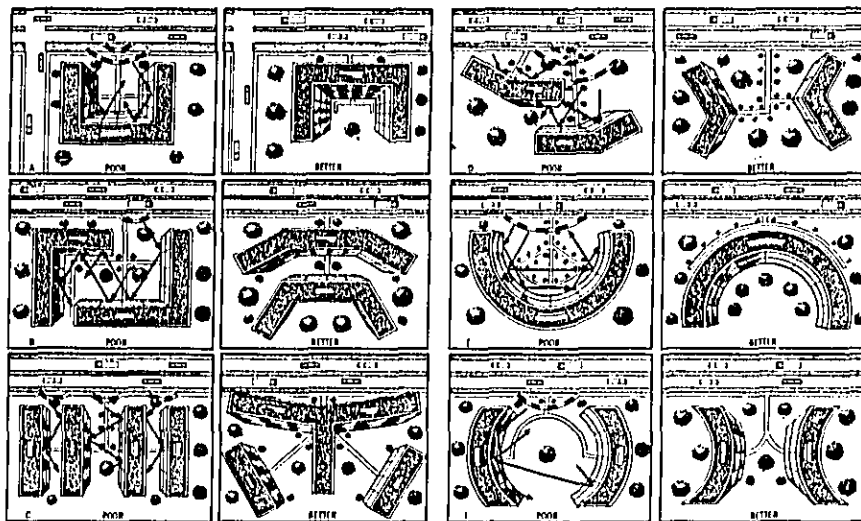
Fig. 5.11. Orientation of Buildings on Sites.

7. In U shaped buildings, the court areas tend to be quite reverberant and noisy, particularly if they are used as recreation areas or face traffic arteries. Therefore, such buildings should be oriented judiciously, as illustrated in Figure 5.11, A and E.

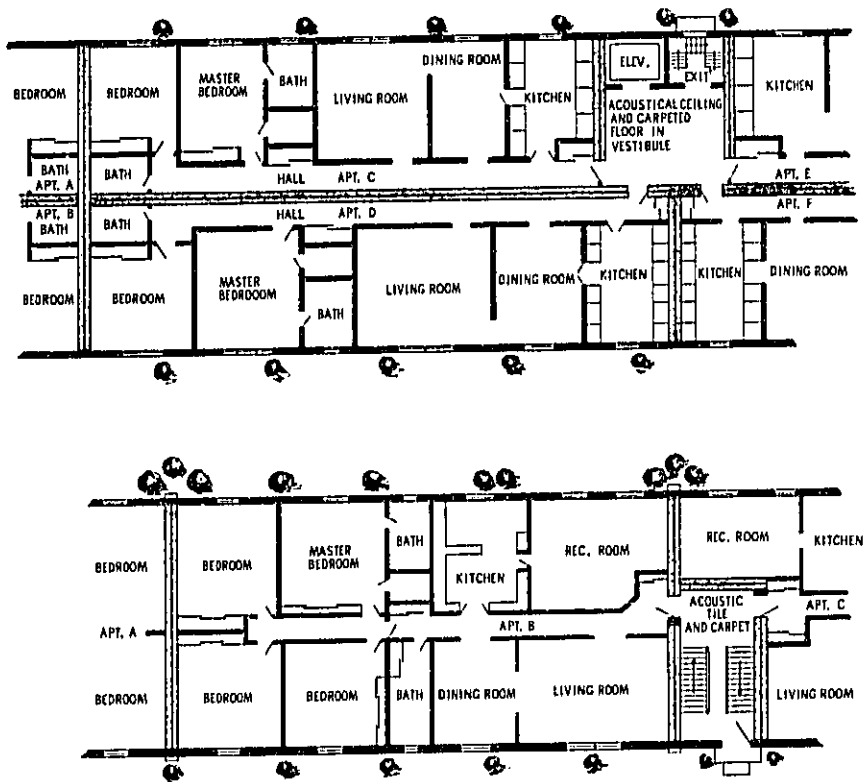
Fig. 5.12. Examples of Well-Planned Buildings in which Quiet Areas are Separated from Noisy Areas.

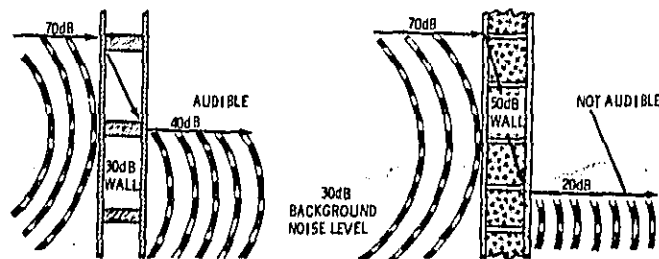
Fig. 6.2. STL of Walls.

reduced in transmission through it. This is illustrated in the first diagram of Figure 6.2, which shows a wall with an STL value of 30 dB reducing an incident noise level of 70 dB to a transmitted level of 40 dB, a 30 dB reduction.

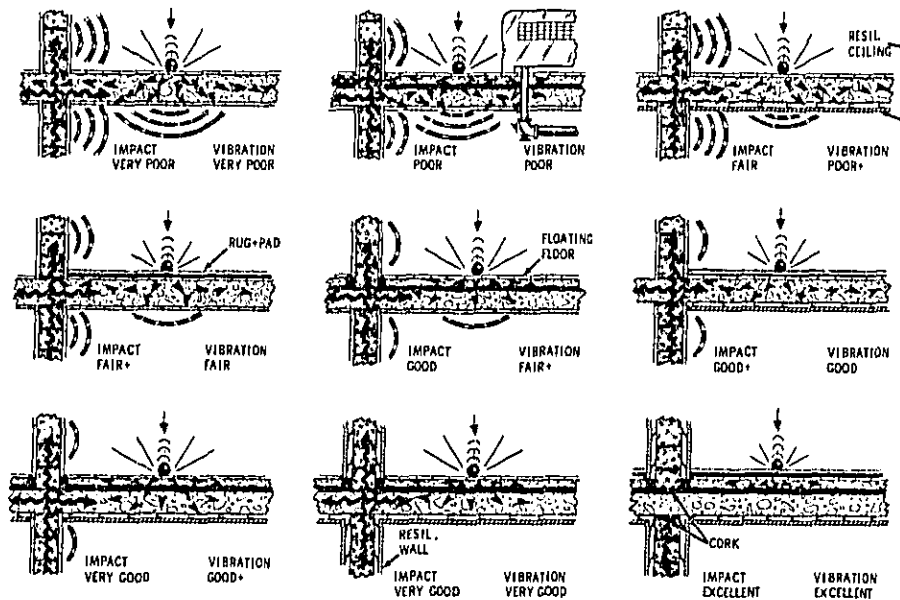
Fig 7.2. Insulation Effectiveness of Various Constructions,
Re: Impact Noise and Equipment Vibration.

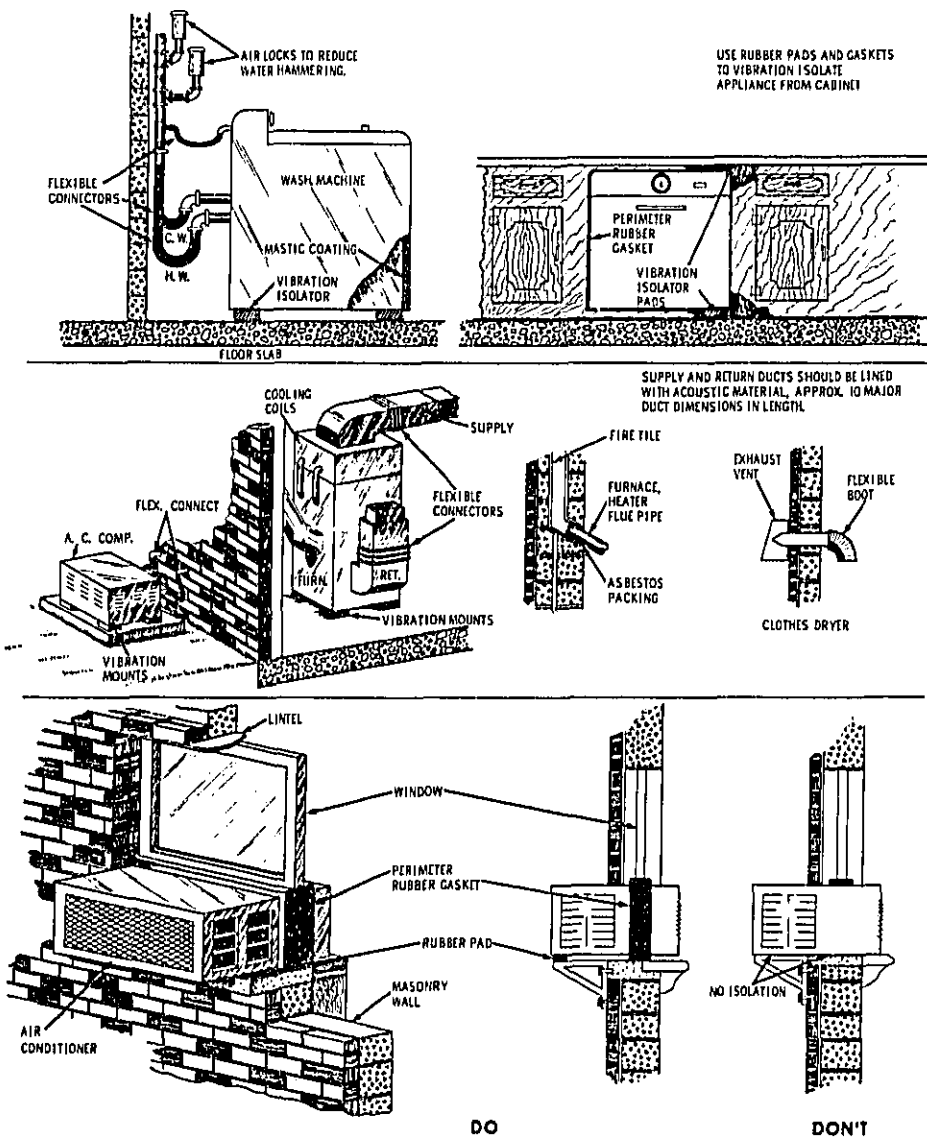
Fig. 8.1. Proper Installation of Appliances.

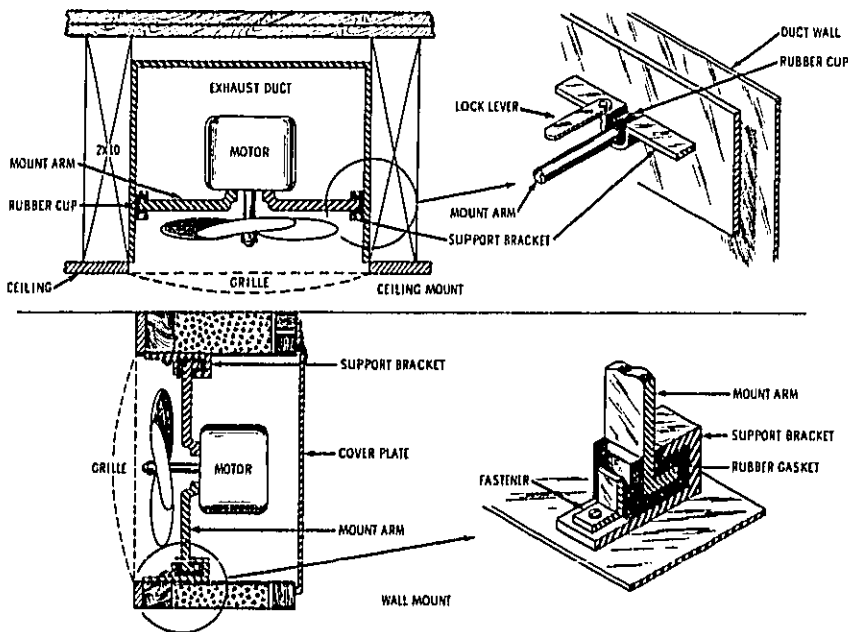
Fig. 8.3. Proper Installation of Exhaust Fan.

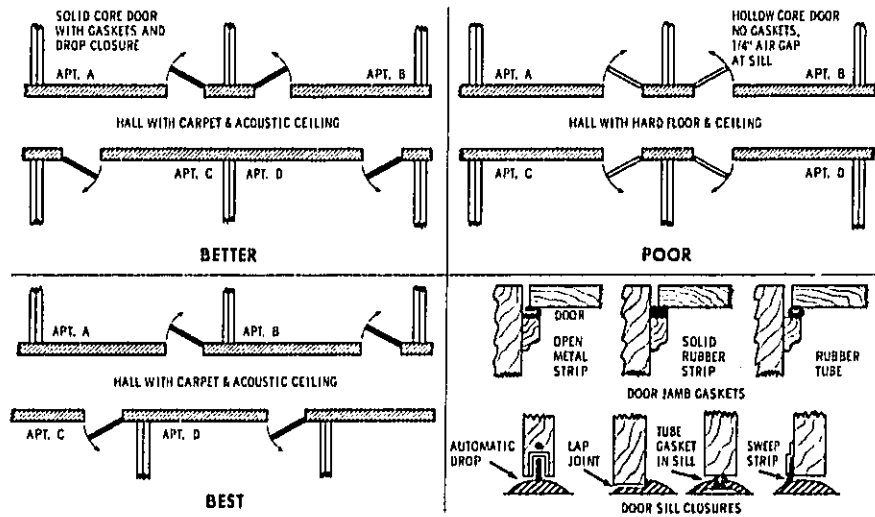
Fig. 8.4. Acceptable Locations and Gasketing of Doors.

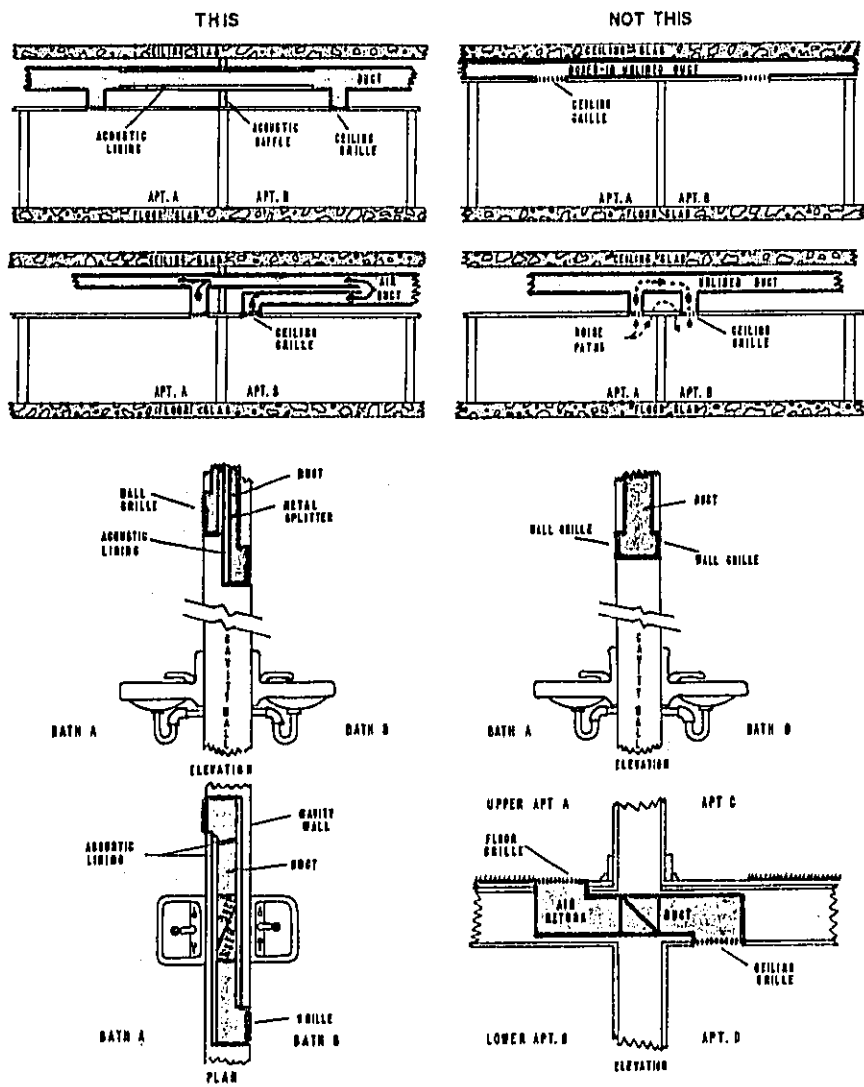
Fig. 8.10. Proper Installation of Ductwork.

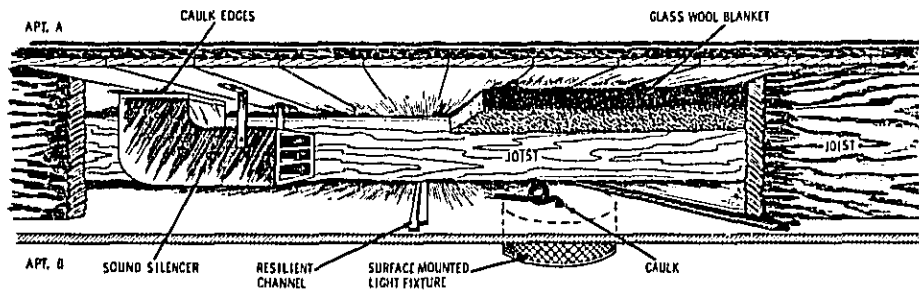
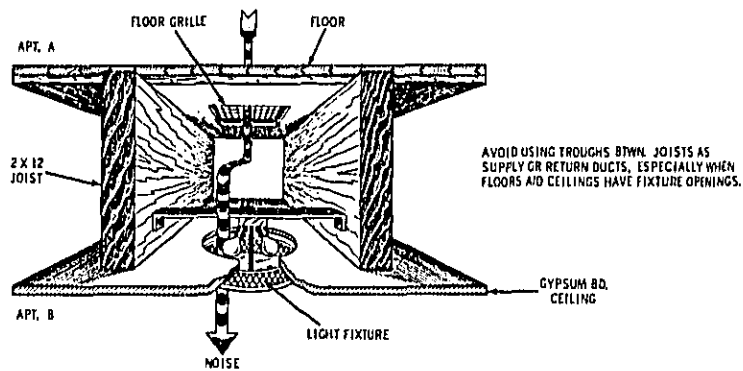
WHEN TROUGHS BTWN. JOISTS ARE USED AS RETURN DUCTS, INSTALL SOUND SILENCERS IN ALL VENT OPENINGS, MINIMIZE AND CAULK OR SEAL PENETRATIONS AND USE SOUND ABSORBING LINING OR BLANKETS.

Fig. 8.11. Installation of Ductwork between Wooden Joists.

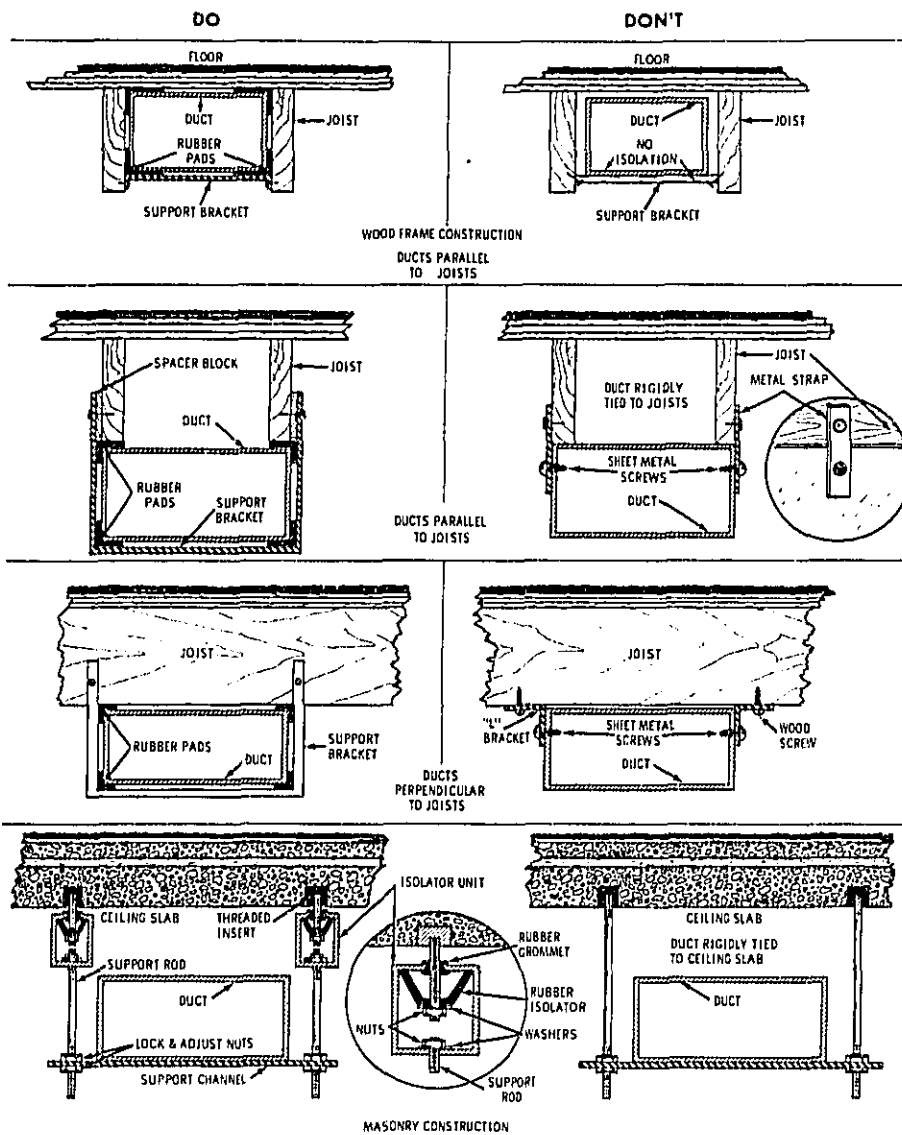
Fig. 8.12. Installation of Duct Hangers and Supports.

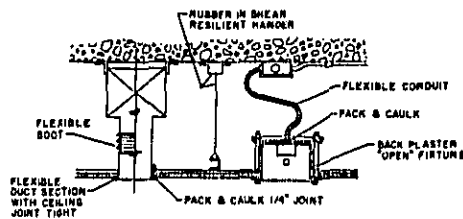
Fig. 8.15. Flexible Connectors.

Use flexible connectors in plumbing, heating and electrical systems which are connected to vibrating equipment such as washers, dryers, compressors, pumps and blowers. Connectors such as flexible boots, conduits and rubber hoses should be installed as near to vibrating equipment as possible. Proper installation of flexible connectors is important to minimize excessive wear.

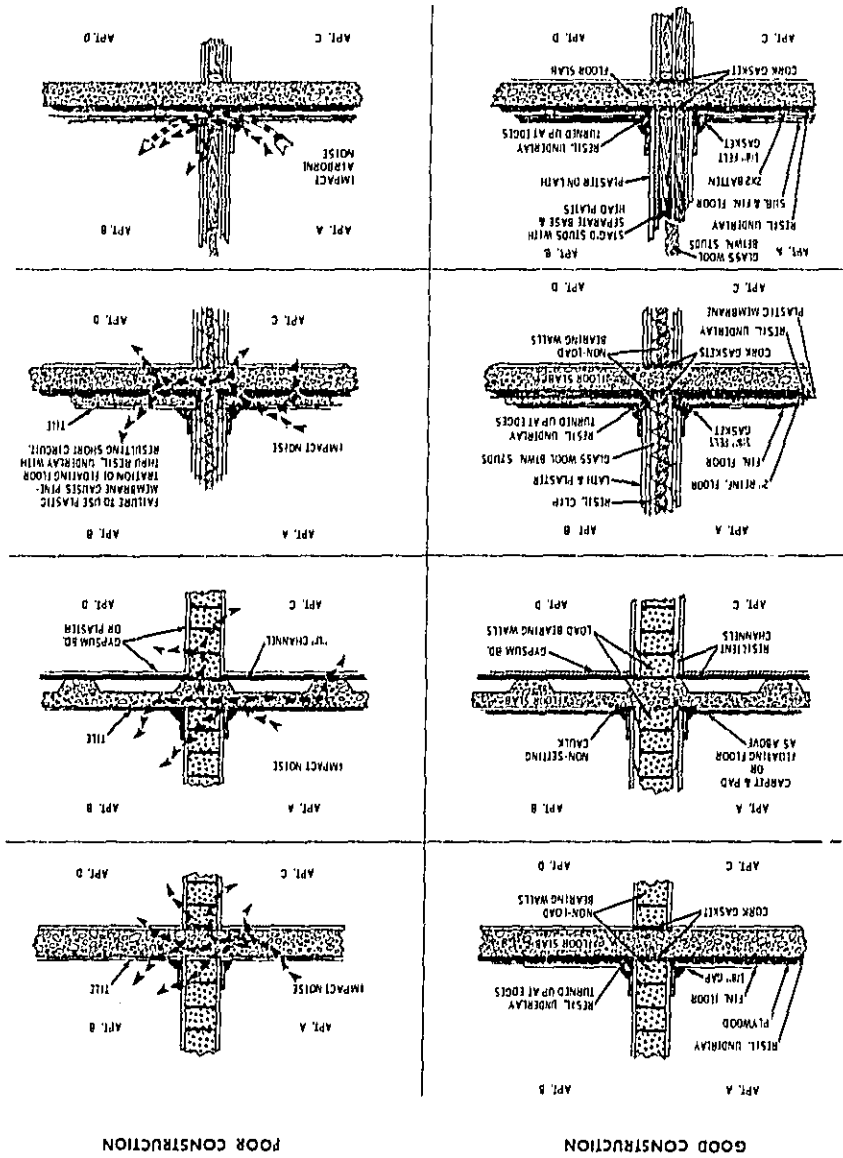
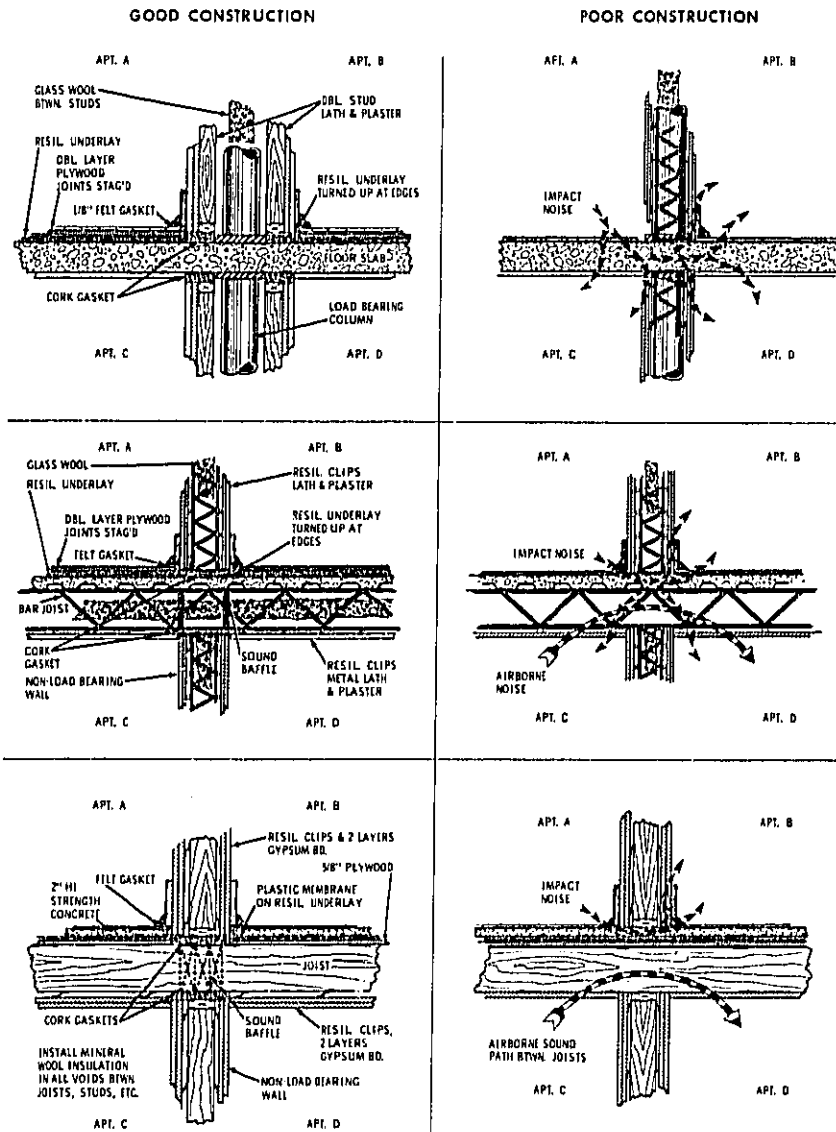
Fig. 8.18. Architectural Detailing of Wall and Floor Junctions.

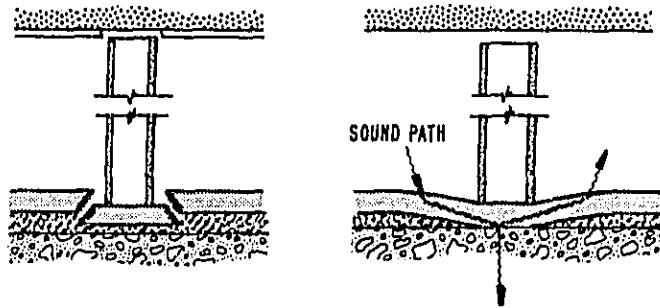
Caution must be exercised when supporting partitions on floating floors to prevent structural failures or short circuiting of the floating element, as illustrated.

For proper installation of floating floors and partition walls see other illustrations of such constructions in this chapter.

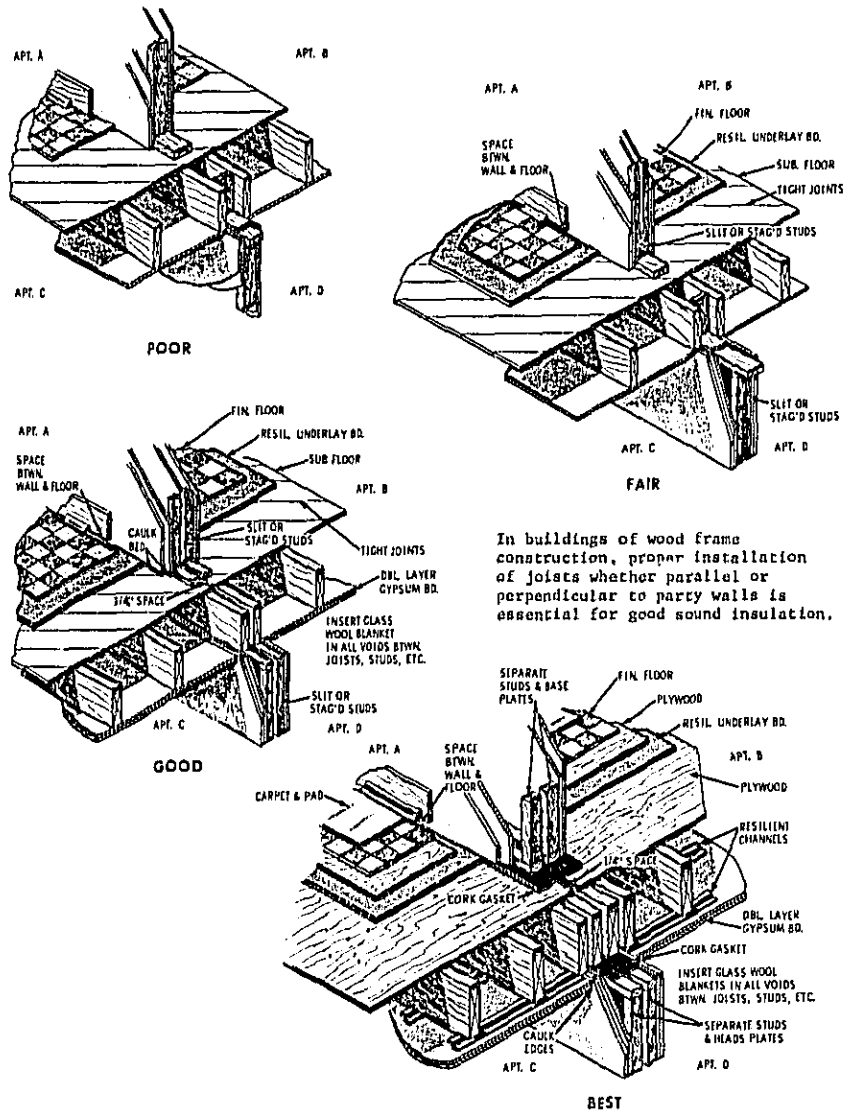
In buildings of wood frame construction, proper installation of joists whether parallel or perpendicular to party walls is essential for good sound insulation.

Fig. 8.29. Architectural Detailing of Wall-Floor Junctions: Walls Parallel to Floor Joists.

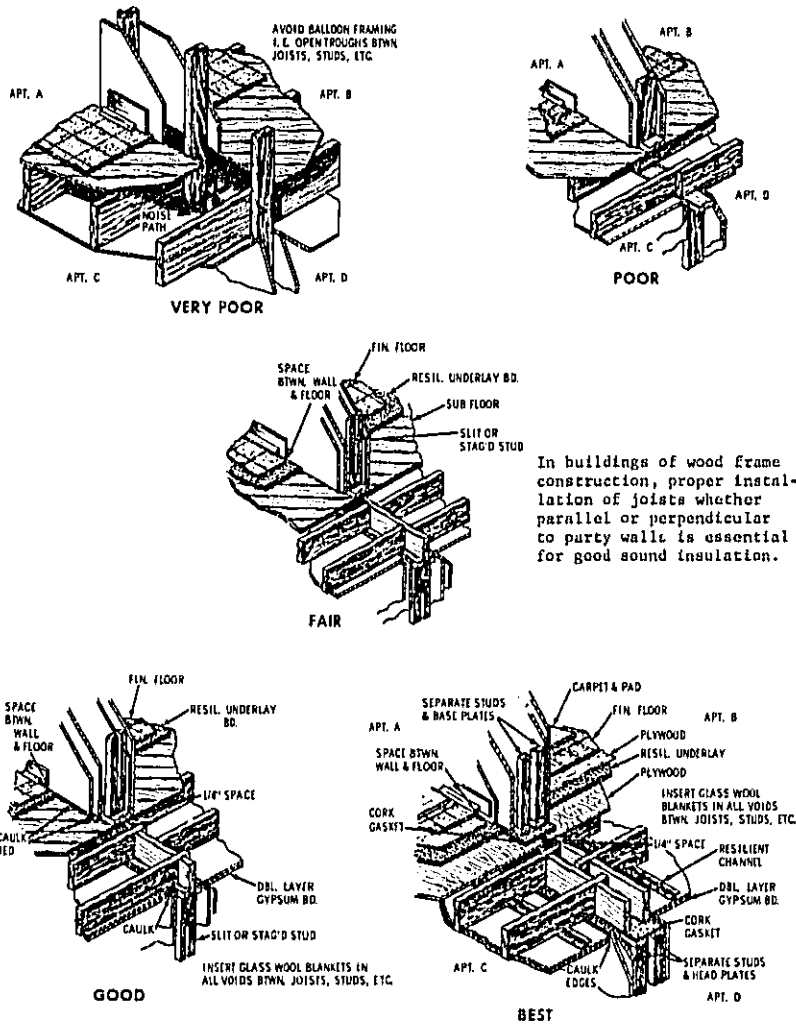
Fig. 8.30. Architectural Detailing of Wall-Floor Junctions: Walls Perpendicular to Floor Joists.

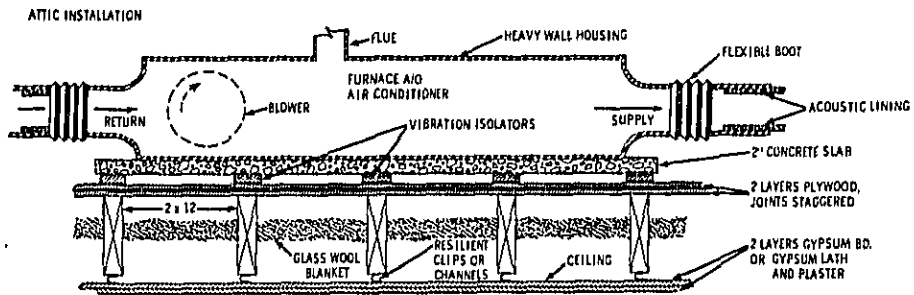
Fig. 8.32. Attic Installation of Furnace and/or Air Conditioner.

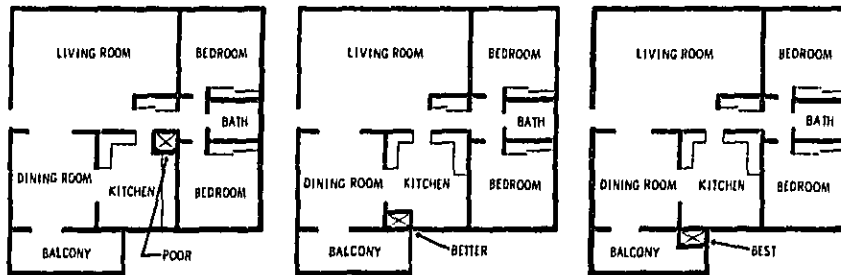
Fig. 8.33. Location of Furnace-Air Conditioner Unit.

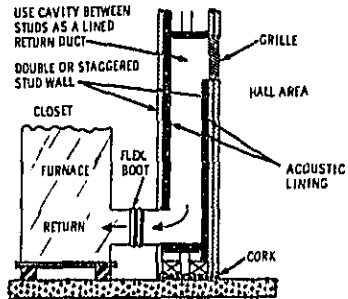
Fig. 8.34. Design of Return Duct of Closet-Installed Furnace.

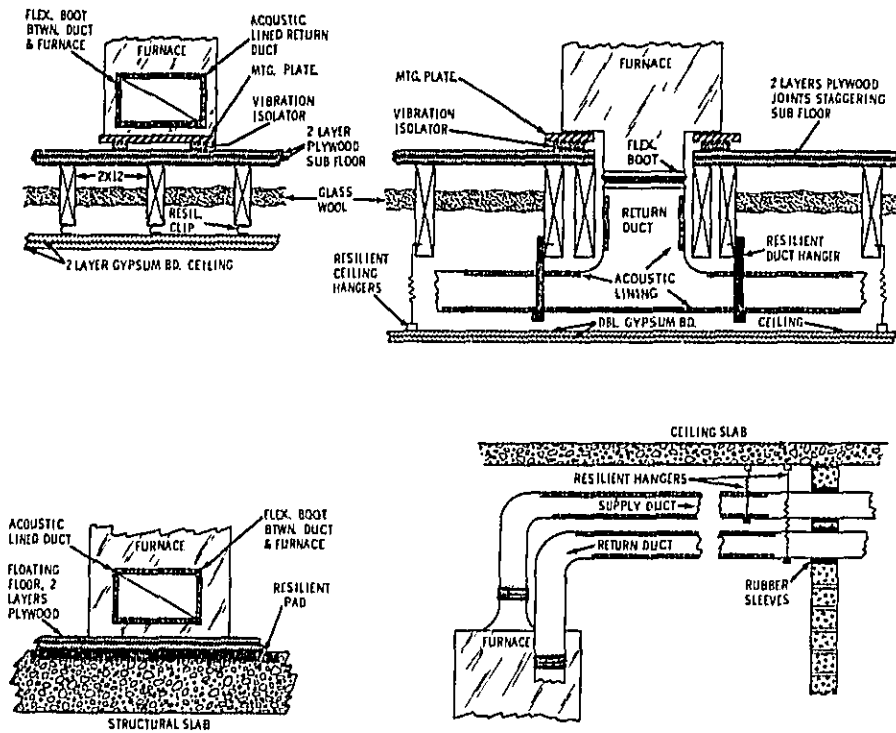
Fig. 8.36. Proper Installation of Furnace Ductwork.

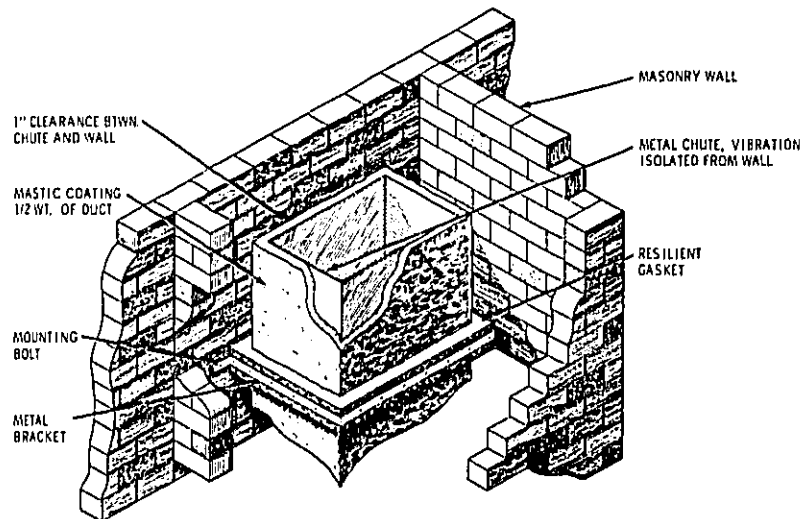
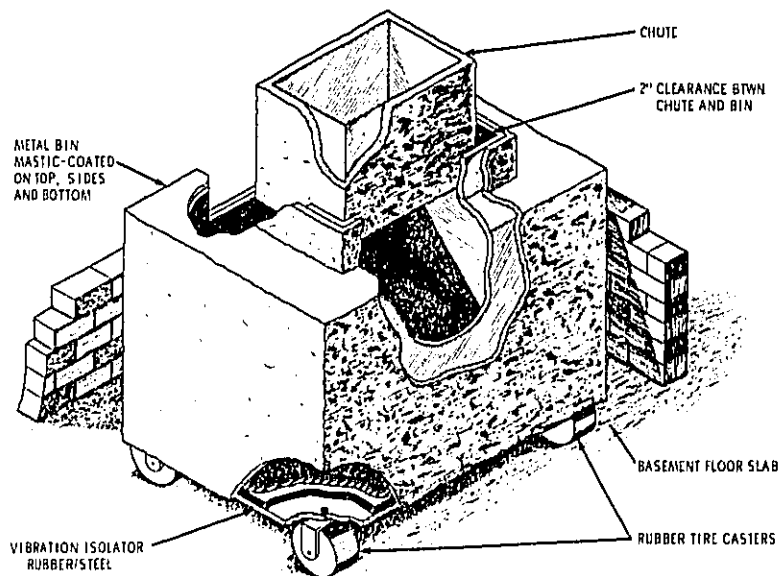
Fig. 8.39. Proper Installation of Incinerator Chutes and Bins.

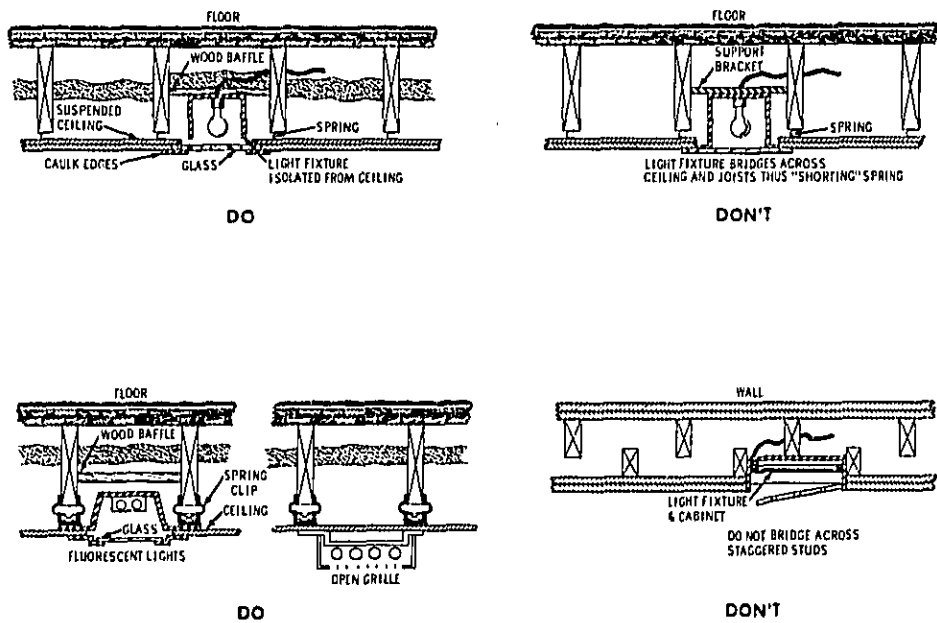
Fig. 8.43. Installation of Lighting Fixtures

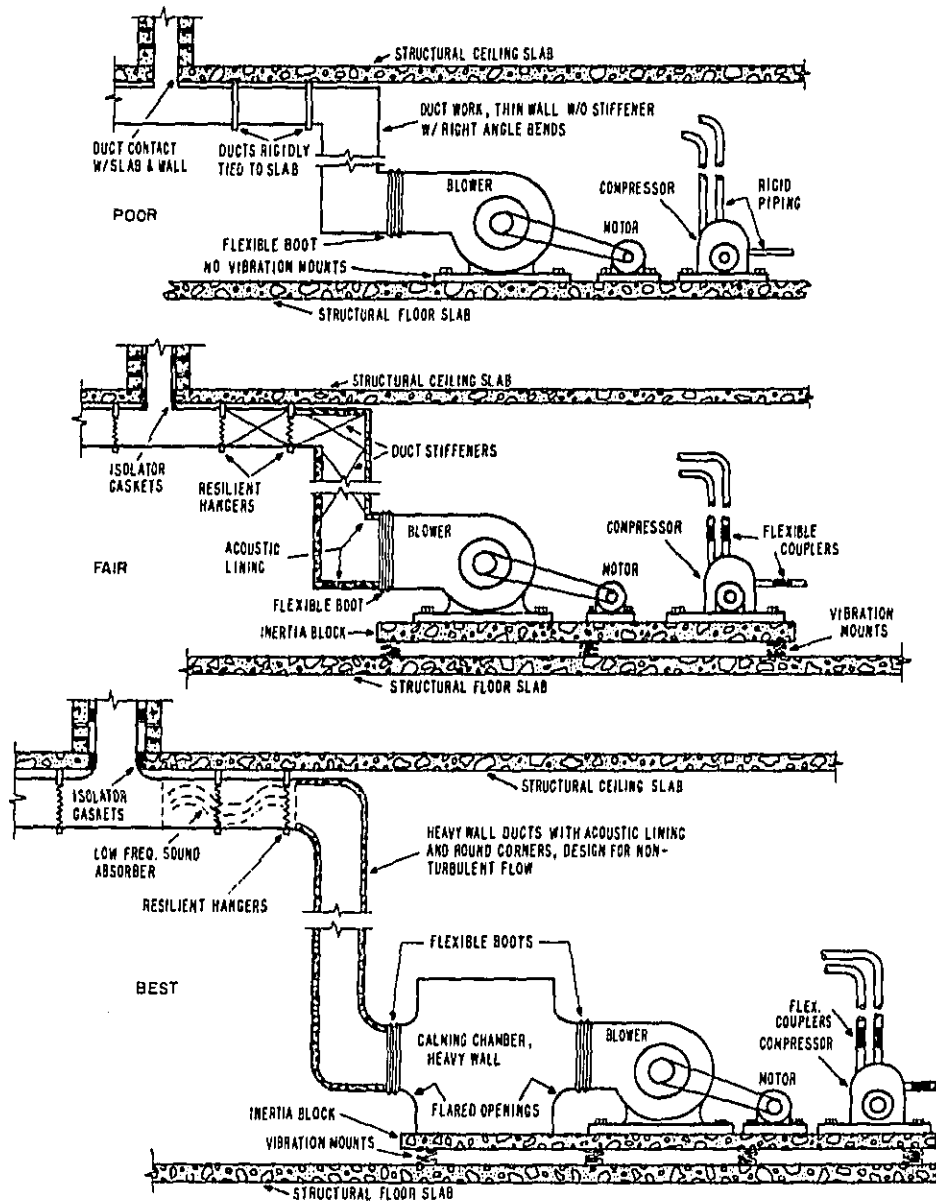
Fig. 8.45. Installation of Air-Distribution Equipment.

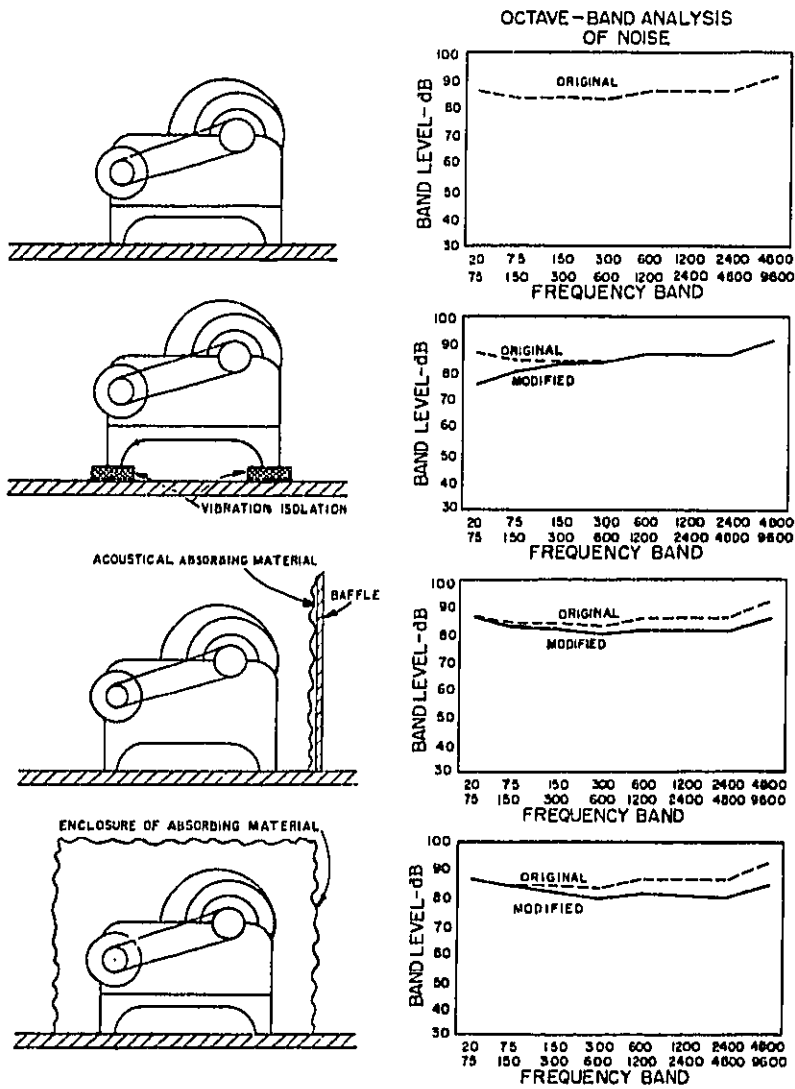
Courtesy of General Radio Company
 Fig. 8.46. Effectiveness of Various Sound Insulating Techniques,
 Re: Nolsy Mechanical Equipment.

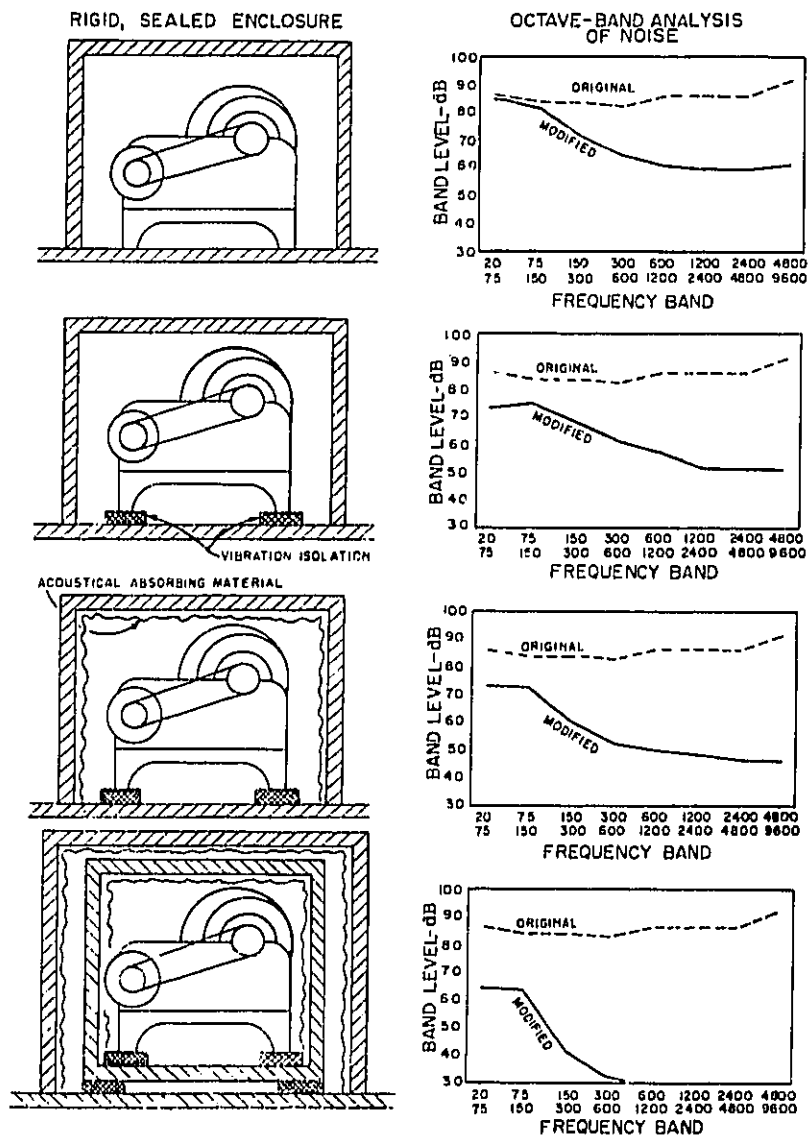
Courtesy of General Radio Company
 Fig. 8.47. Effectiveness of Various Sound Insulating Techniques,
 Re: Noisy Mechanical Equipment.

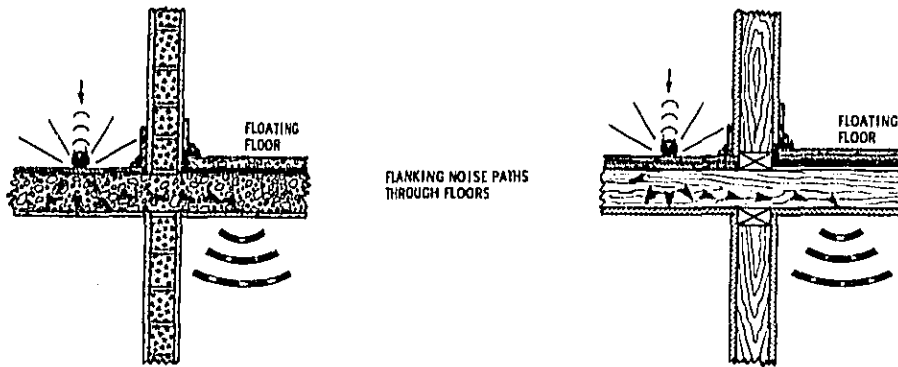
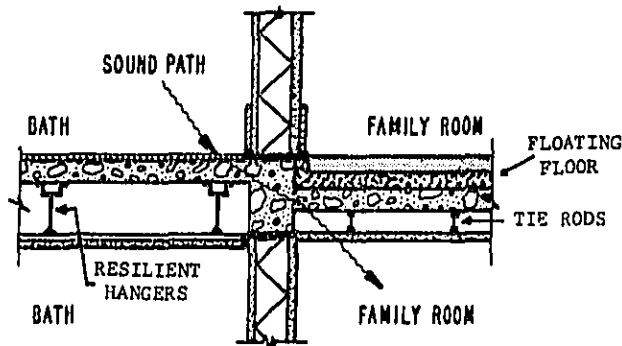
Fig. 8.48. Acoustical Failures Due to Mixed Constructions.

**DO NOT MIX CONSTRUCTION TYPES UNLESS PROVISIONS
HAVE BEEN MADE TO PREVENT "FLANKING".
THESE PROVISIONS INCLUDE EXPANSION JOINTS OR
BREAKS IN ALL STRUCTURAL PATHS BETWEEN EACH SPACE.**

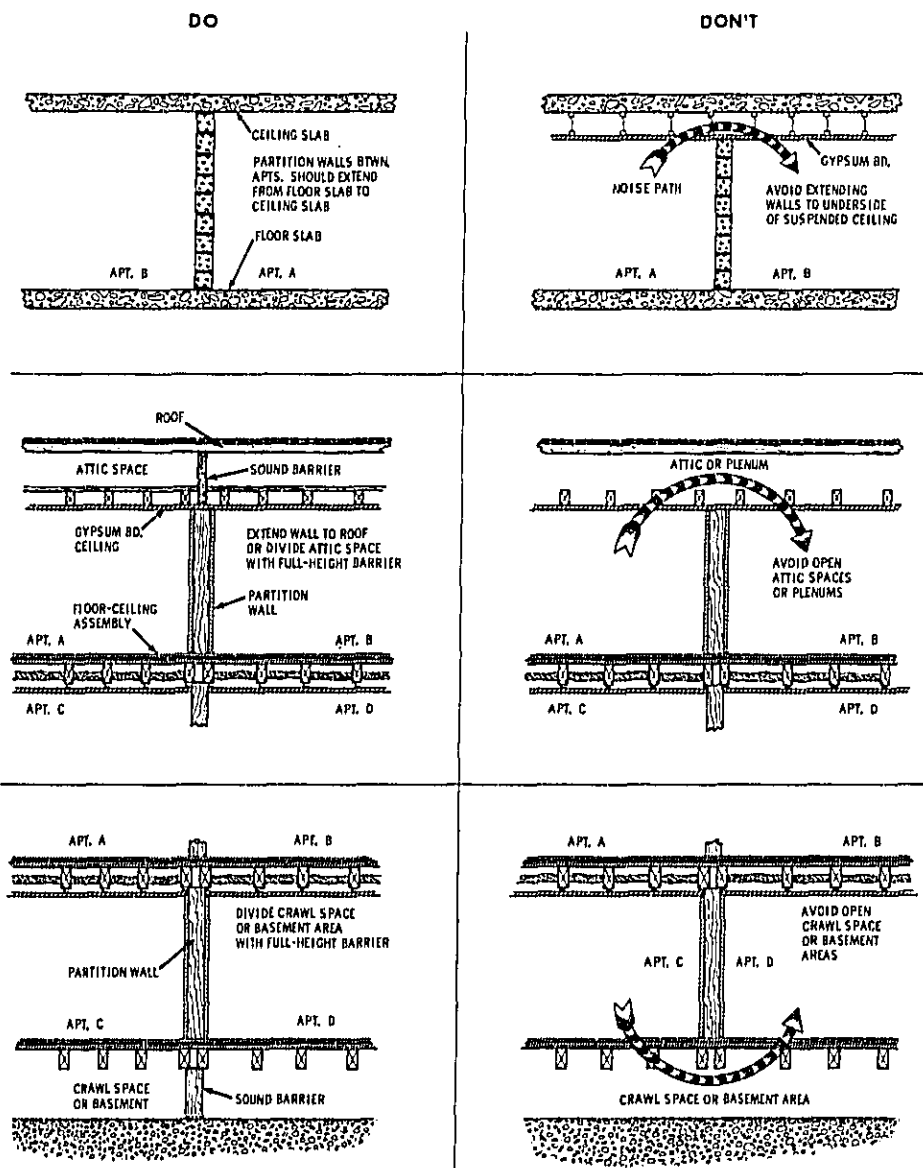
Fig. 8.50. Insulation against Airborne Noise in Plenum Spaces.

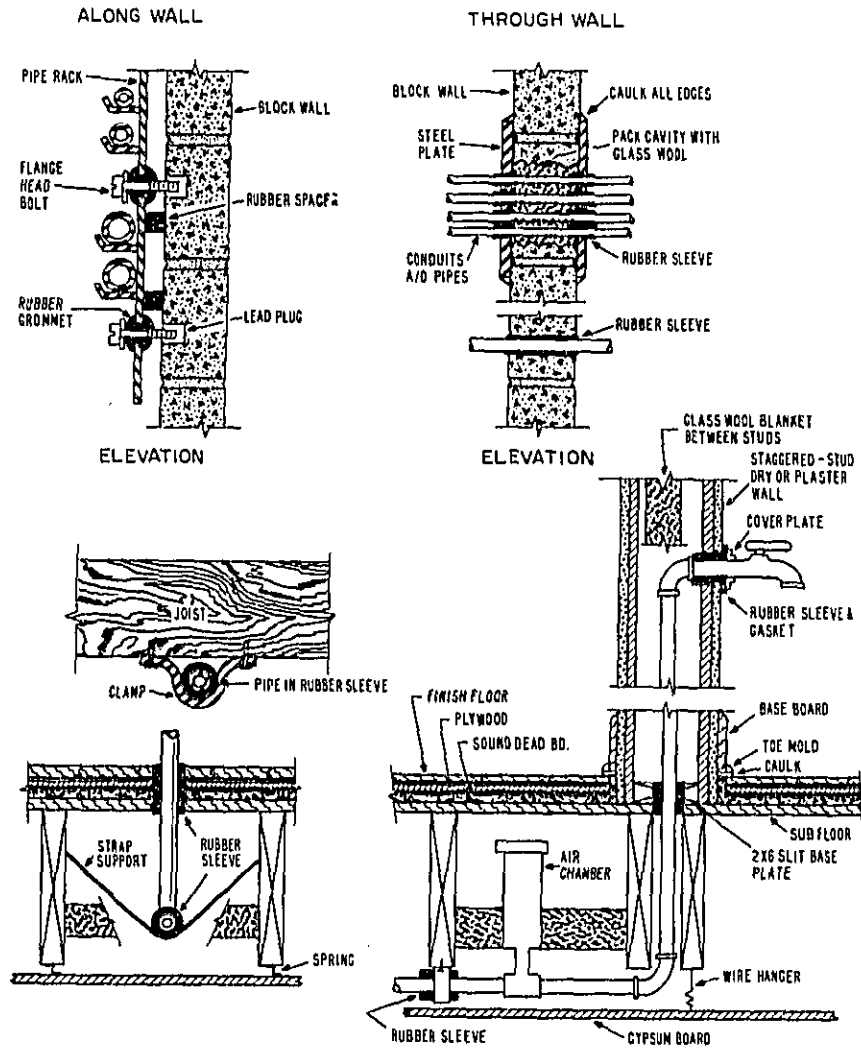
Fig. 8.51. Proper Installation of Pipe Runs.

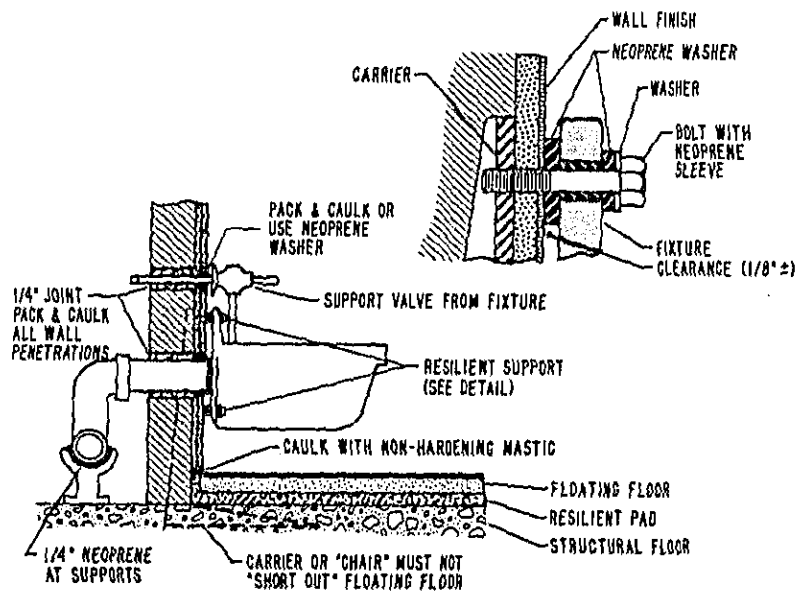
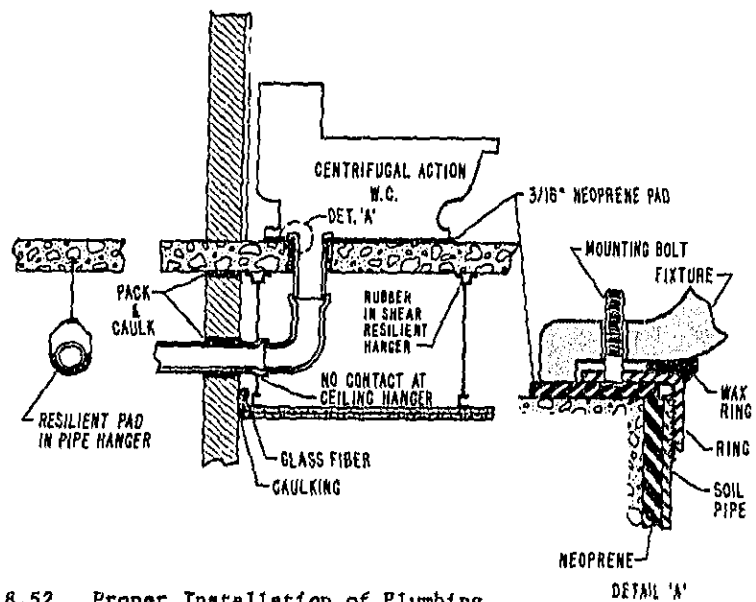
Fig. 8.52. Proper Installation of Plumbing Fixtures.

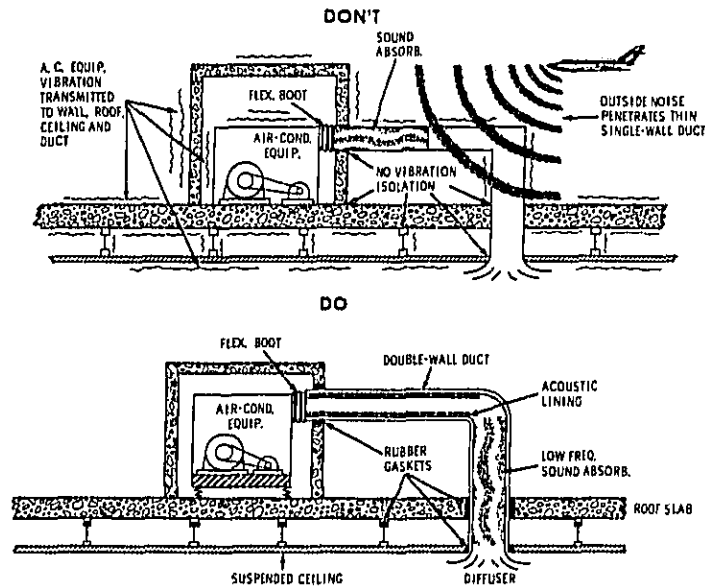
Fig. 8.63. Installation of Roof Mounted Air-Conditioning Equipment.
