A Guide to Airborne, Impact, and Structureborne Noise Control in Multifamily Dwellings

U. S. DEPARTMENT OF HOUSING AND URBAN DEVELOPMENT
WASHINGTON, D. C. 20410

Prepared for the
FEDERAL HOUSING ADMINISTRATION

by
National Bureau of Standards
Washington, D.C. 20234

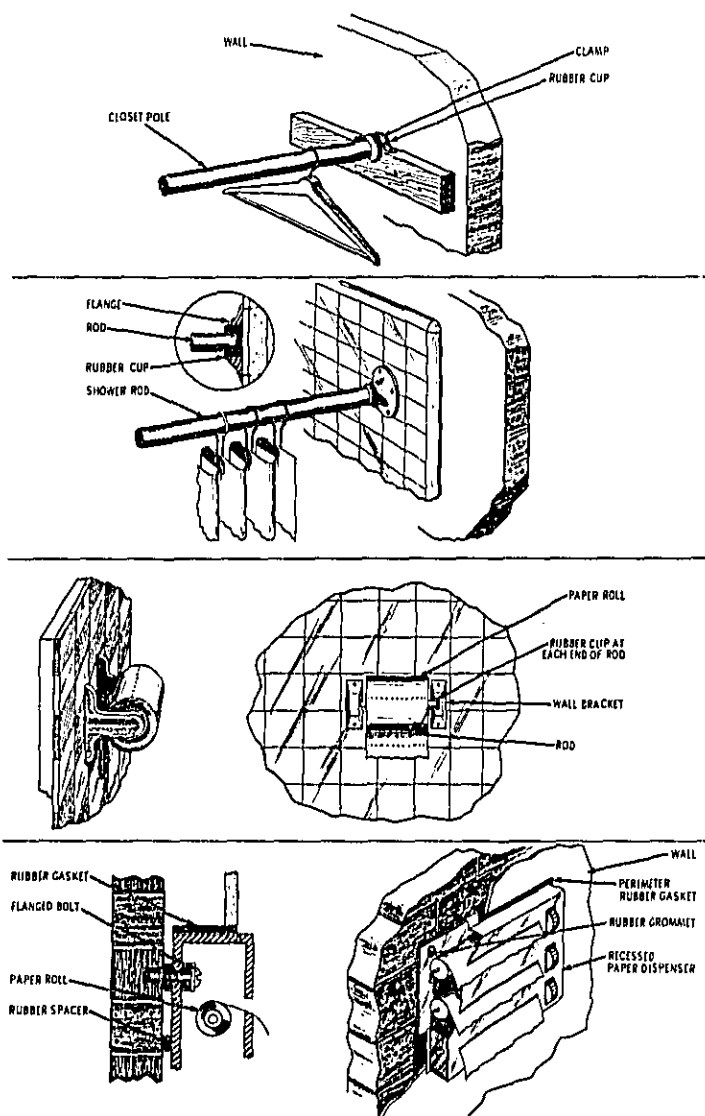
Fig. 8.64. Proper Installation of Rods and Rollers.

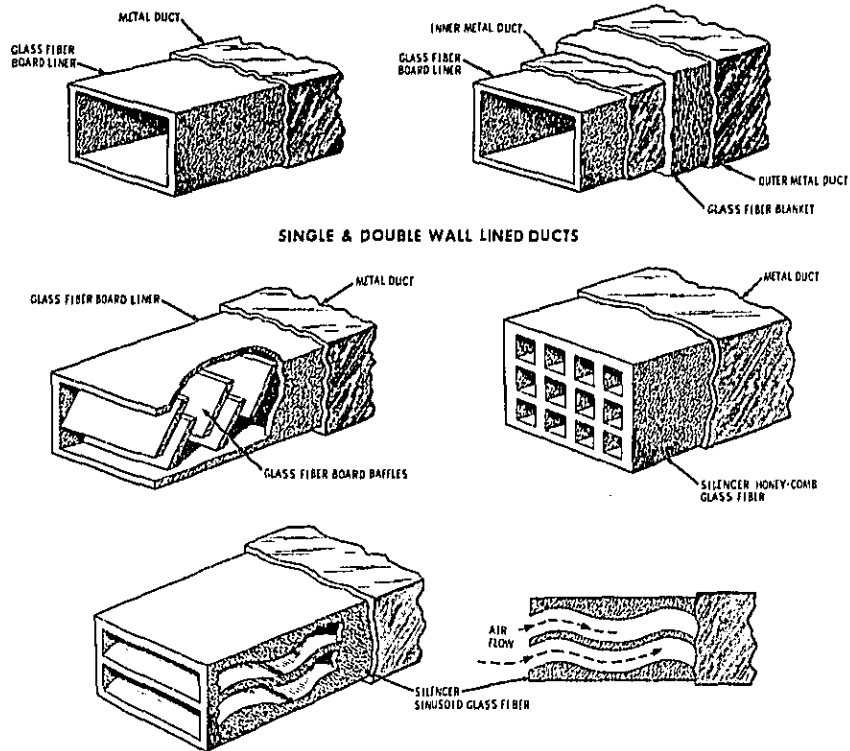
Fig. 8.66. Duct Silencers and Baffles.

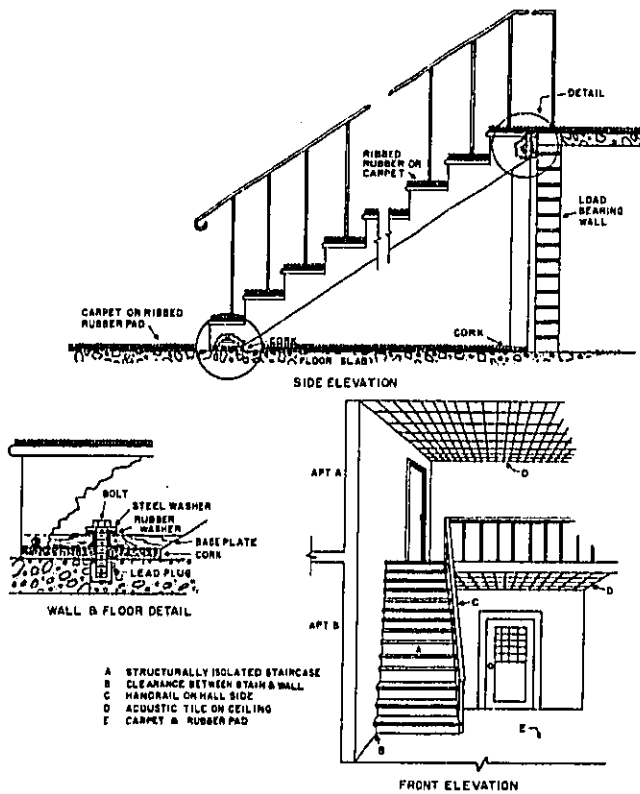
Fig. 8.67. Proper Installation of Staircases.

- a. isolating the staircase from the building structure,
- b. using double or staggered stud wall construction or walls with resilient elements along side of staircase.
- c. avoiding the nailing of stair stringers to adjacent wall studs,
- d. requiring that staircase walls be completely surfaced before staircase is installed, and
- e. installing rubber pads or carpets on stair treads.

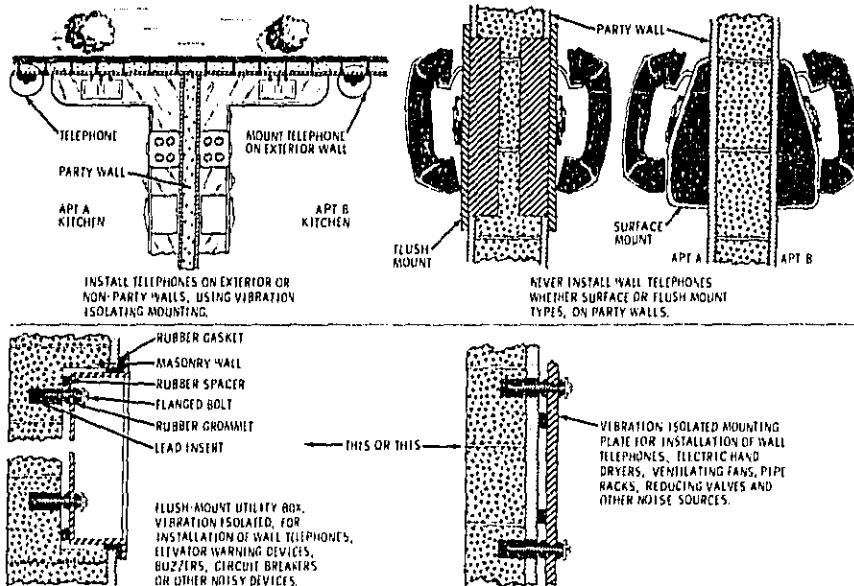
Fig. 8.69. Installation of Wall Mounted Telephones.

Avoid mounting of telephones on party walls, particularly of light frame construction. Because of the poor sound insulation afforded by such structures, the occupants in adjacent apartments seldom know which of the telephones is actually ringing.

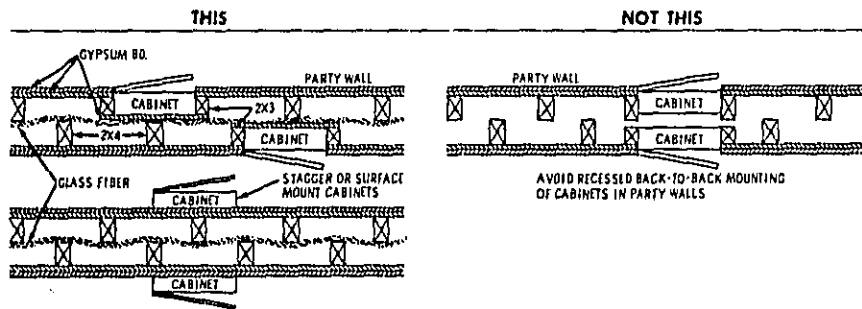
Fig. 8.71. Wall Installation of Cabinets.

- f. Avoid "short circuiting" the effectiveness of a high performance wall by back-to-back installation of electrical outlets and recessed cabinets.
- g. All holes and cracks in and around the wall should be properly sealed to ensure an airtight installation.

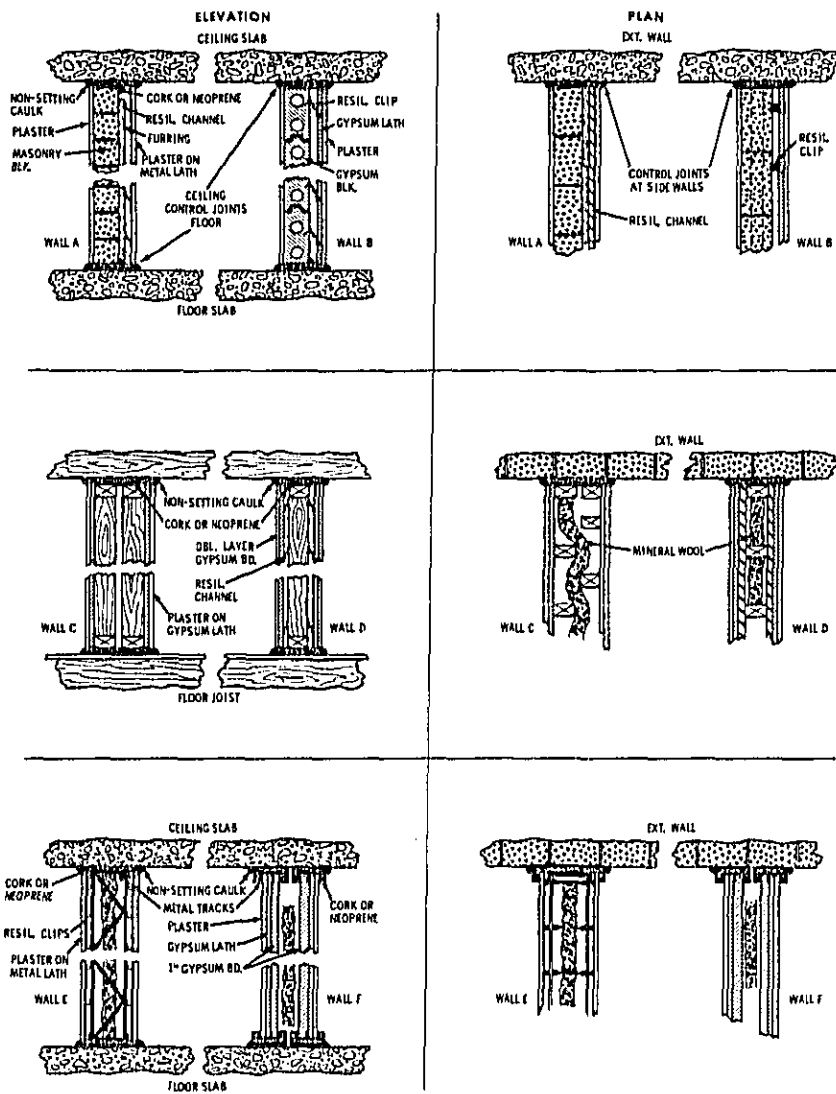
Fig. 8.72. Bonding of Partition Walls to Ceilings, Floors and Exterior Walls.

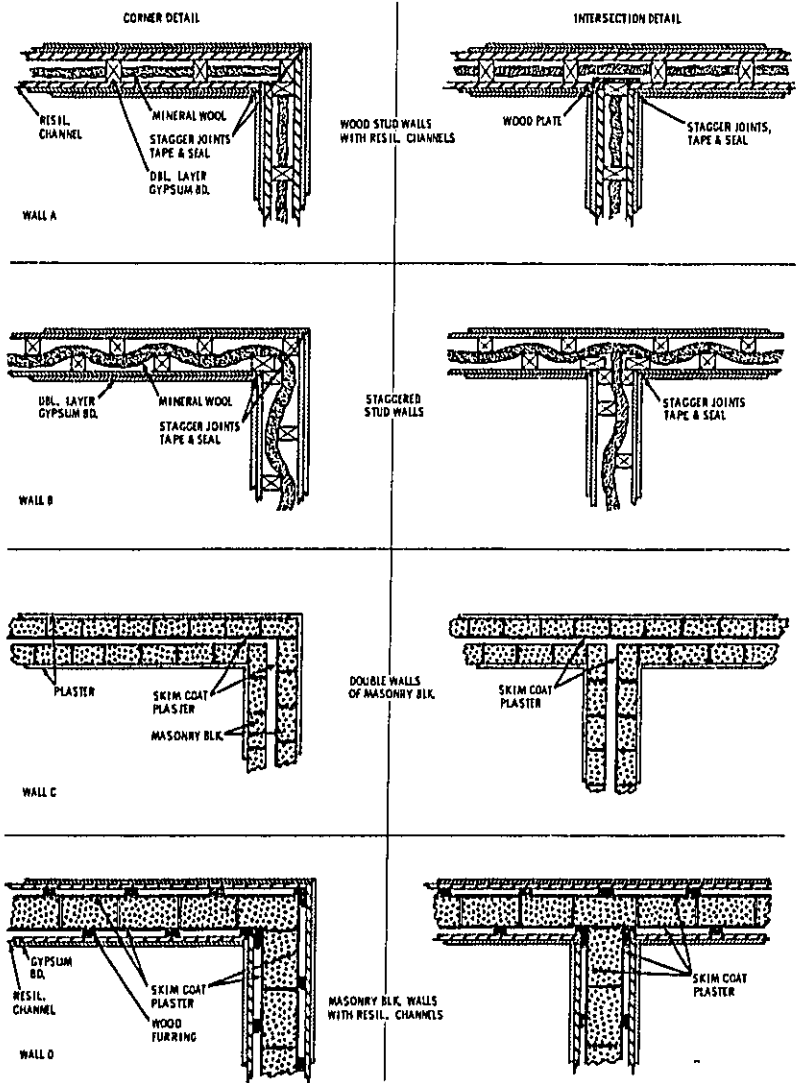
Fig. 8.73. Framing of Sound Insulating Walls at Corners and Intersections.

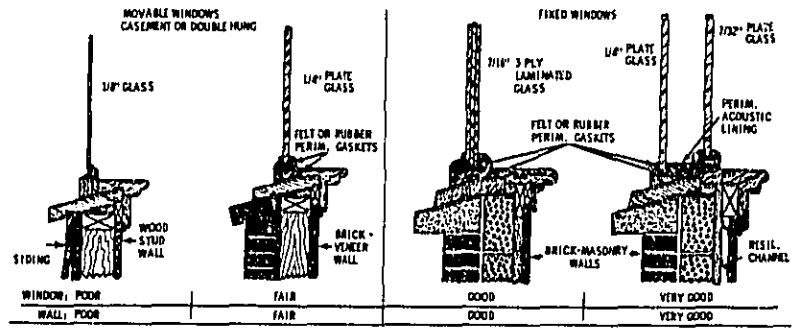
Fig. 8.74. Sound Insulation Effectiveness of Window-Wall Assemblies.

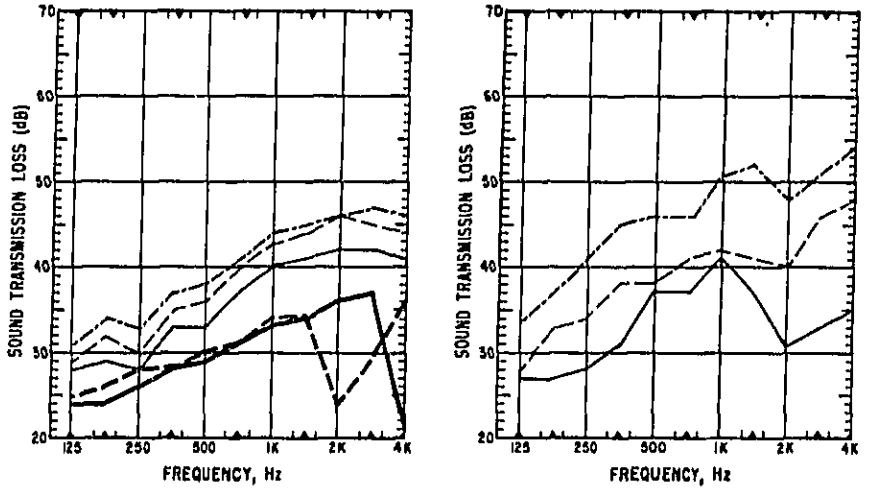
- 1/8-in. plate glass
 - - - 1/4-in. plate glass
 - 0.45-in., 3 ply, laminated glass panel
 - - - 0.62-in., 4 ply, laminated glass panel
 - - - 0.80-in., 5 ply, laminated glass panel
- Aluminum framed windows with glass panes isolated with neoprene gaskets;
- two 1/4-in. glass panes, 1/2-in. air space.
 - - - 1/4-in. and 3/16-in. glass panes, 2 1/2-in. air space.
 - - - 1/4-in. and 7/32-in. glass panes, 3 3/4-in. air space.

Fig. 8.75. Sound Transmission Loss of Windows.

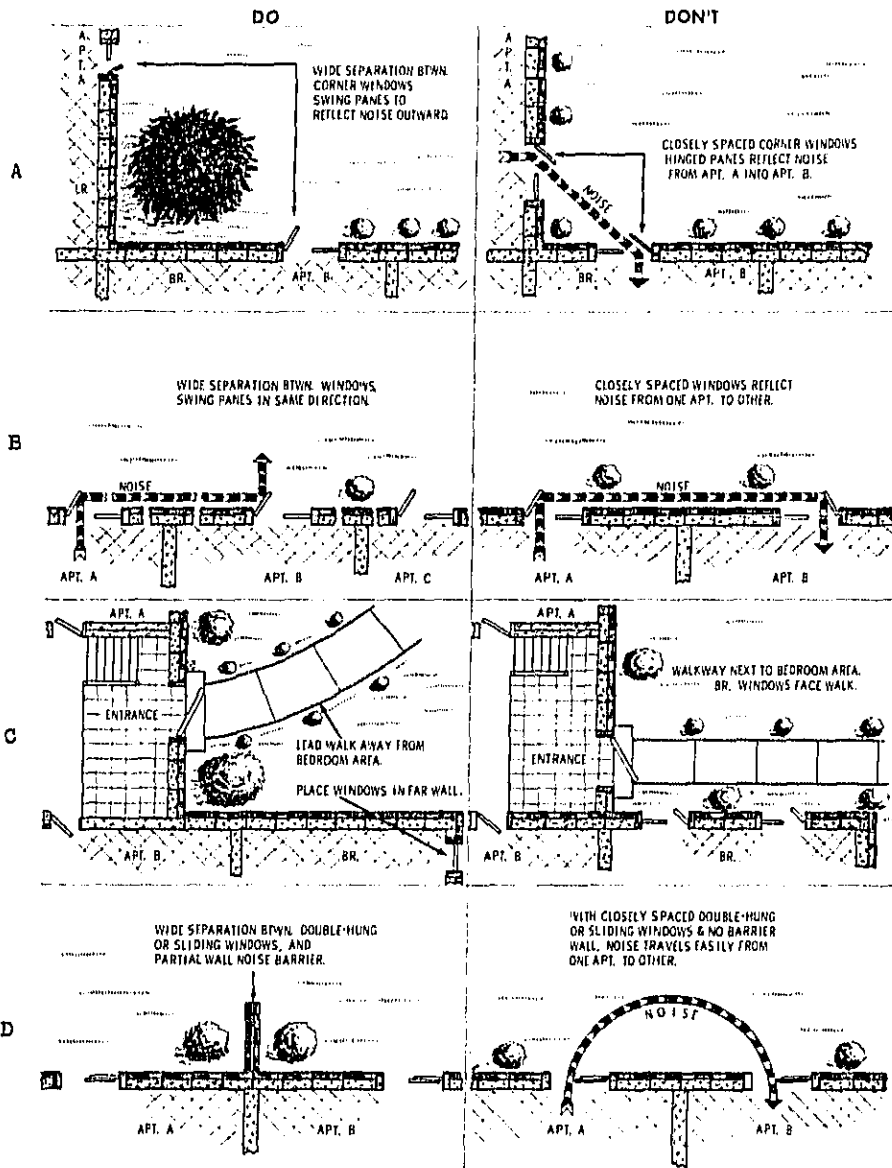
Fig. 8.76. Window Arrangement.

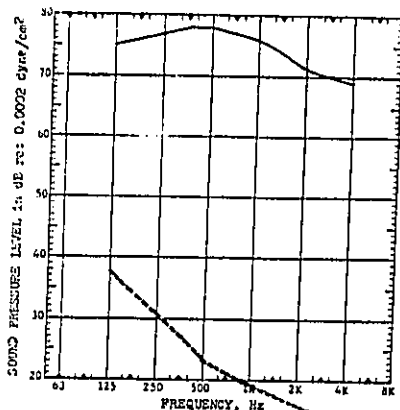
Fig. 9.1

- (1) — Anticipated peak noise levels.
- (2) — Assumed acceptable levels.
(NC-20 adjusted to 1/2-octave band levels)

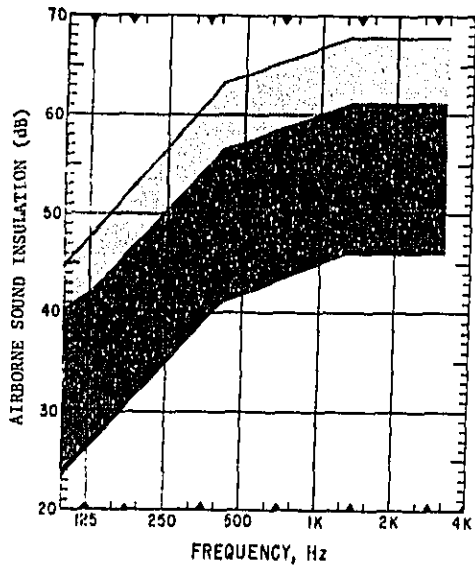
Fig. 9.22. AIRBORNE

Range of minimum airborne sound insulation requirements or recommendations.
Suggested range of values for particular cases where better airborne sound insulation is required.

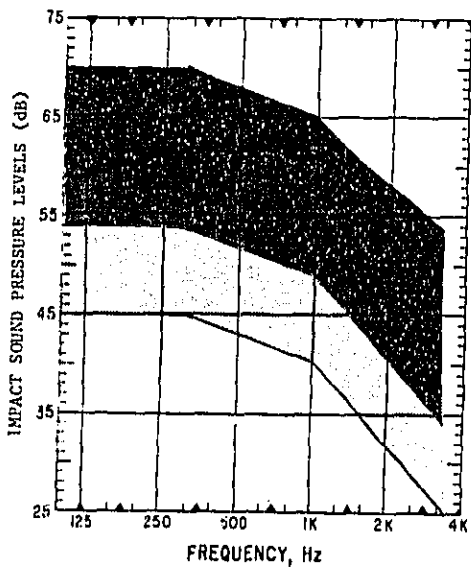
Fig. 9.23. IMPACT

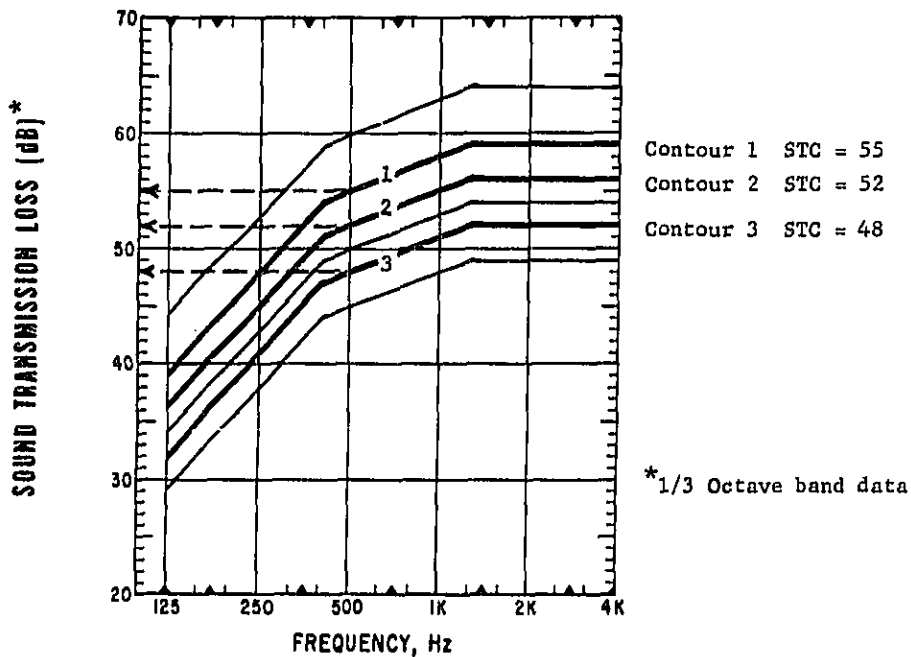
Fig. 10.1. Sound Transmission Class Contours.

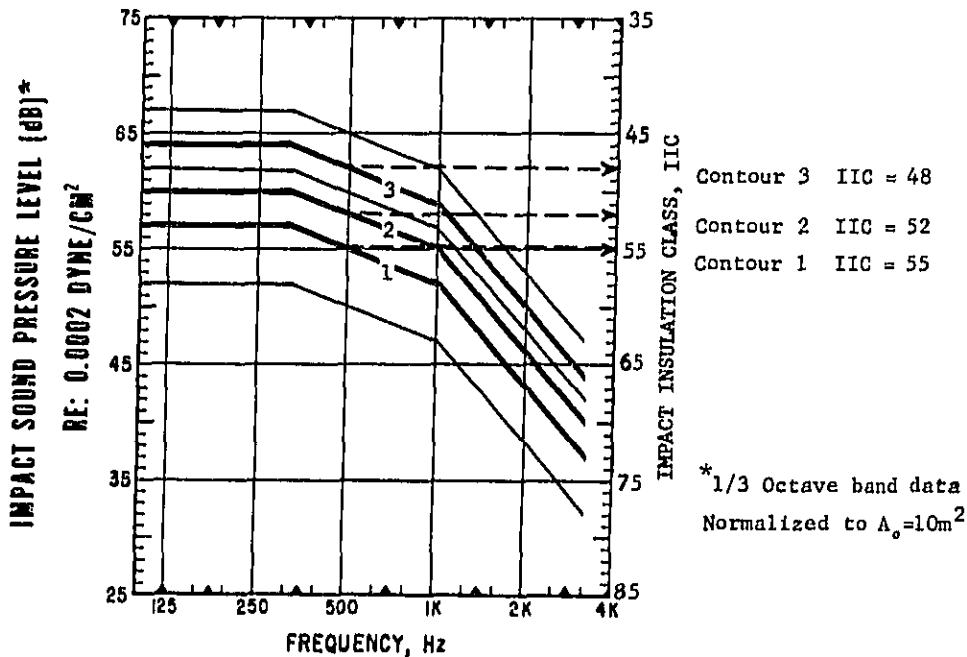
Fig. 10.3. Impact Insulation Class Contours.

On the average, the IIC rating is about 51 points higher (algebraic addition), than the INR rating used in FHA No. 750. However, it would be dangerous to apply an "across the board" adjustment to all INR ratings, for the spread between the two rating systems might be about ± 2 points.

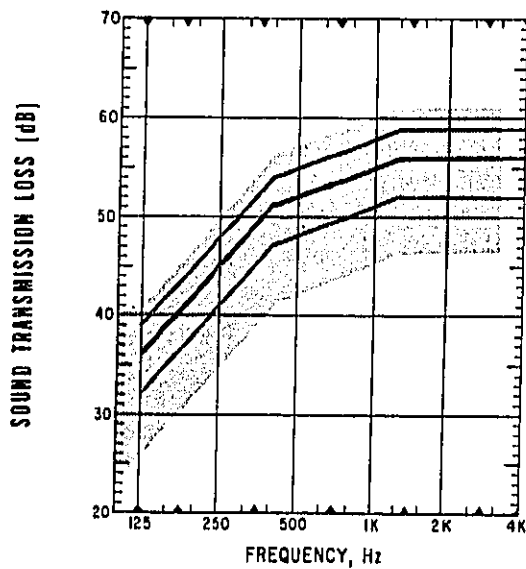
Fig. 10.5. AIRBORNE

Approximate range of airborne sound insulation requirements or recommendations of other countries.

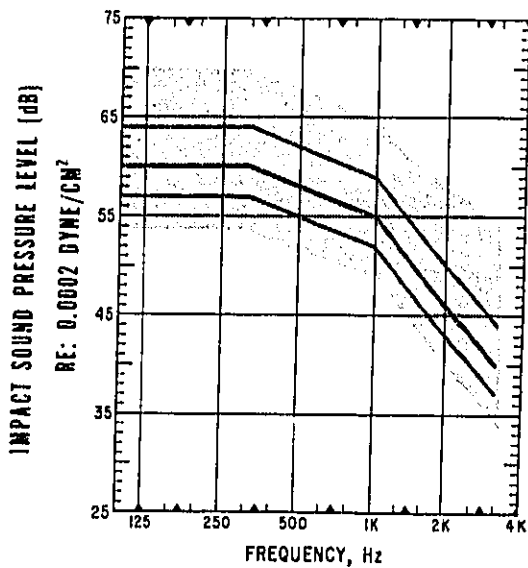
Fig. 10.6. IMPACT

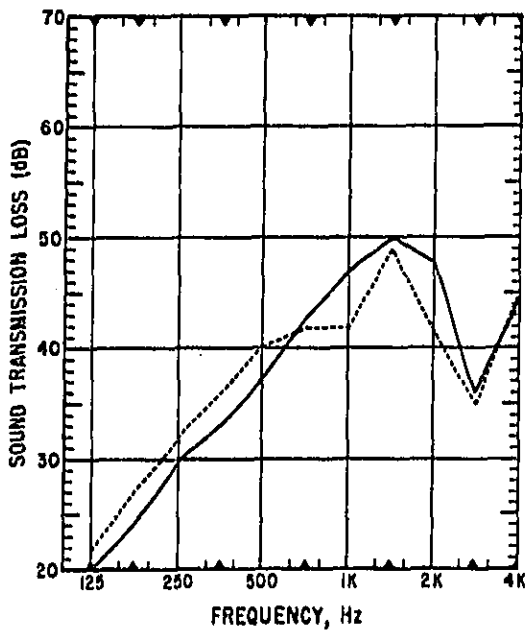
REMARKS: The plotted curve, (a), shows the average value of four laboratory measurements of the same structure under four different conditions of relative humidity (28% - 92%) in the source room. The relative humidity in the receiving room held constant at 55%.

TYPE: METAL CHANNEL STUD, GYPSUM BOARD

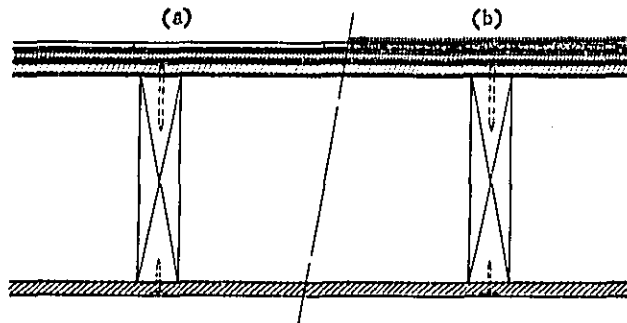
(a) ——— STC = 37; IIC = 33; Fire Rating: 1/2 hr. (est.) - combustible
